MASSACHUSETTS HIGHWAY DEPARTMENT
STRUCTURES INSPECTION FIELD REPORT

ROUTINE INSPECTION

CITY/TOWN CHATHAM	8-STRUCTURE NO. C07001-437-MUN-NBI	11-Kilo. POINT 000.322	41-STATUS A:OPEN	90-ROUTINE INSP. DATE OCT 10, 2006
07-FACILITY CARRIED HWY BRIDGE ST	MEMORIAL NAME/LOCAL NAME	27-YR BUILT 1936	106-YR REBUILT 1980	YR REHAB'D (NON 106) 0000
06-FEATURES INTERSECTED WATER MITCHELL RIVER	26-FUNCTIONAL CLASS Urban Collector	DIST. BRIDGE INSPECTION ENGINEER D.A. Palmer		
43-STRUCTURE TYPE Timber Movable - Bascule	22-OWNER Town Agency	21-MAINTAINER Town Agency	TEAM LEADER S. Reichl	PROJ MGR HNTB Corporation
107-DECK TYPE Timber	WEATHER Sunny	TEMP. (air) 21°C	TEAM MEMBERS D. MYKULAK

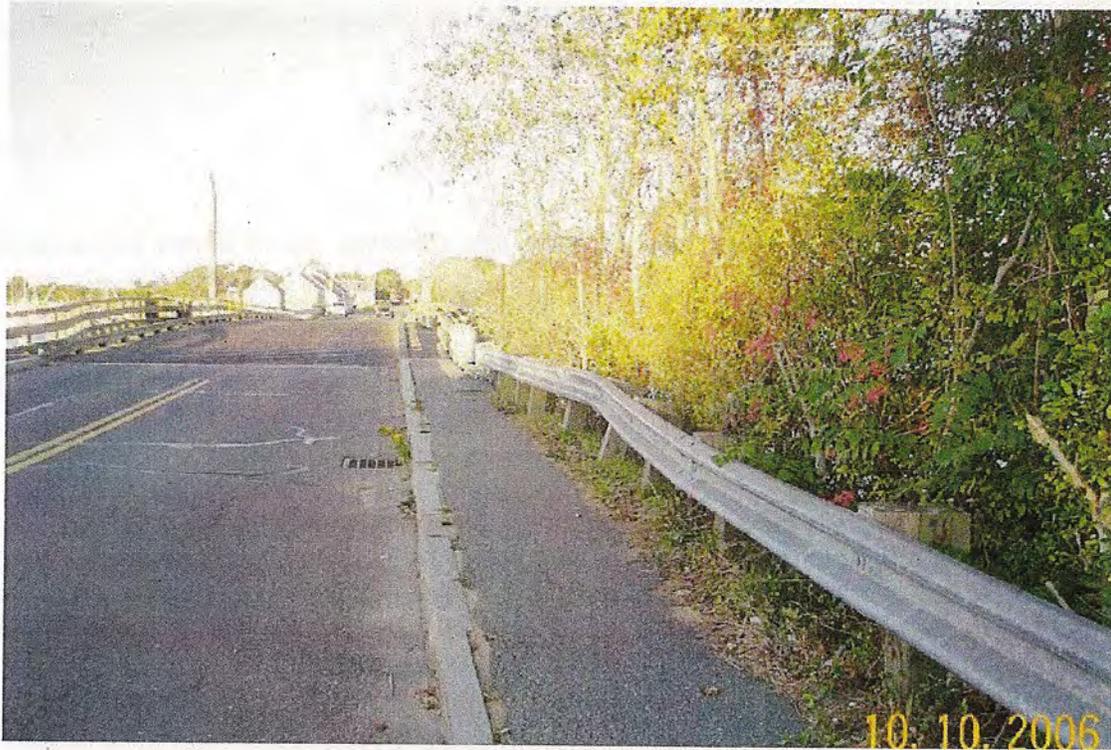
(Fair): The approach guardrails exhibit minor to moderate impact damage at the northwest (15'-0" long by 3" deflection), northeast (25'-0" long by 1'-6" deflection) (**see Photo 1**) and southeast (20'-0" long by 4" deflection) corners of the bridge. The southeast guardrail also has five (5) posts that are not up tight against the abutment wingwall with up to a 1.25" gap (**see Photo 2**). The guardrails consist of multiple types of construction and material and are not continuous for their entire length.

Photo 1: Impact damage to the northeast approach guardrail, looking west.

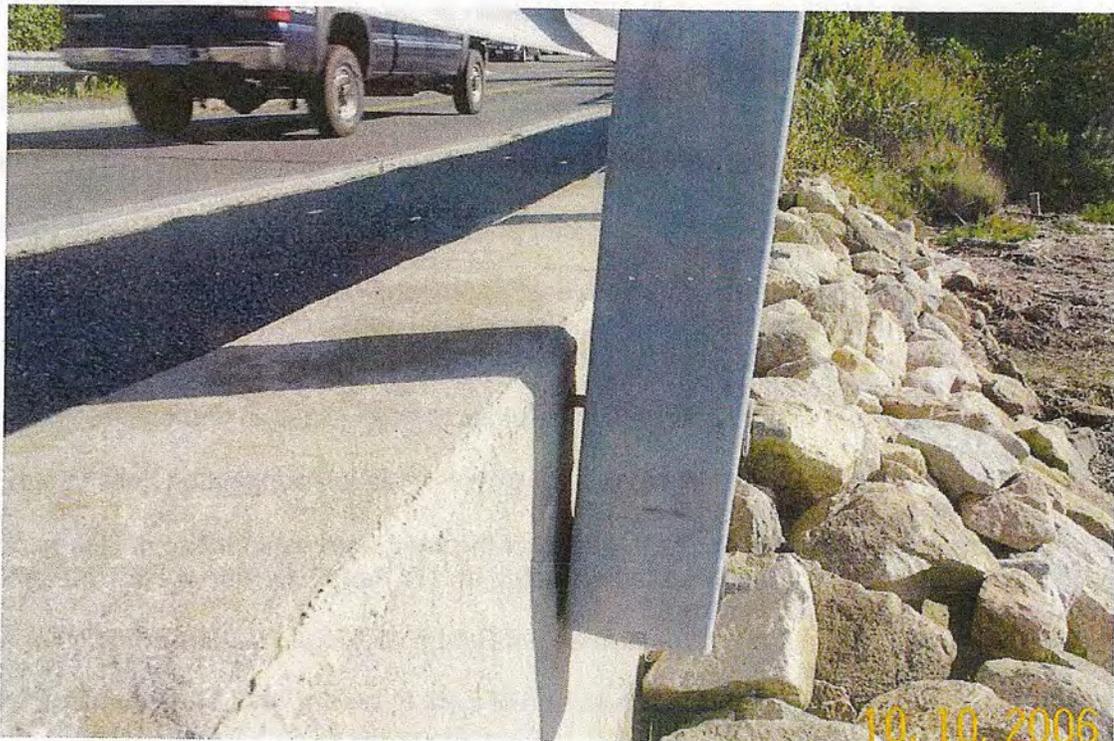
Photo 2: 1 1/4" gap between the southeast approach guardrail post and wingwall, looking east.

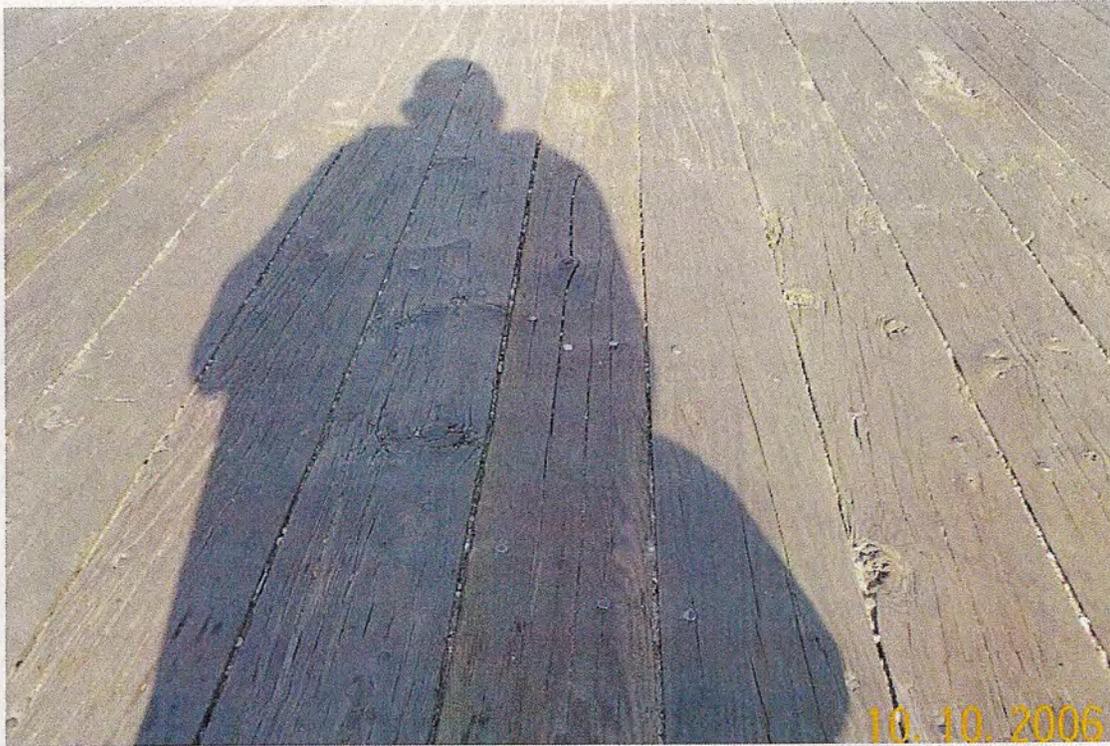
Photo 3: Typical condition of the timber wearing surface in Span 6, looking northwest.

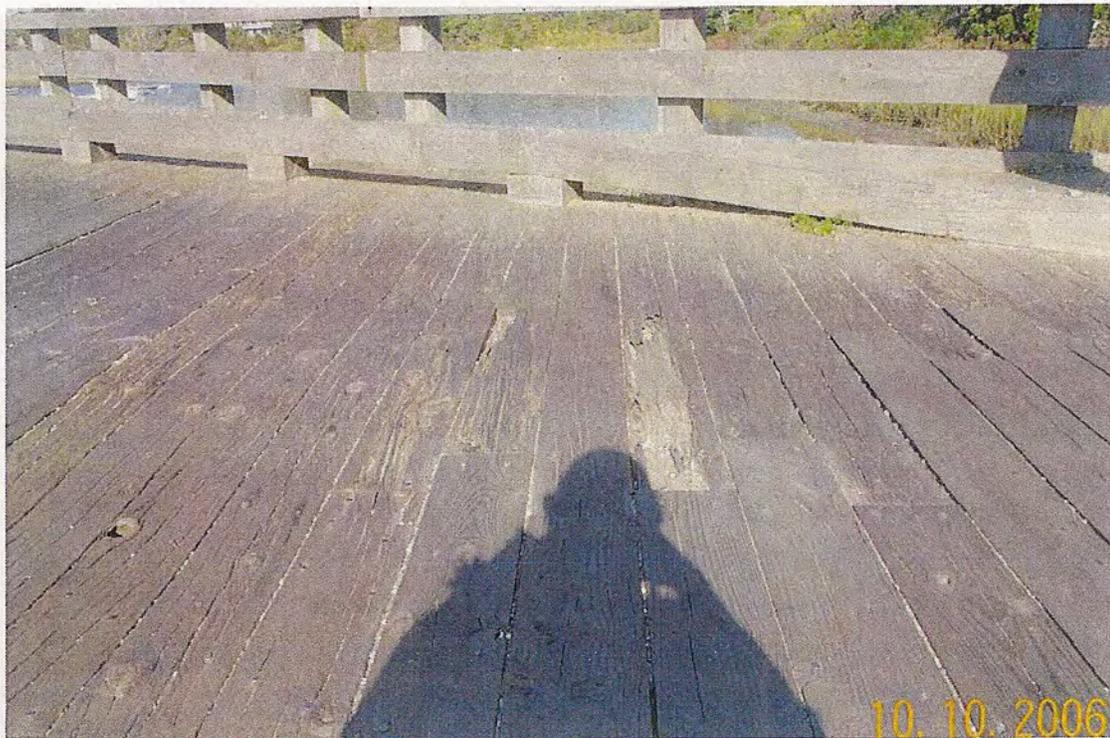
(Poor): The timber wearing surface generally exhibits minor to moderate wear, particularly in the wheel lines, with minor punkiness, splitting and checking throughout. The knots in the wood and the nail heads generally protrude above the surface. Span 6 exhibits the heaviest wear (**see Photo 3**). There are local areas of moderate to heavy deterioration within several of the spans and a few areas with loose and slightly raised up planking in Spans 1 and 12. The approximate area of moderate to heavy deterioration is as follows: Span 1 - 1 s.f., Span 5 - 2 s.f., Span 8 - 4 s.f., Span 9 - 2 s.f. and Span 12 - 5 s.f. (**see Photo 4**).

Photo 4: Moderate to heavy deterioration of the timber wearing surface in Span 12, looking northwest.

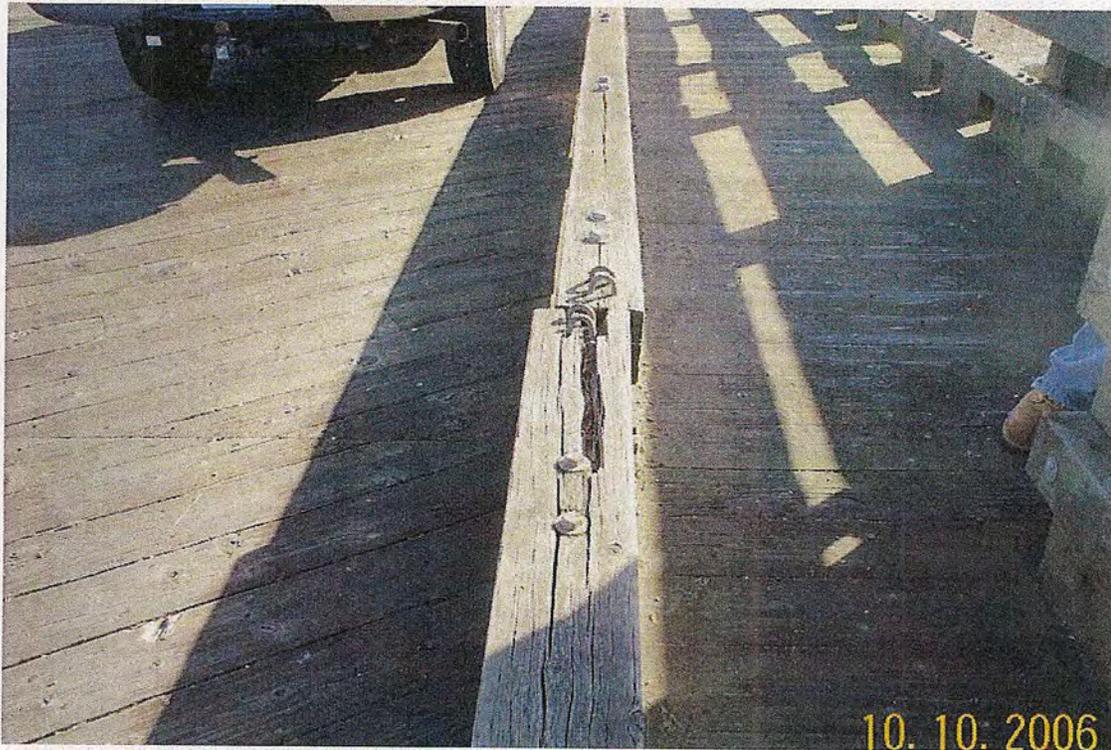
(Satisfactory): The toe of the bascule span (Span 8) appears to have shifted 1.5" to the north (see Photo 5).

Photo 5: Mod/hvy deterioration of curb in bascule span at toe, looking east. Note tight deck joint & 1 1/2" shift of bascule span toe to north.

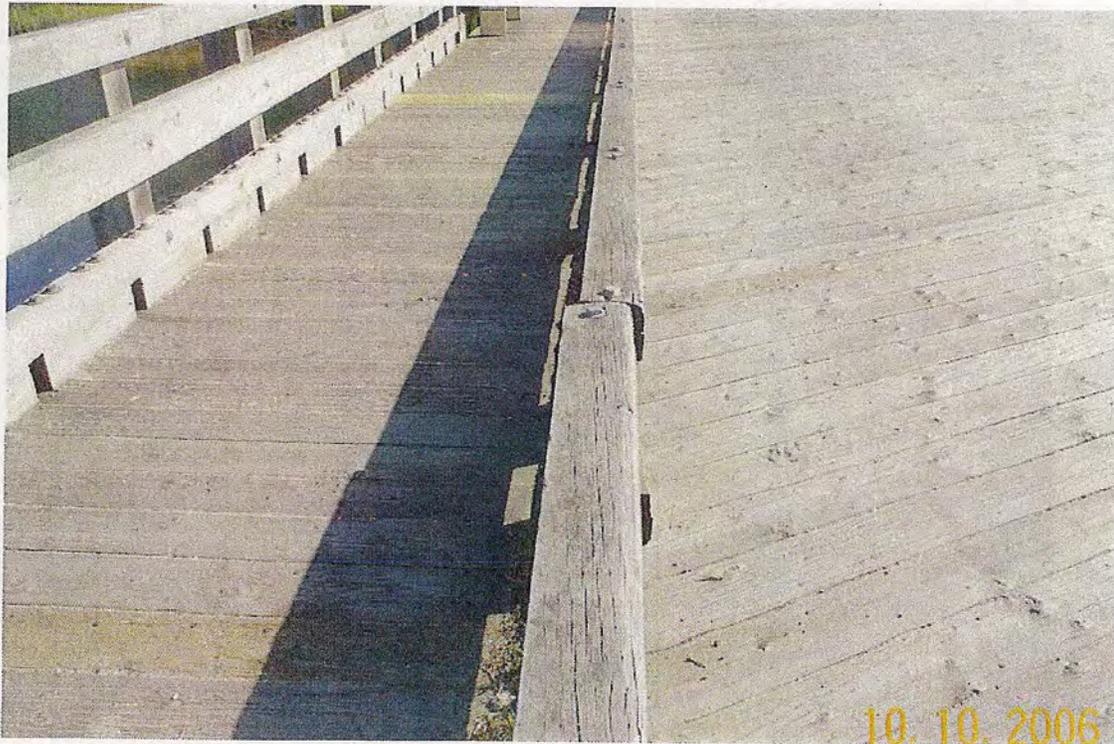
(Fair): The timber curbs exhibit minor punkiness, splitting and checking throughout. The worst case is at the south curb of the bascule span (Span 8) at the east end where there is a 3'-0" length of curb with moderate to heavy deterioration (**see Photo 5**). At several locations the curbs are also slightly misaligned transversely (**see Photo 6**).

Photo 6: Transverse misalignment of the north curb at the east end of Span 12, looking west.

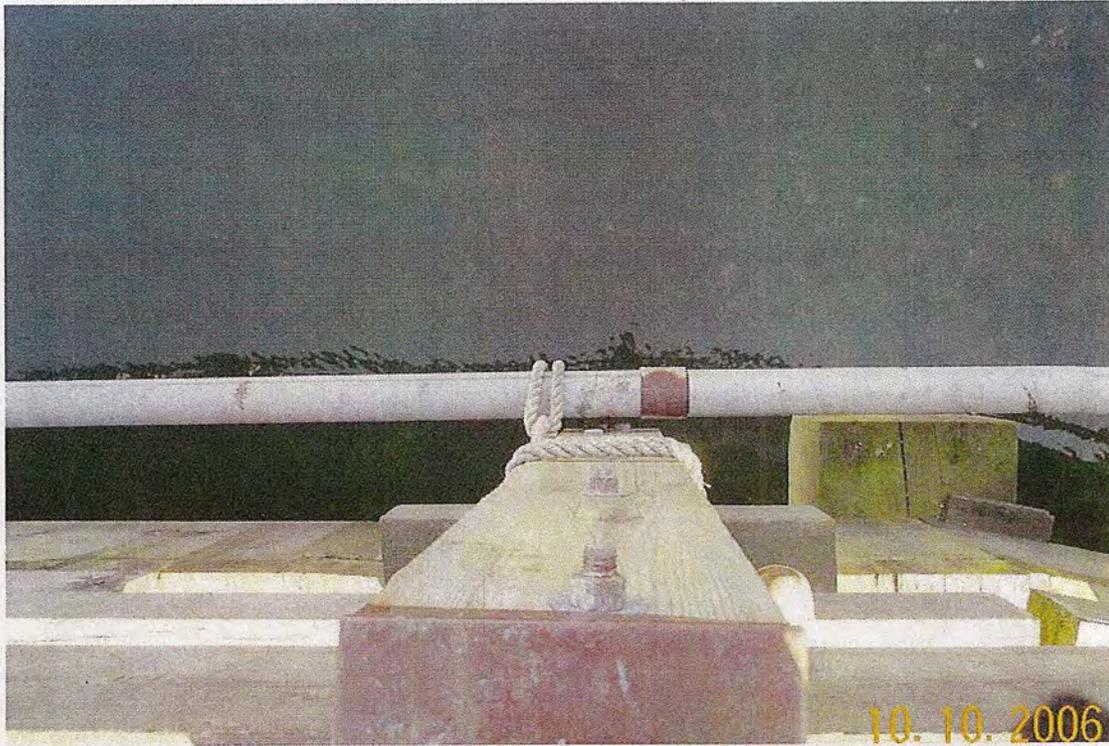
(Fair): There are several deteriorated, broken and loose or missing support brackets for the electrical conduit running along the north side of the bridge (**see Photo 7**). There are deteriorated, broken and loose electrical conduits with exposed wiring running along the west side of Bents 5 and 7A (**see Photo 8**).

Photo 7: Temporary nylon rope support for the electrical conduit on the north side of the bridge at Bent 10, looking down.

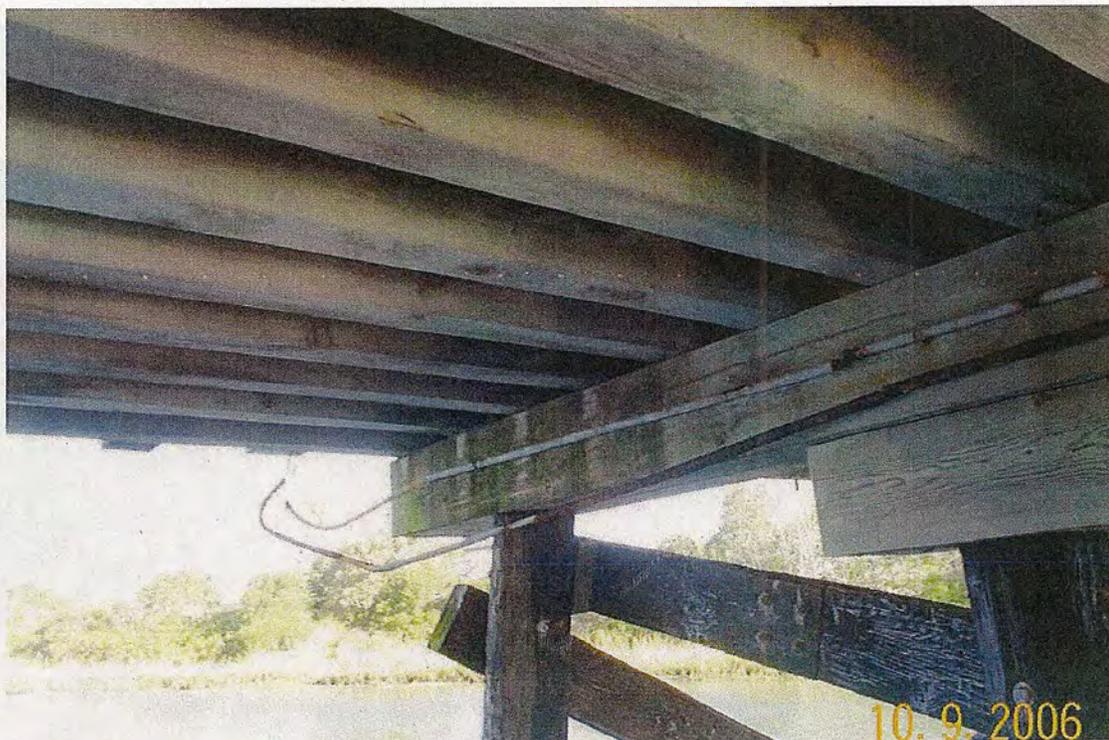
Photo 8: Deteriorated, broken & loose electrical conduit with exp. wiring on west side of Bent 5 at north end, looking northeast.

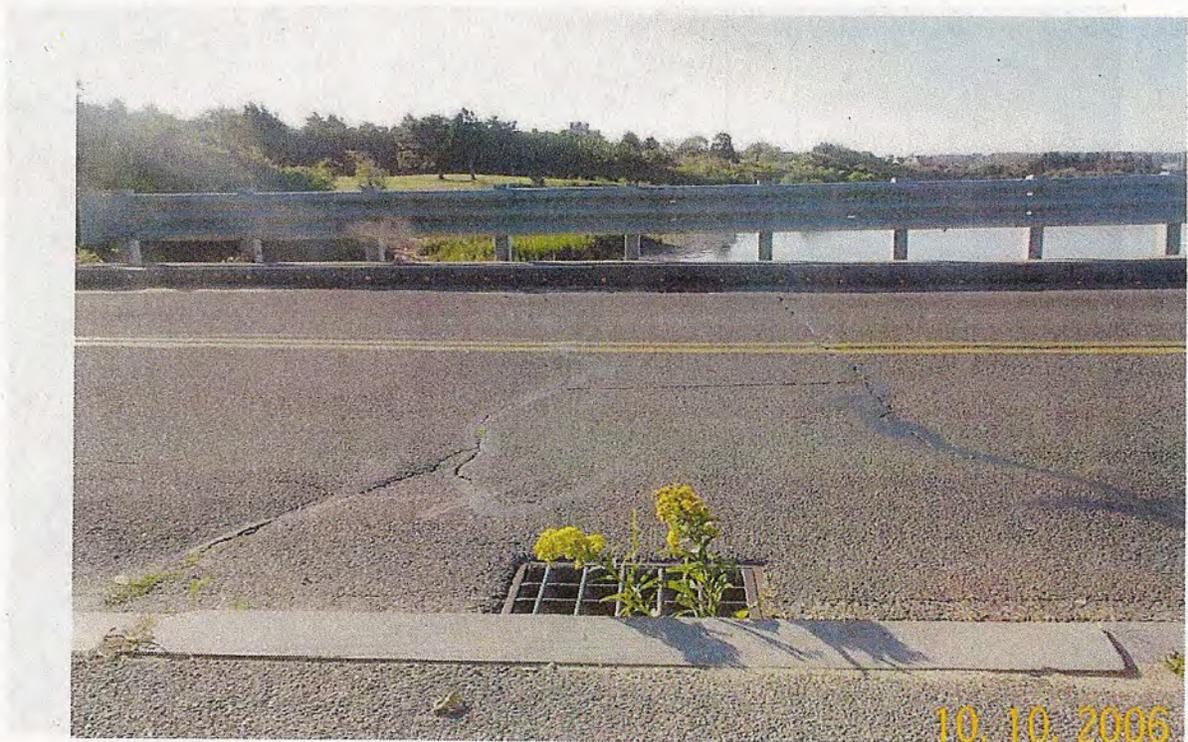
(Fair): The bituminous pavement at both approaches exhibits minor longitudinal and transverse cracking. The cracks have generally been sealed (**see Photo 10**).

(Fair): There is some minor settlement in the westbound lane of the east approach (**see Photo 10**). The settlement noted during the previous inspection in the westbound lane of the west approach appears to have been repaired (**see Photo 11**).

Photo 10: Minor cracking and settlement at the east approach, looking south.

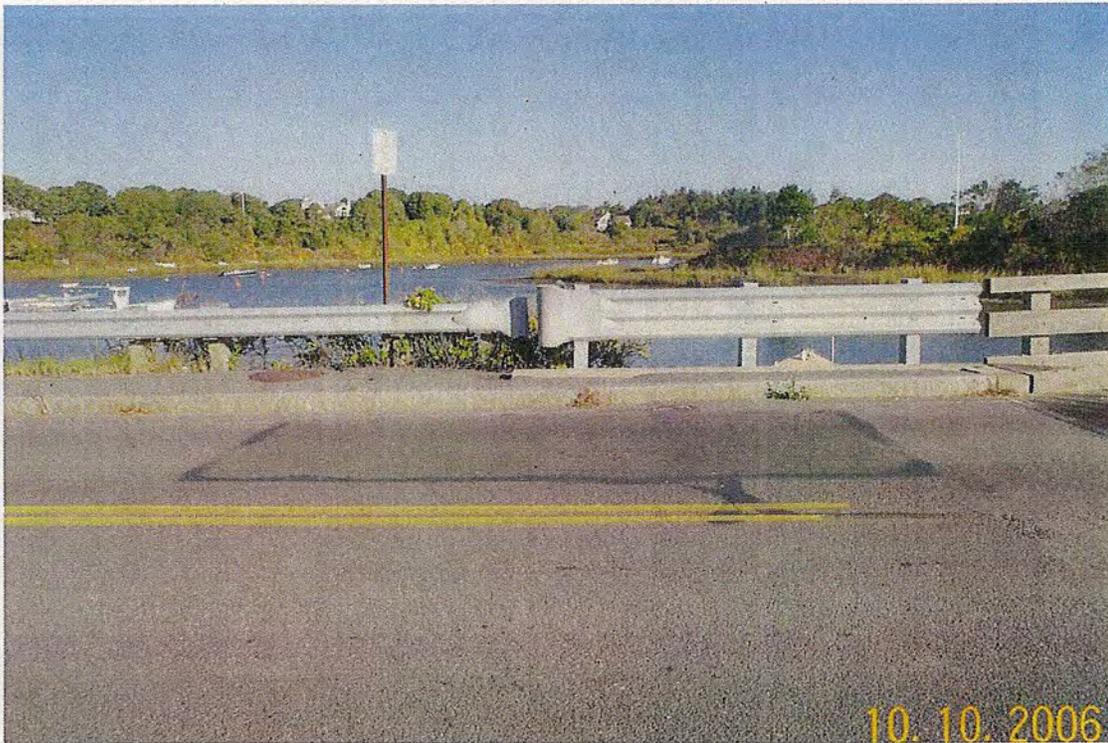
Photo 11: Apparent repair to the westbound lane of the west approach, looking north.

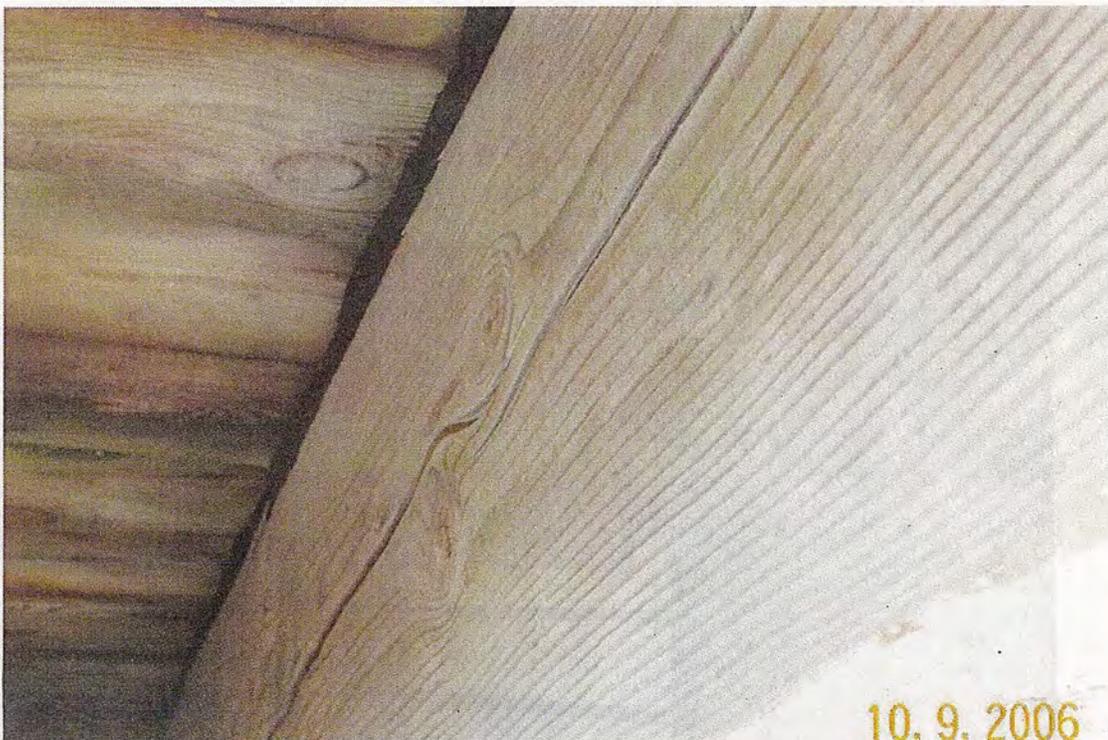
(Satisfactory): The timber stringers generally exhibit minor splitting and checking. Isolated stringers exhibit checks up to 5/16" wide by 5'-0" long with a maximum depth of 1 7/8" (**see Photo 12**). There is some minor collision damage (scrapes and gouges) to the underside of the stringers in the bascule span (Span 8). There is a 3'-0" long by 6" high spall with exposed and rusted rebar on the south side of the abutment span beam at the northeast corner of the bridge.

Photo 12: 5/16" wide by 5'-0" long check on the north side of Stringer 9 from the south in the bascule span (Span 8), looking southeast.

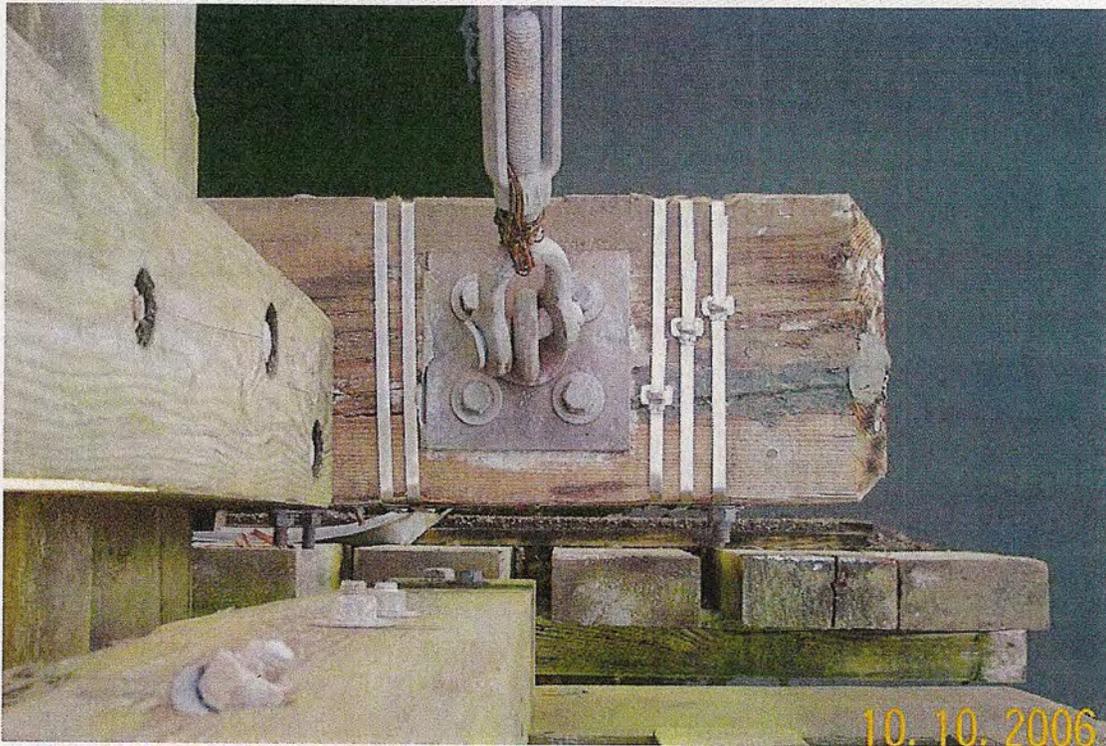
(Fair): The north end of the bascule span (Span 8) timber lifting beam, located at the bascule span toe beneath the stringers, has been temporarily repaired with steel through bolts and metal straps around its perimeter (**see Photo 13**). The Harbor Master informed the inspection crew that the beam had major cracking and splitting at this location and that this is only an interim repair. A new beam has been ordered and will be installed in the near future.

Photo 13: Temporary repair to the north end of the bascule span (Span 8) timber lifting beam, looking west and down.

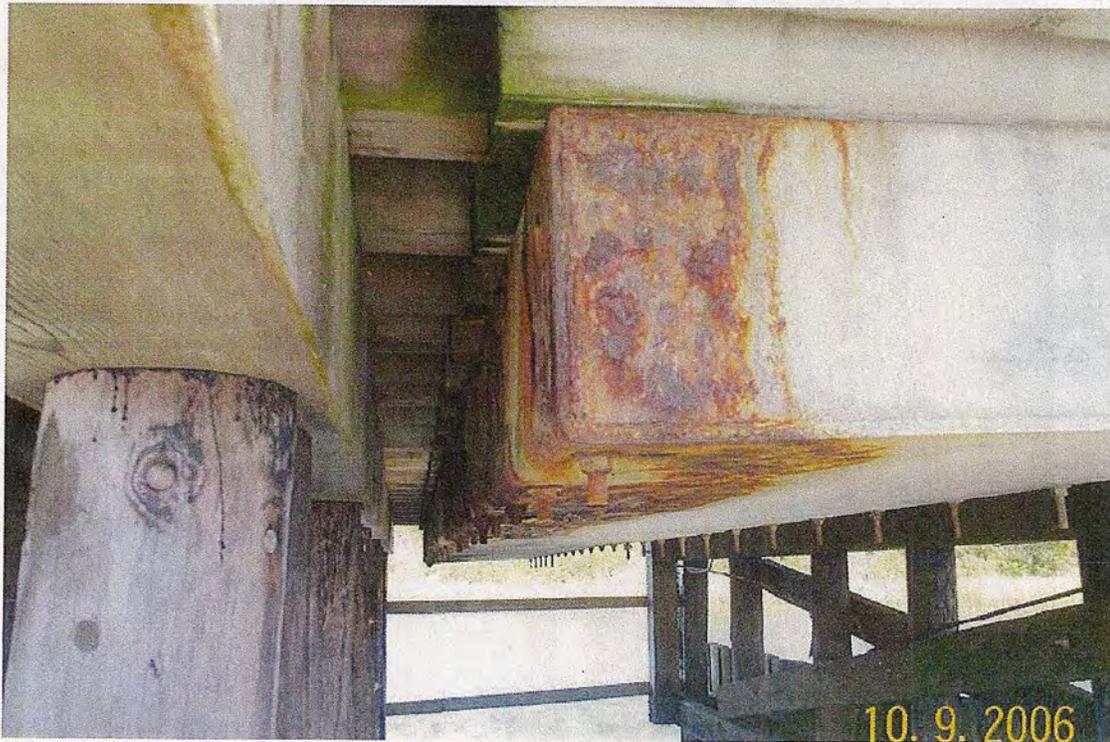
(Fair): There is minor corrosion of the bolts throughout the superstructure. The bascule span (Span 8) counterweight steel shell connection bolts (located in Span 7) exhibit moderate to heavy corrosion with some very minor section loss (see Photo 14).

(Satisfactory): The bascule span (Span 8) counterweight steel shell welds (located in Span 7) are generally in satisfactory condition with some minor rusting (see Photo 14).

(Fair): The bascule span (Span 8) counterweight steel shell galvanized coating (located in Span 7) exhibits moderate to heavy corrosion with some very minor section loss on its west end (see Photo 14).

Photo 14: Mod/hvy corrosion of bascule span ctrnwght steel shell & connection bolts (Span 7), looking north. Note steel welds ok.

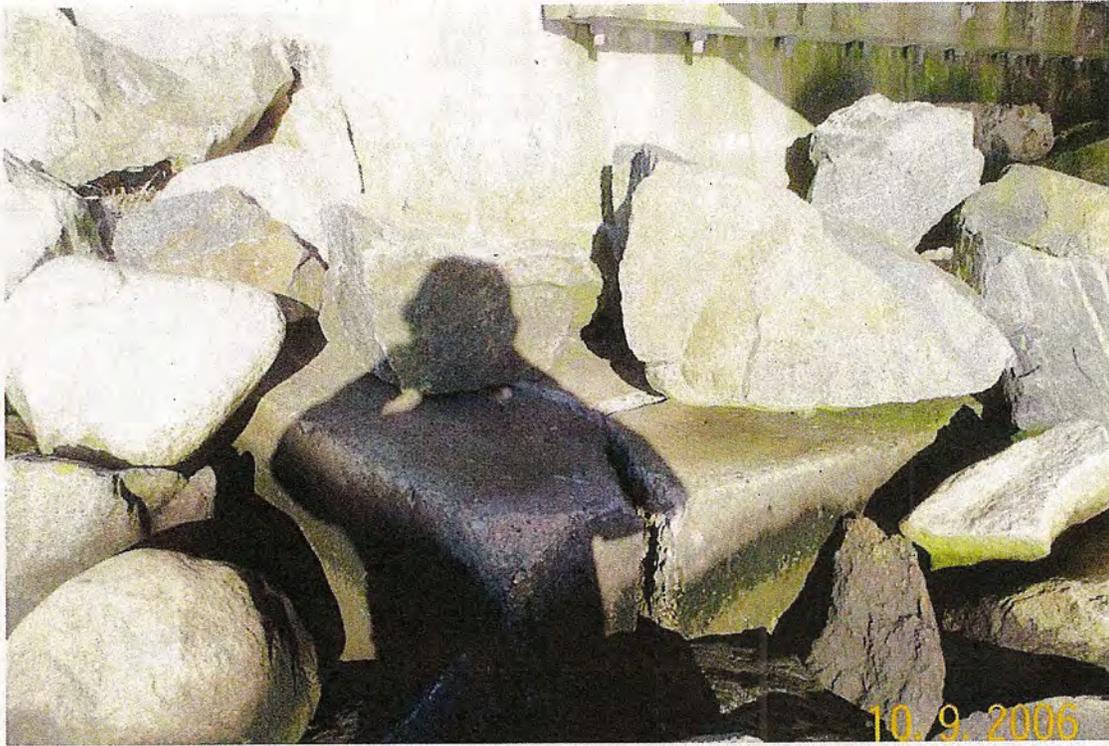
(Fair): There are 2" wide cracks through the south corner of the west abutment footing (see Photo 15). Both the east and west abutment footings at the south end are partially exposed through the rip-rap. Note these footings appear to be only a concrete apron, but there are no available plans to support this.

Photo 15: 2" wide cracks through the south corner of the west abutment footing, looking northwest.

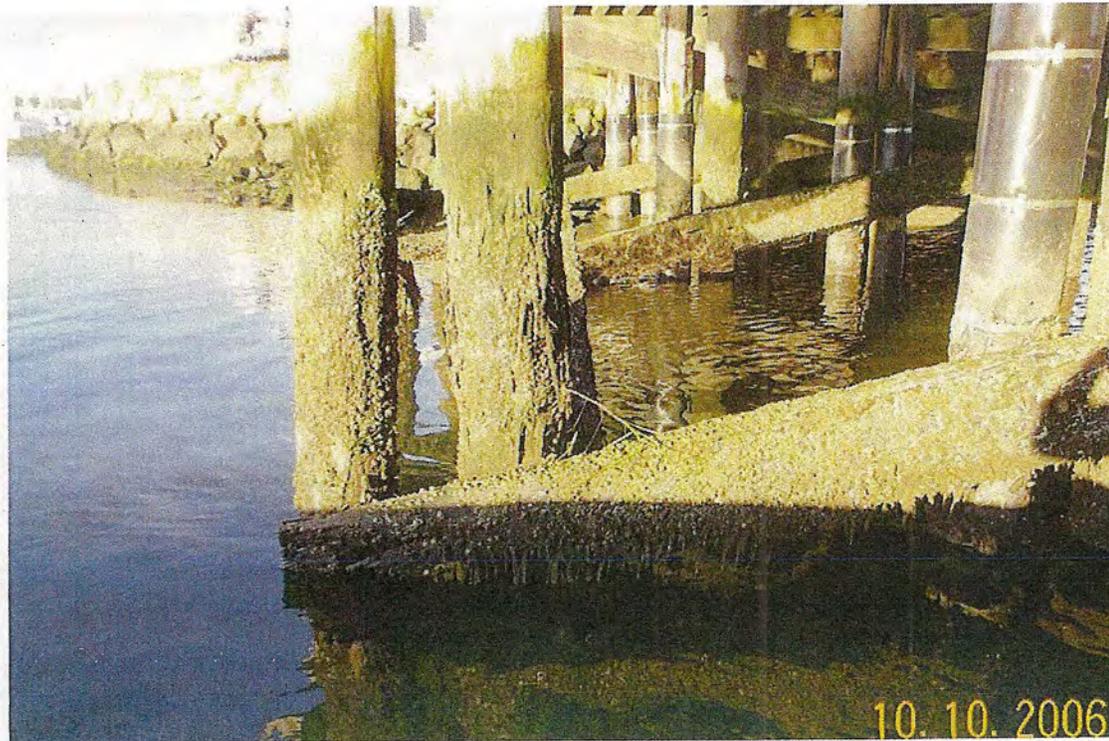
(Fair): The timber piles generally exhibit heavy marine growth with minor to moderate brooming and section loss in the tidal zone (see Photo 16). Above the tidal zone, the piles generally exhibit vertical checks up to 1/8" wide at random locations. There is little to no protective creosote coating remaining on the piles.

Photo 16: Typ. condition of timber piles/bracing, south end of Bent 3, looking west. Note protective sleeve repairs on other piles in view.

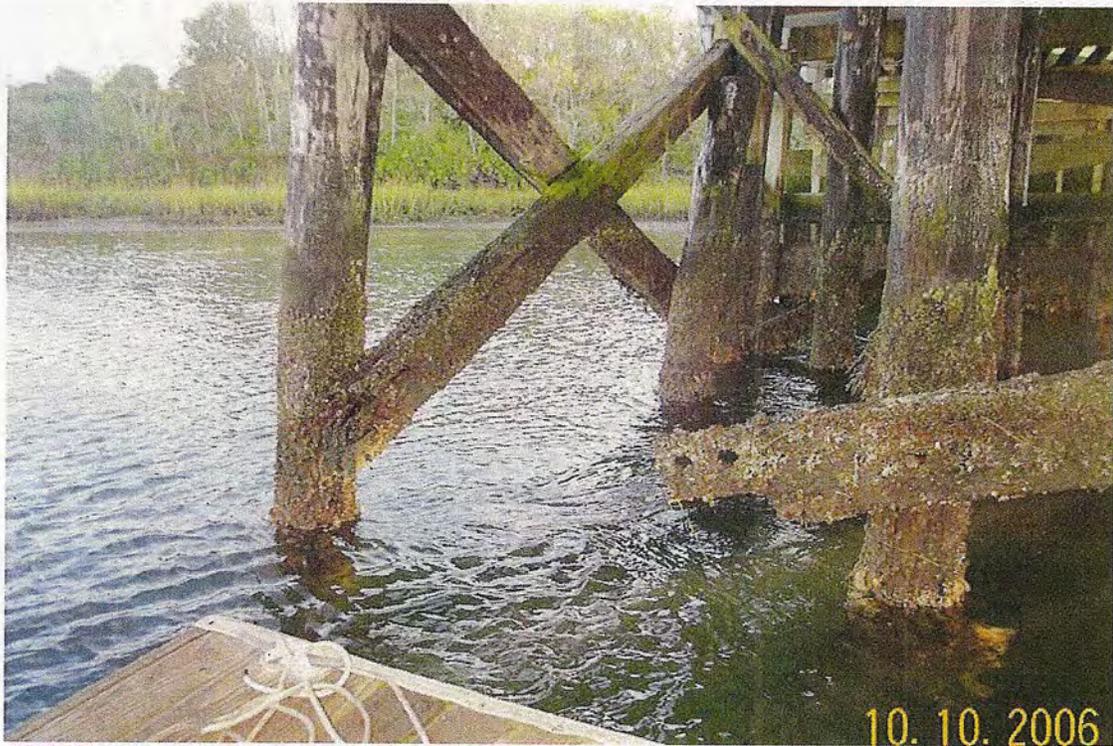
(Poor): (DEF=S/A) The timber bracing (for each individual pile bent) generally exhibits moderate to heavy deterioration and section loss in the tidal zone. **The worst cases are at the north end of Bent 5 where there is a 5'-0" section of the bracing missing (see Photo 17) and at Bent 6 where the center bracing is missing.**

(Poor): The fasteners that attach the bracing generally exhibit moderate to heavy corrosion with moderate to heavy section loss in the tidal zone (primarily at the bolt ends, the washers and the nuts) (see Photos 17 and 18).

Photo 17: Missing sect. of diag. bracing, north end of Bent 5, looking NE. Note condition of fasteners on remaining portion at pile.

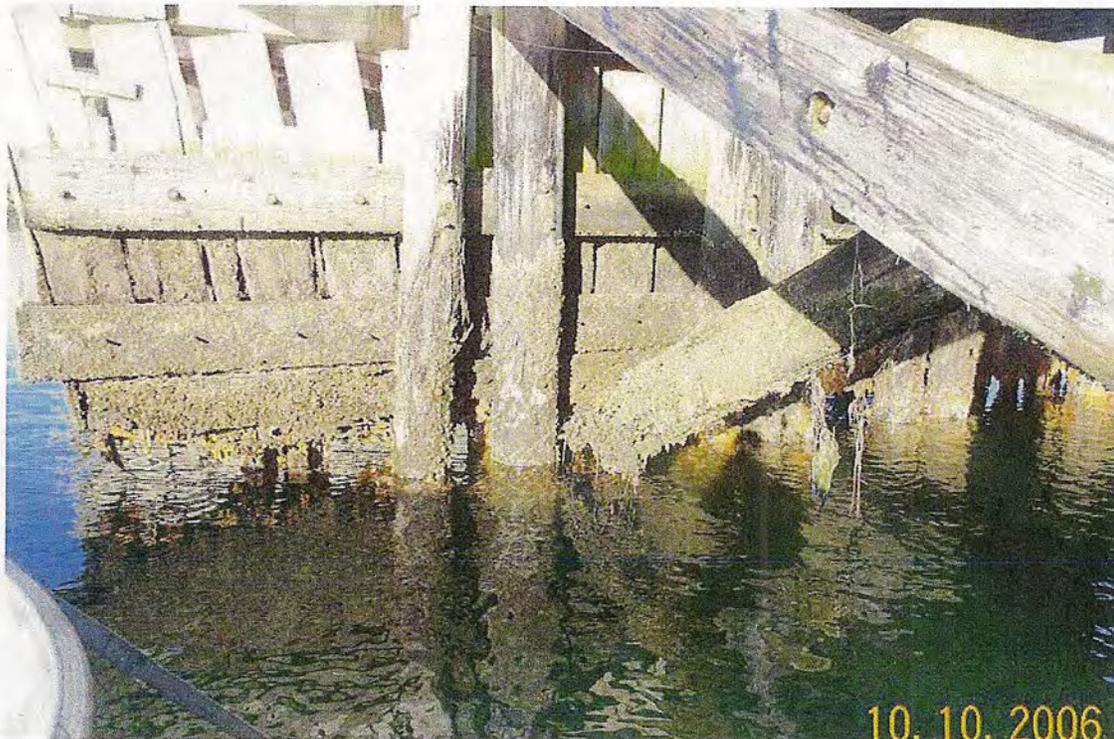
(Poor): (DEF=S/A) The timber bracing (between pile bents) generally exhibits moderate to heavy deterioration and section loss in the tidal zone. **The worst case is at the south end of Bent 8 where there is a 4'-0" section of the bracing missing (see Photo 18).**

(Poor): (DEF=S/A) The horizontal timber members generally exhibit moderate splitting and checking above the tidal zone. **In the tidal zone, these members exhibit heavy marine growth with moderate to heavy deterioration and section loss (up to 100%) (see Photo 18).** See Routine Underwater Inspection Report for more information.

Photo 18: Missing sect. of horiz. bracing, south end of Bent 8, looking NW. Note cond. of fasteners on remaining portion & fender walers.

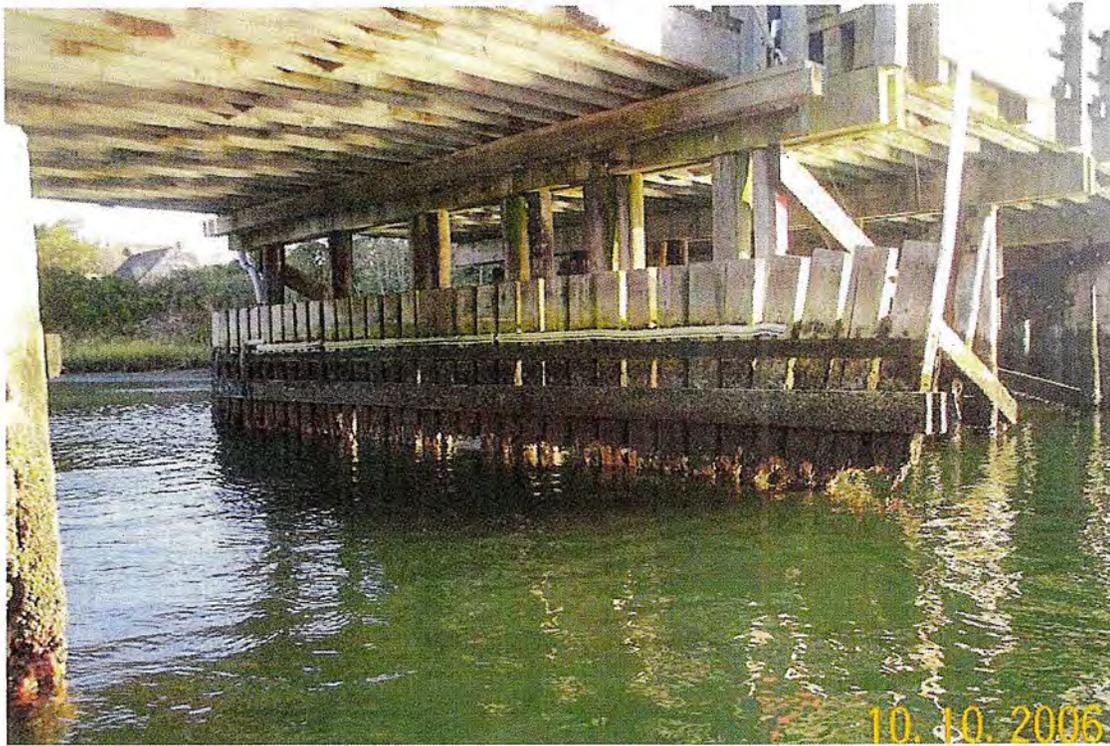
Photo 19: Typical condition of the vertical timber members of the fender at Bent 8, looking northeast. Note the impact damage at both ends.
