STRUCTURES INSPECTION FIELD REPORT

2-DIST 05
B.I.N. 437

ROUTINE INSPECTION

CITY/TOWN CHATHAM		8-STRUCTURE NO. C07001-437-MUN-NBI		11-KILO POINT 000.322	41-STATUS A:OPEN	90-ROUTINE INSP DATE OCT 7, 2008	
07-FACILITY CARRIED HWY BRIDGE ST		MEMORIAL NAME/LOCAL NAME		27-YR BUILT 1936	106-YR REBUILT 1980	YR REHAB'D (NON 106) 2007	
06-FEATURES INTERSECTED WATER MITCHELL RIVER		26-FUNCTIONAL CLASS Urban Collector		DIST. BRIDGE INSPECTION ENGINEER D. A. Palmer			
43-STRUCTURE TYPE 716 : Timber Movable - Bascule		22-OWNER Town Agency	21-MAINTAINER Town Agency	TEAM LEADER S. M. Darling		PROJ MGR Transystems Lichtenstein	
107-DECK TYPE 8 : Timber		WEATHER Sunny	TEMP (air) 16°C	TEAM MEMBERS J. KLOFAS

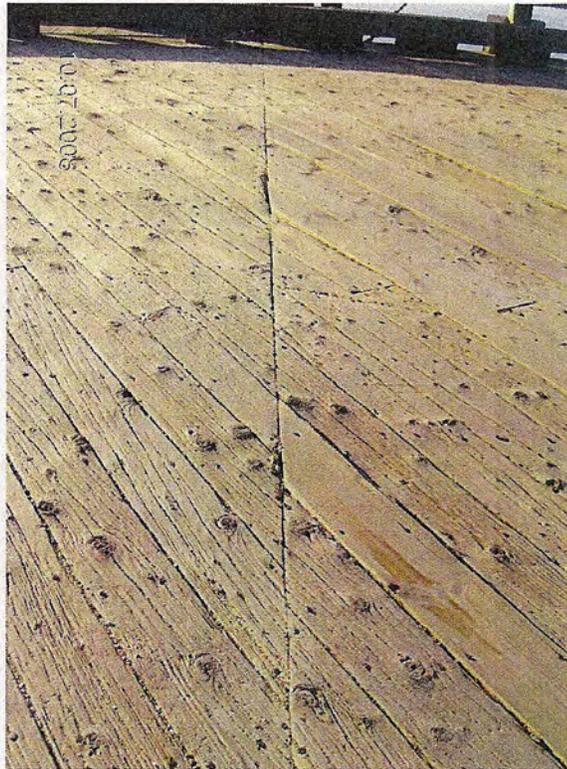
(Fair): The timber wearing surface has moderate wear, particularly in the wheel lines, with slight punkiness, splits and checks throughout. The knots in the wood and the nail heads generally protrude above the surface (**see photo 1**). Random wearing surface planks have been replaced throughout the deck.

Photo 1: Worn wearing surface with protruding knots and nail heads. Note also the very tight joint (toe end of bascule span).

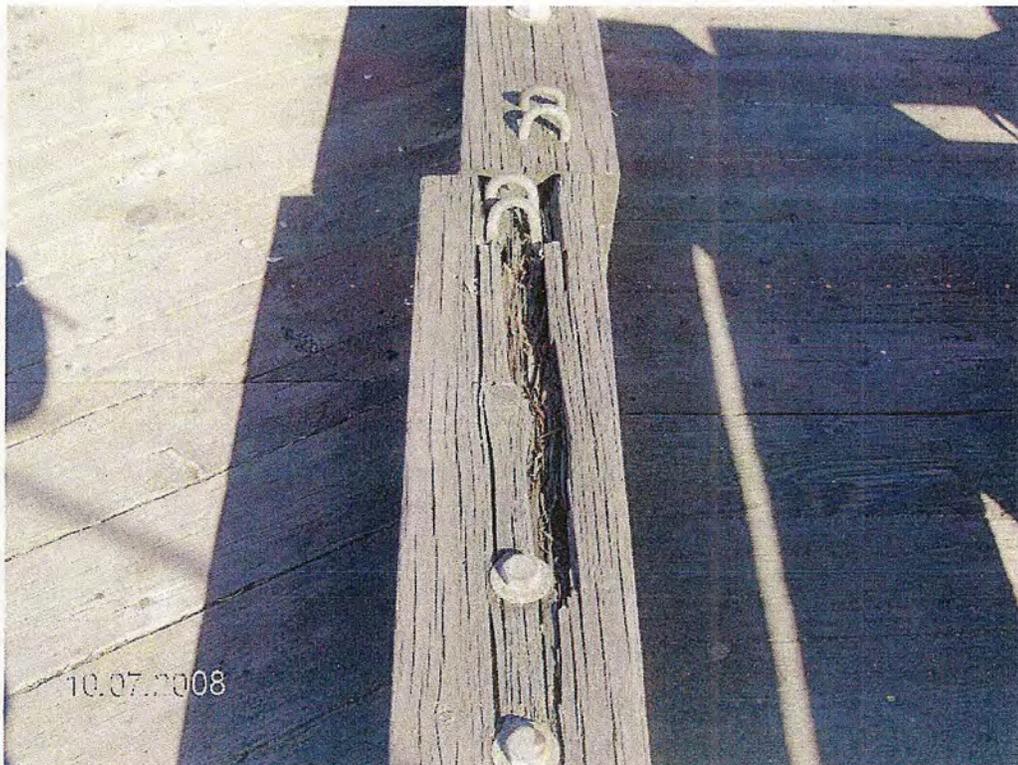
(Fair): The timber curbs which also act as a traffic rail have minor splits and checks throughout. The worst case is at the east end of the bascule span (span 8) south curb where a 3'-0" length of curb is heavily deteriorated (**see photo 2**). At several locations the curb/traffic rails are misaligned transversely up to 1 1/2" (**see photo 3**).

Photo 2: Deterioration of the south curb/traffic rail at the east end of span 8.

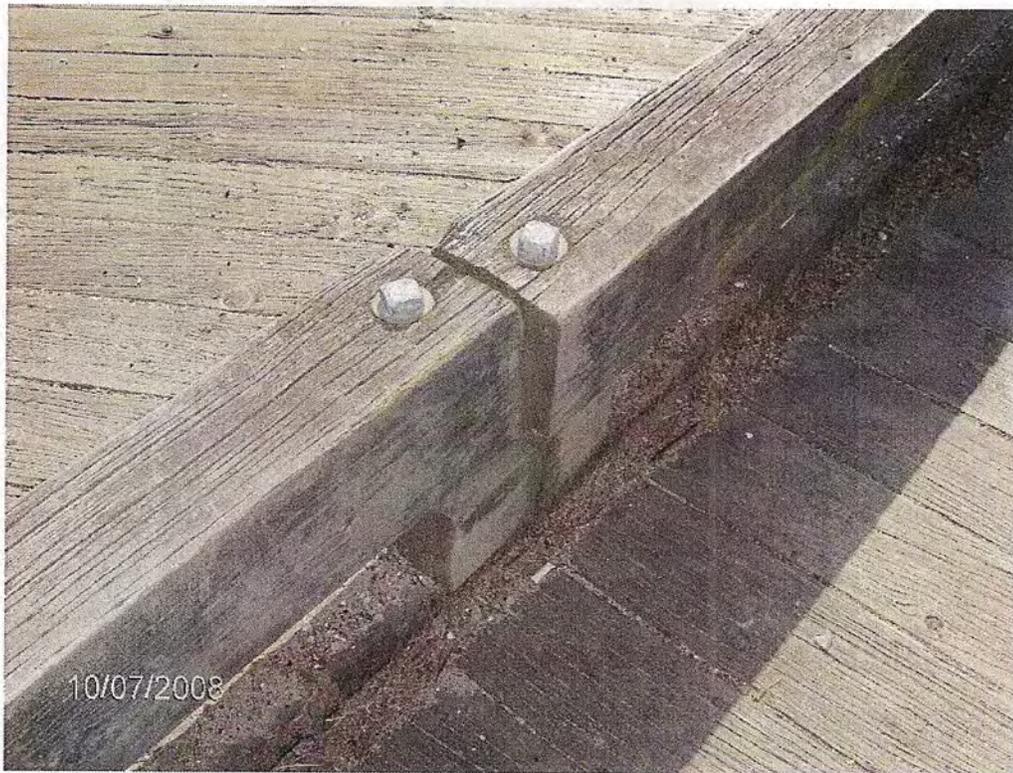
Photo 3: 1 1/2" of misalignment of the north curb/traffic rail between spans 2 and 3.

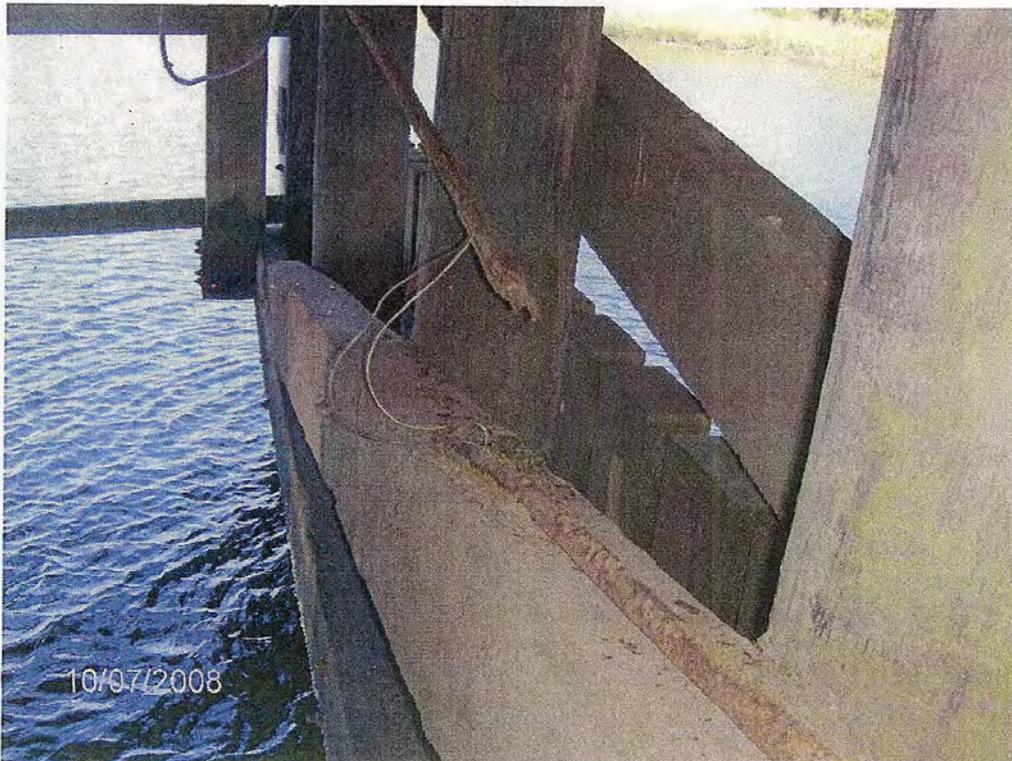
(Fair): There are several deteriorated, broken, loose or missing support brackets for the electrical conduit along the north side of the bridge. At one location in span 11, the conduit has been temporarily fastened with rope. In addition, there are deteriorated, broken and loose electrical conduits with exposed wiring along the west side of bents 5 and 7A which appear abandoned (**see photo 4**).

Photo 4: Deteriorated utility conduit with exposed wires at bent 7A.

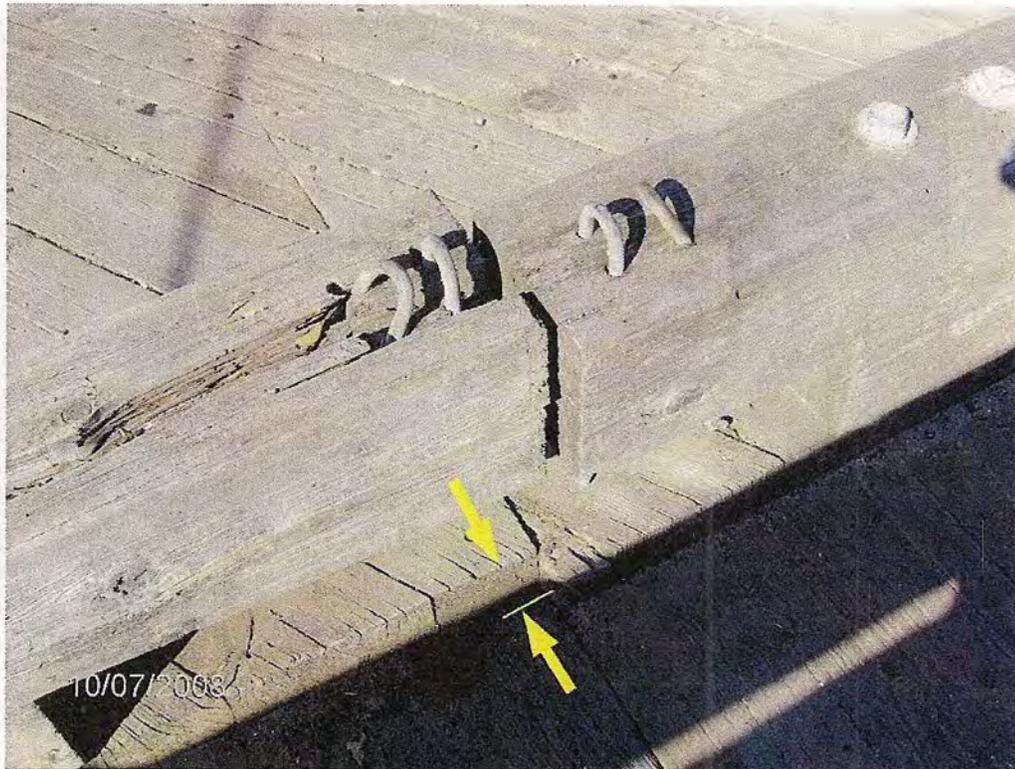
(Poor): The steel armor at both abutment deck joints exhibits minor scraps and gouges, particularly at the east abutment. The timber joint at the east end of the bascule span (span 8) is extremely tight when the bridge is closed. The bascule span deck remains approximately 1/2" higher than the adjacent span deck at this joint after an opening and does not close completely until traffic drives over the joint. There is 1 1/2" of lateral misalignment between the span 8 and span 9 deck along the bent 8 deck joint (**see photo 5**).

(Satisfactory): The toe end of the bascule span (span 8) appears to have shifted 1 1/2" to the north, see Item 58.13 for additional comments.

Photo 5: 1 1/2" of misalignment of the bascule span toe towards the north.

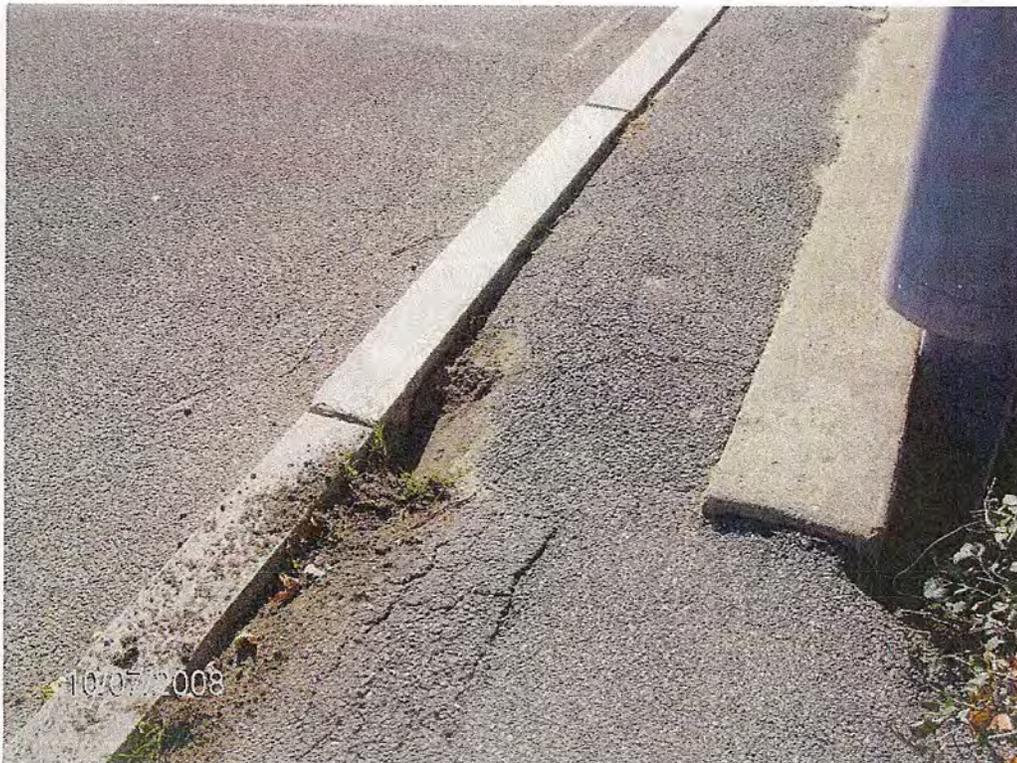
(Fair): The northwest and southwest approach sidewalks have settled up to 2". The northeast approach sidewalk has a 2'-1" wide area with up to 4" of settlement along the curb (**see photo 6**).

Photo 6: 4" deep settlement of the northeast approach sidewalk.

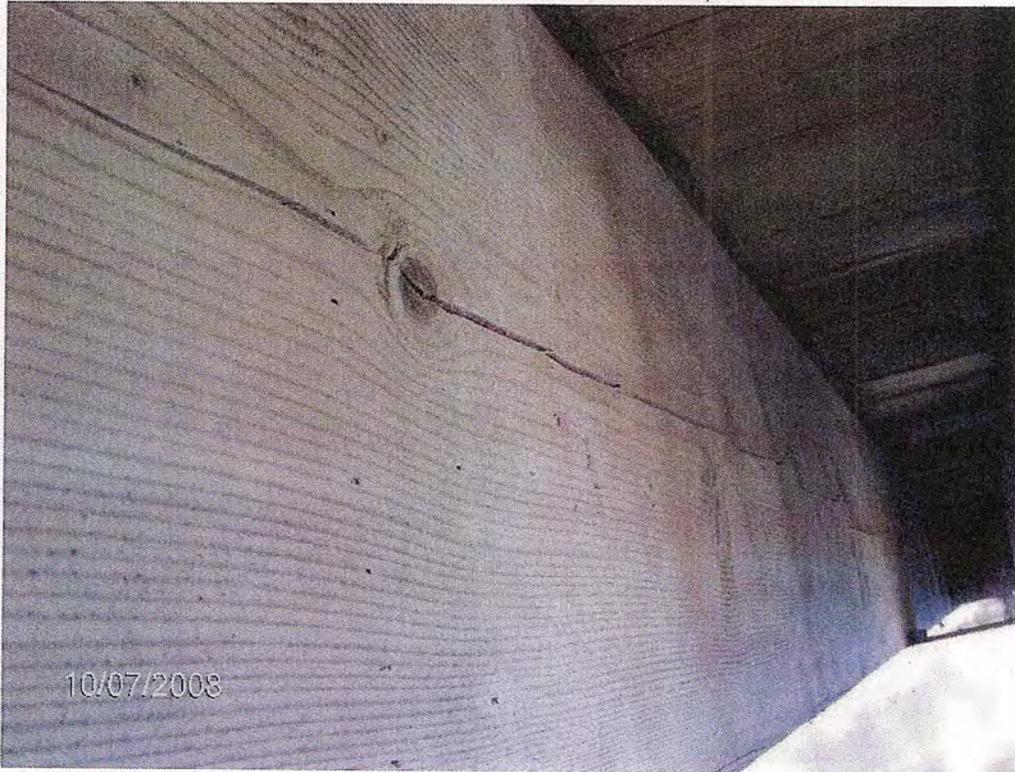
Photo 7: 1/8" wide check in timber stringer S2 of span 10.

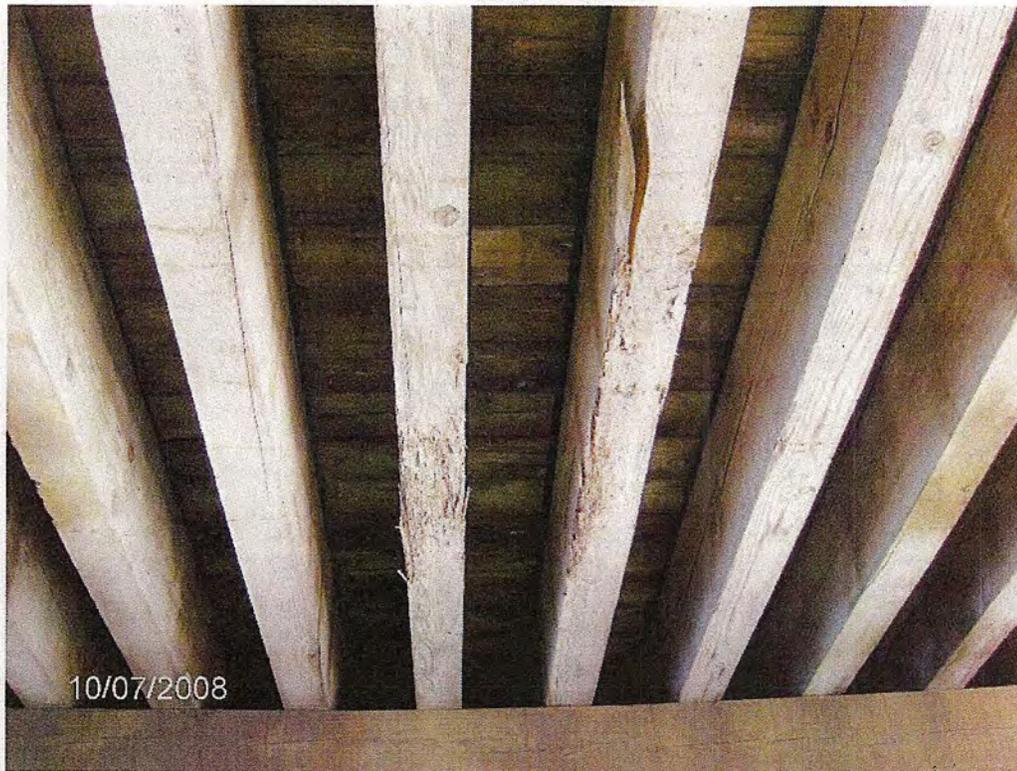
There is minor collision damage (scrapes and gouges) to the underside of the stringers in the bascule span (span 8) (see photo 9).

Photo 9: Collision damage to the underside of the bascule span (span 8) stringers.

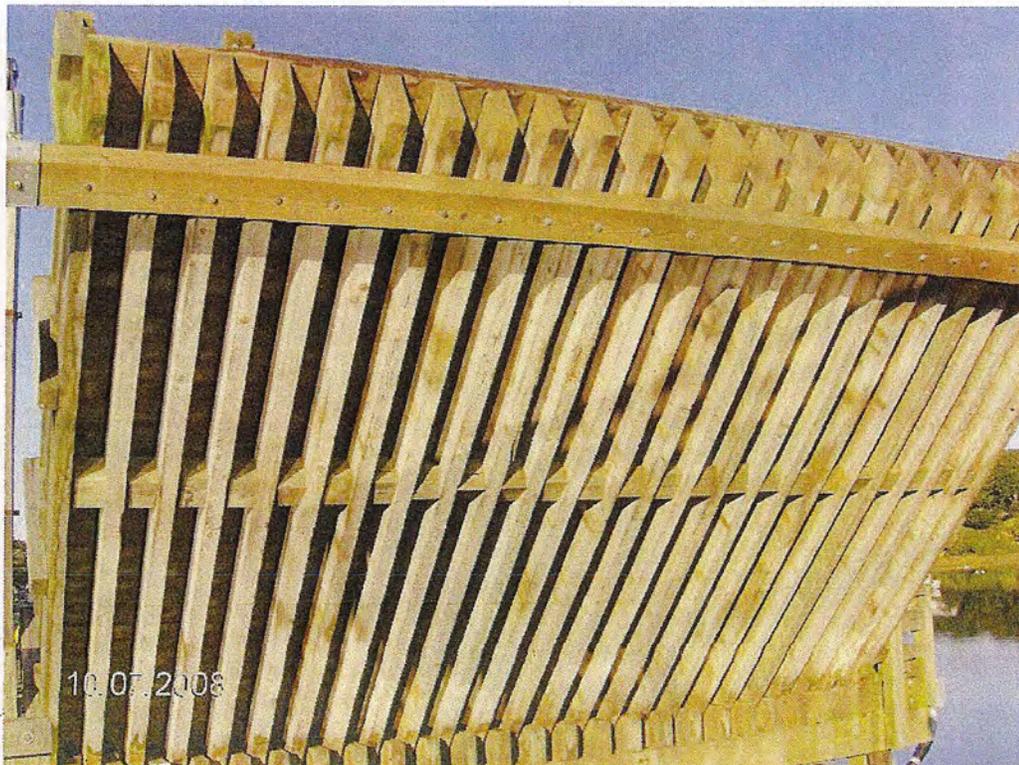
(Good): The bascule span (span 8) timber lifting beam has been replaced since the last inspection (**see photo 10**).

Photo 10: New bascule span lifting beam.

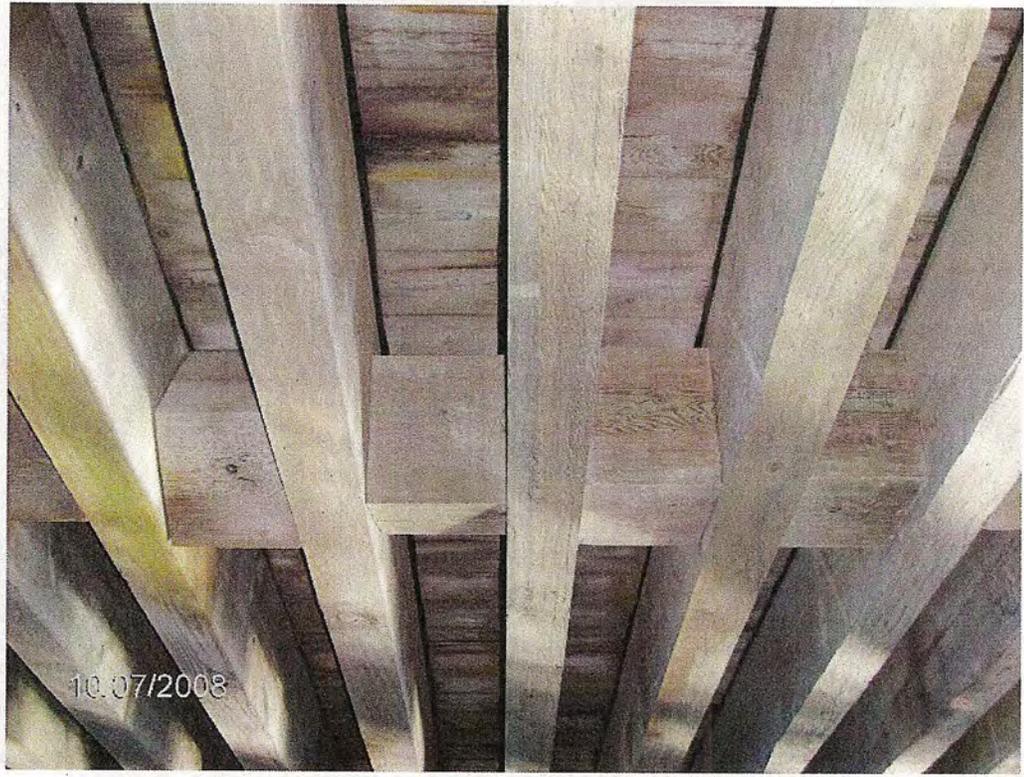
(Satisfactory): Many of the timber spacer blocks between the stringers are loose and/or have rotated (**see photo 11**). Random blocks exhibit minor shakes and checking. There is an isolated spacer block in span 12 which exhibits severe deterioration between the third and fourth stringers from the south.

Photo 11: Loose and rotated spacer blocks in span 3.

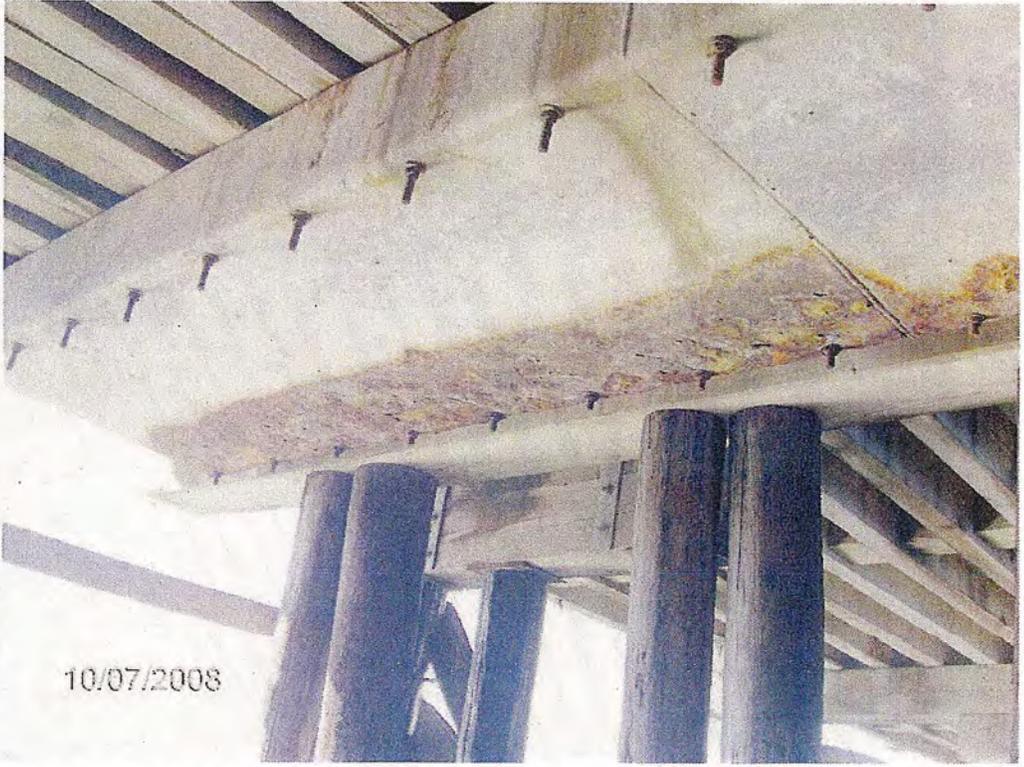
(Fair): The bascule span (span 8) counterweight steel shell galvanized coating (located in span 7) exhibits moderate to heavy corrosion with some minor section loss on its west end (see photo 12).

Photo 12: Failed galvanized coating on the underside of the counterweight steel shell.

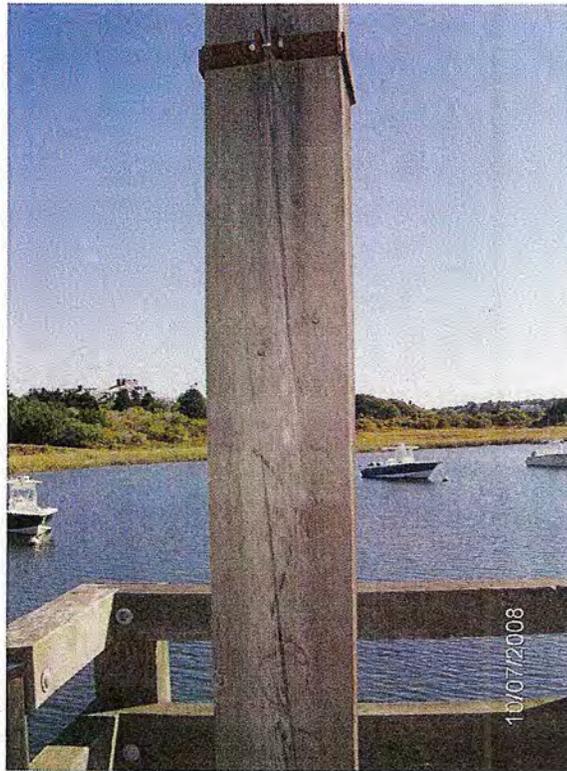
(Satisfactory): The timber king posts exhibit checks up to 1/4" wide by 4'-0" long with a maximum depth of 3" throughout their entire height with the heaviest concentration on the north face of the south post (see photo 13).

Photo 13: Checks in the north face of the bascule span south king post.

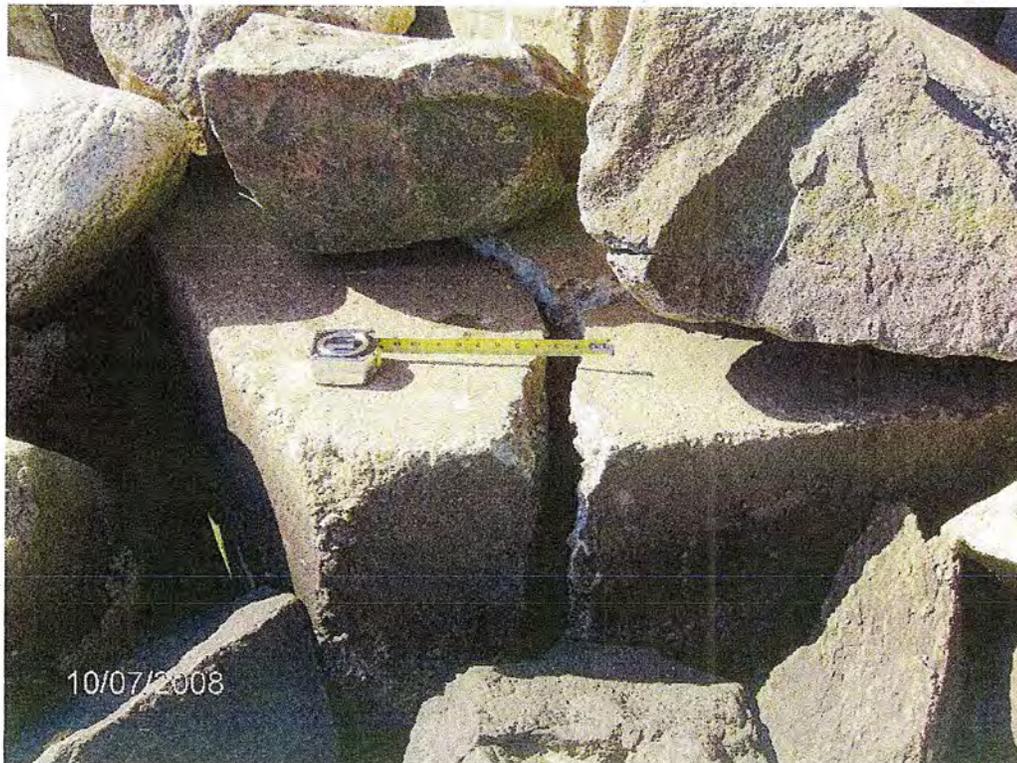
(Fair): Both the east and west abutment footings at the south end are partially exposed through the rip-rap. There are up to 3" wide cracks through the south corner of the west abutment footing (see photo 14). Note these footings appear to be a concrete apron, but there are no available plans to support this.

Photo 14: 3" wide crack in the south end of the west abutment footing/apron.

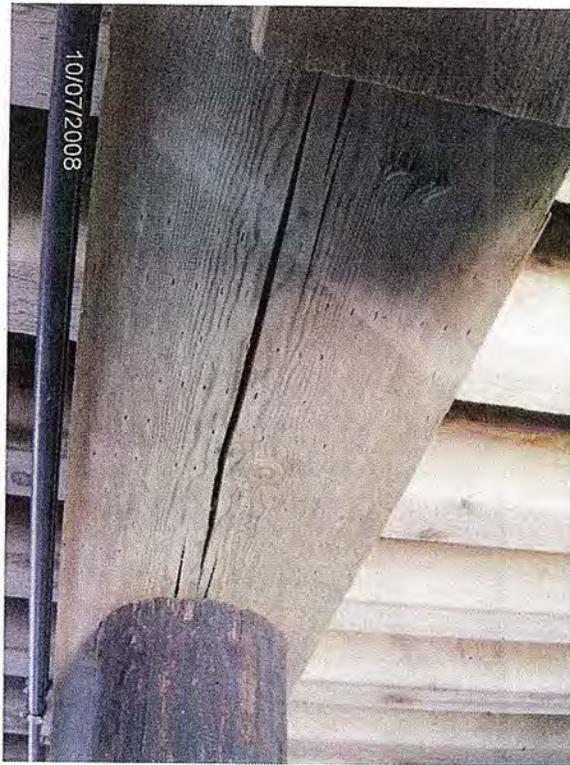
(Satisfactory): The timber pile caps typically have up to 1/16" wide checks on all surfaces. Isolated timber caps have 1/8" to 1/4" wide checks which measure up to 3'-0" long (see photo 15).

Photo 15: 1/4" wide check in the underside of the bent 5 cap.

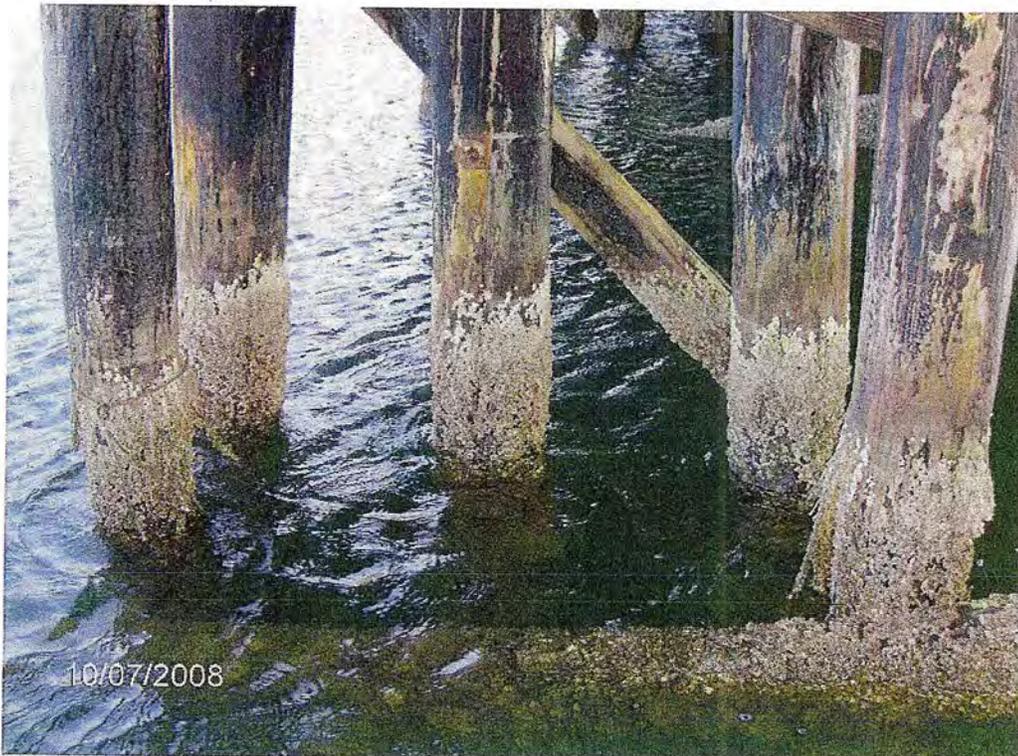
(Fair): The timber piles typically have heavy marine growth with minor to moderate brooming and section loss in the tidal zone (**see photo 16**). Above the tidal zone, the piles have vertical checks up to 1/8" wide at random locations. Random piles throughout have had a section removed from the upper portion of the pile typically 3" deep by 2'-6" high. There is little to no protective creosote coating remaining on the piles. Protective sleeves have been placed around several piles at bents 1, 2, 3 and 4. See the attached Routine Underwater Inspection Report for more information.

Photo 16: Typical condition of timber piles/bracing in the tidal zone (north end of bent 4 shown).

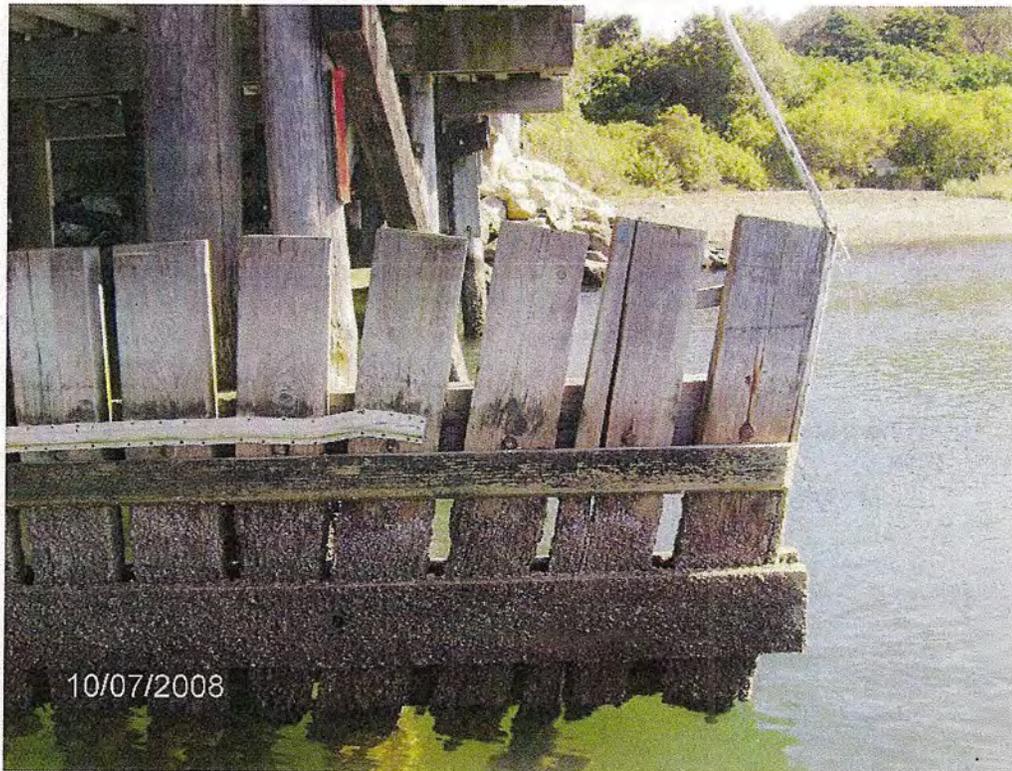
(Serious): (DEF=S/A) The vertical timber members generally exhibit moderate splitting and checking above the tidal zone. **In the tidal zone, these members exhibit heavy marine growth with moderate to heavy deterioration and section loss (up to 100%).** The east fender also exhibits impact damage at its north and south ends with several vertical timber members leaning/rotated (**see photo 17**). See the attached Routine Underwater Inspection Report for more information.

Photo 17: Collision damage and heavy deterioration to south end of the bent 8 fender.

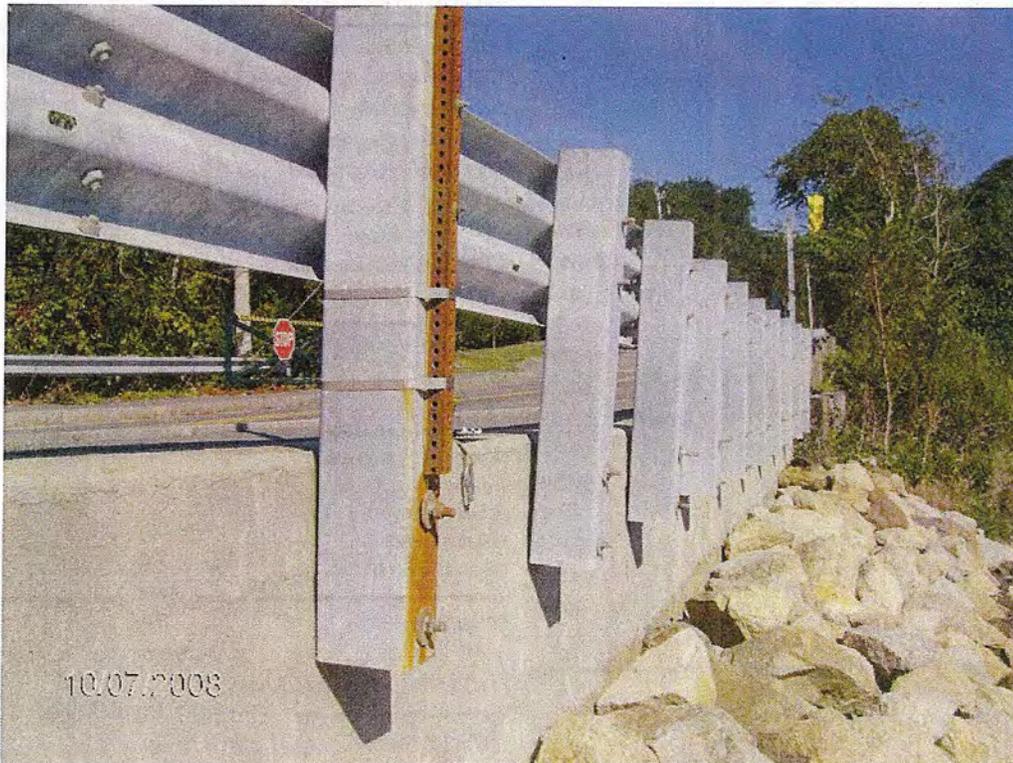
(Fair): The southeast guardrail has five posts that are not up tight against the abutment wingwall with up to a 1 1/2" gap (see photo 18). There is minor impact damage to the northeast approach guardrail. The guardrails consist of multiple types (thrie beam and w-beam) which are not continuous for their entire length and do not conform to the current standards.

Photo 18: 1 1/2" gaps between the southeast approach guardrail posts and the face of the wingwall.
