2-DIST <b>05</b>	B.I.N. <b>437</b>	STRUCTURES INSPECTION FIELD REPORT	BR. DEPT. NO. <b>C-07-001</b>
<b>ROUTINE INSPECTION</b>

CITY/TOWN <b>CHATHAM</b>	8-STRUCTURE NO. <b>C07001-437-MUN-NBI</b>	11-Kilo. POINT <b>000.322</b>	41-STATUS <b>A:OPEN</b>	90-ROUTINE INSP. DATE <b>OCT 5, 2010</b>
07-FACILITY CARRIED <b>HWY BRIDGE ST</b>	MEMORIAL NAME/LOCAL NAME	27-YR BUILT <b>1936</b>	106-YR REBUILT <b>1980</b>	YR REHAB'D (NON 106) <b>2007</b>
06-FEATURES INTERSECTED <b>WATER MITCHELL RIVER</b>	26-FUNCTIONAL CLASS <b>Urban Collector</b>	DIST. BRIDGE INSPECTION ENGINEER <b>D. A. Palmer</b> REVIEWED BY: <i>[Signature]</i>		
43-STRUCTURE TYPE <b>716 : Timber Movable - Bascule</b>	22-OWNER Town Agency	21-MAINTAINER Town Agency	TEAM LEADER <b>A. Amuzgar</b> PROJ MGR <b>HNTB Corporation</b> <i>[Signature]</i> <i>[Signature]</i>	
107-DECK TYPE <b>8 : Timber</b>	WEATHER <b>Rain</b>	TEMP. (air) <b>15°C</b>	TEAM MEMBERS <b>J. CLOGSTON, J. CLOGSTON</b>

Bridge C-07-001 (437) carries Bridge Street over the Mitchell River in the Town of Chatham. The bridge is oriented west/east with the Mitchell River oriented north/south.

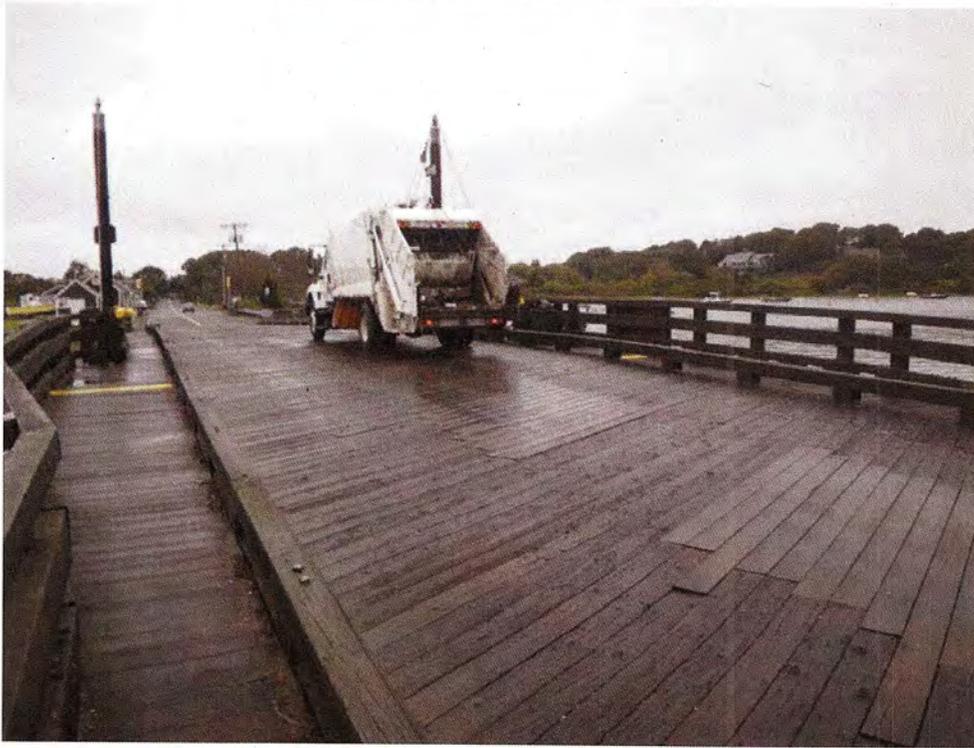
The timber wearing surface has moderate wear, particularly in the wheel lines, with slight punkiness, splits and checks throughout. The knots in the wood and the nail heads generally protrude above the surface (**see photo 1**). Random wearing surface planks have been replaced throughout the deck. These replacement wearing surface planks do not sit flush with the remaining, worn planks. Isolated timber wearing surface planks are loose or have deteriorated to the point of failure.

**Photo 1:** Typical worn wearing surface with protruding knots and nail heads. Also note the replacement plank not sitting flush with worn planks.

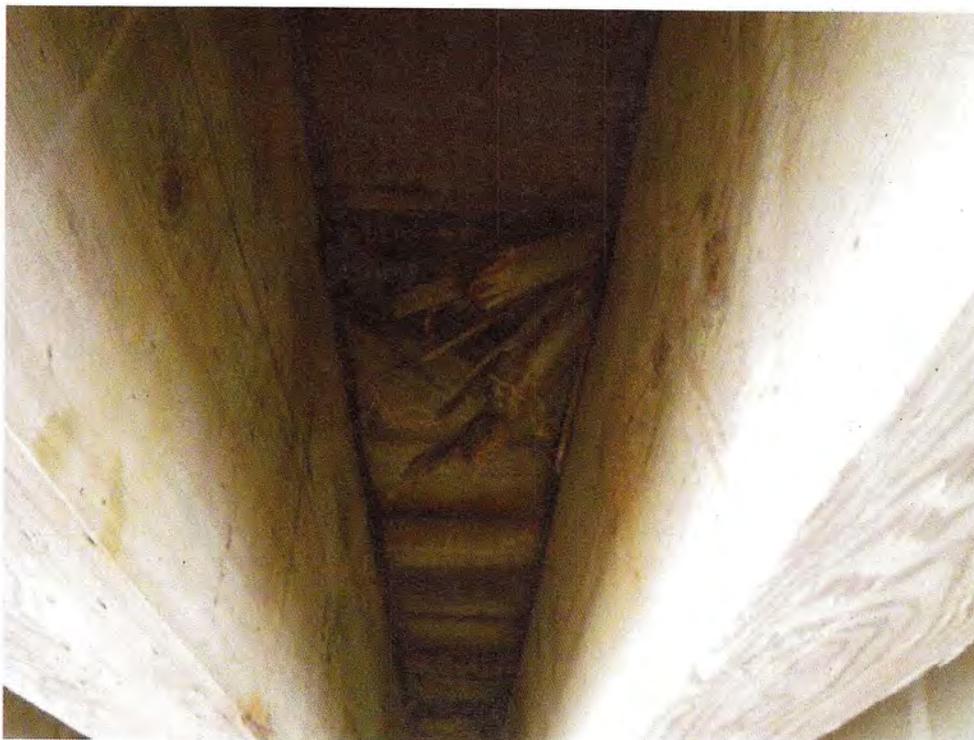
The timber deck typically exhibits some random areas with slight punkiness on the underside. There is one isolated location where one deck timber has failed between stringers 10 and 11 (numbered from the south) in span 4 (**see photo 2**).

**Photo 2:** Failed deck timber between stringers 10 and 11 in span 4.

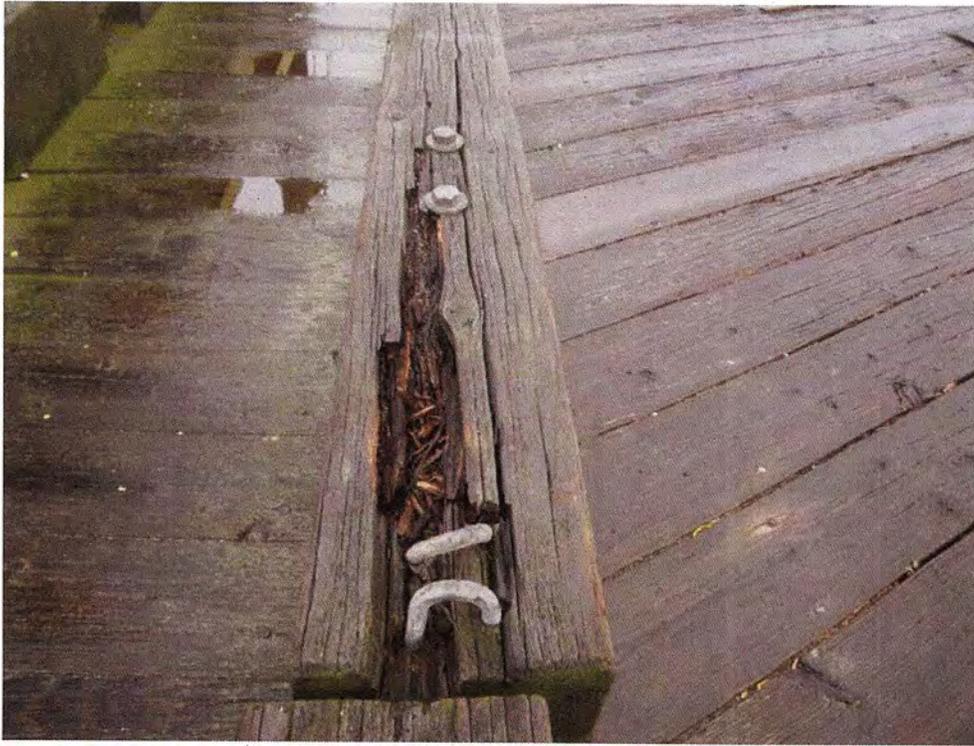
The timber curbs, which also act as a traffic rail, have minor splits and checks throughout. The worst case is at the east end of the bascule span (span 8) south curb where a 3'-0" length of curb is heavily deteriorated (**see photo 3**). At several locations the curb/traffic rails are misaligned transversely up to 1 1/2" (**see photo 4**).

**Photo 3: Deterioration of the south curb/traffic rail at the east end of the bascule span (span 8).**

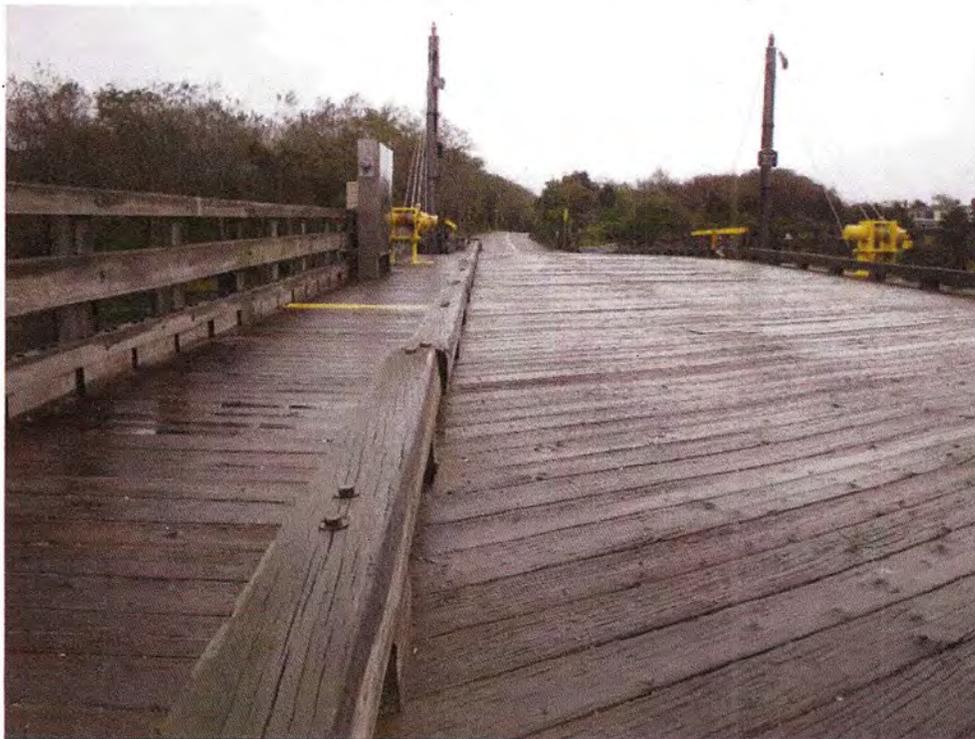
**Photo 4: Typical misalignment of up to 1 1/2" of curb/traffic rails (north curb shown).**

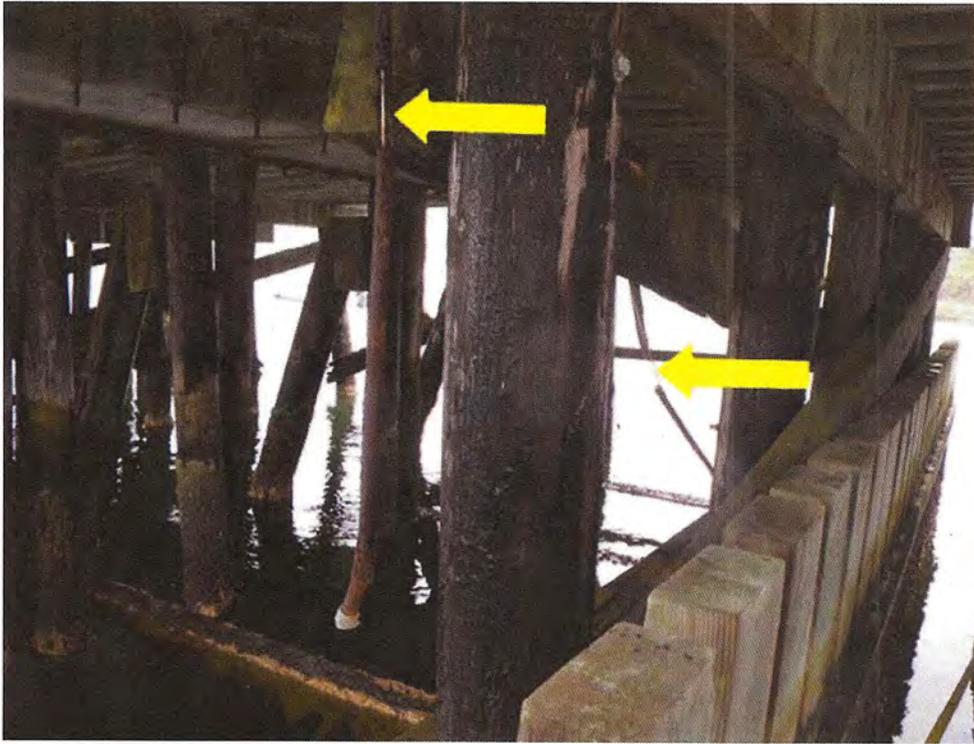
There are several deteriorated, broken, loose or missing support brackets for the electrical conduit along the north side of the bridge in spans 9 through 12. At one location in span 11, the conduit has been temporarily fastened with rope. In addition, there are deteriorated, broken and loose electrical conduits with exposed wiring along the west side of bents 5 and 7A (**see photo 5**).

**Photo 5: Deteriorated, broken and loose electrical conduits with exposed wiring along the west side of bent 7A.**

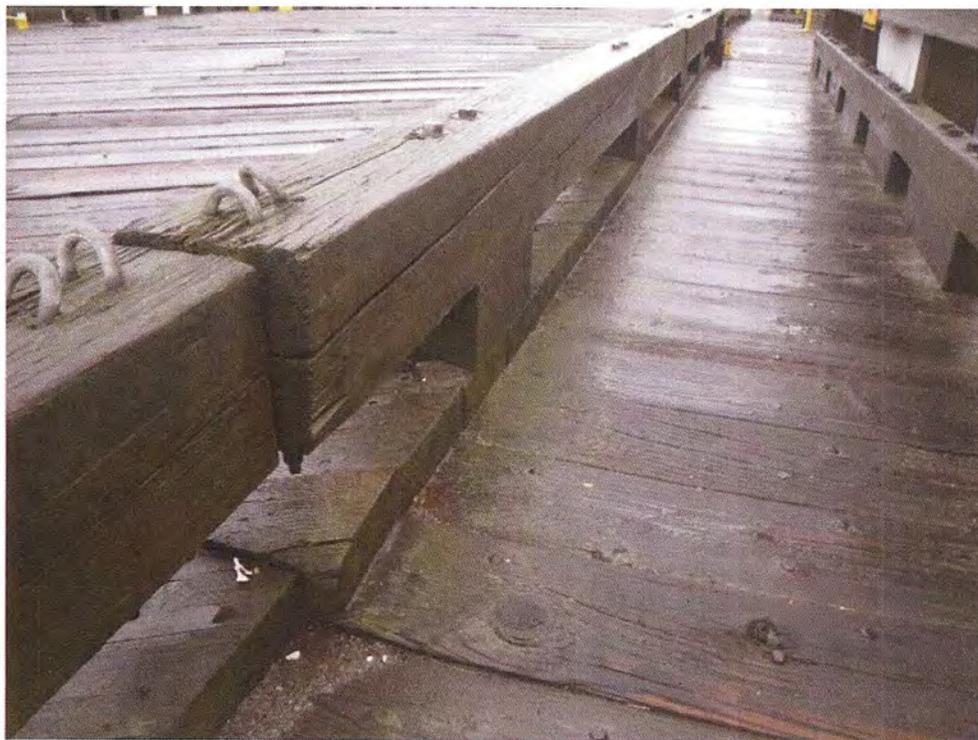
The steel armor at both abutment deck joints exhibits minor scrapes and gouges, particularly at the east abutment. The timber joint at the east end of the bascule span (span 8) is extremely tight when the bridge is closed. There is 1 1/2" of lateral misalignment between the bascule span (span 8) and span 9 deck along the bent 8 deck joint at the toe end of the bascule span (**see photo 6**).

**Photo 6: 1 1/2" of misalignment of bascule span toe towards the north.**

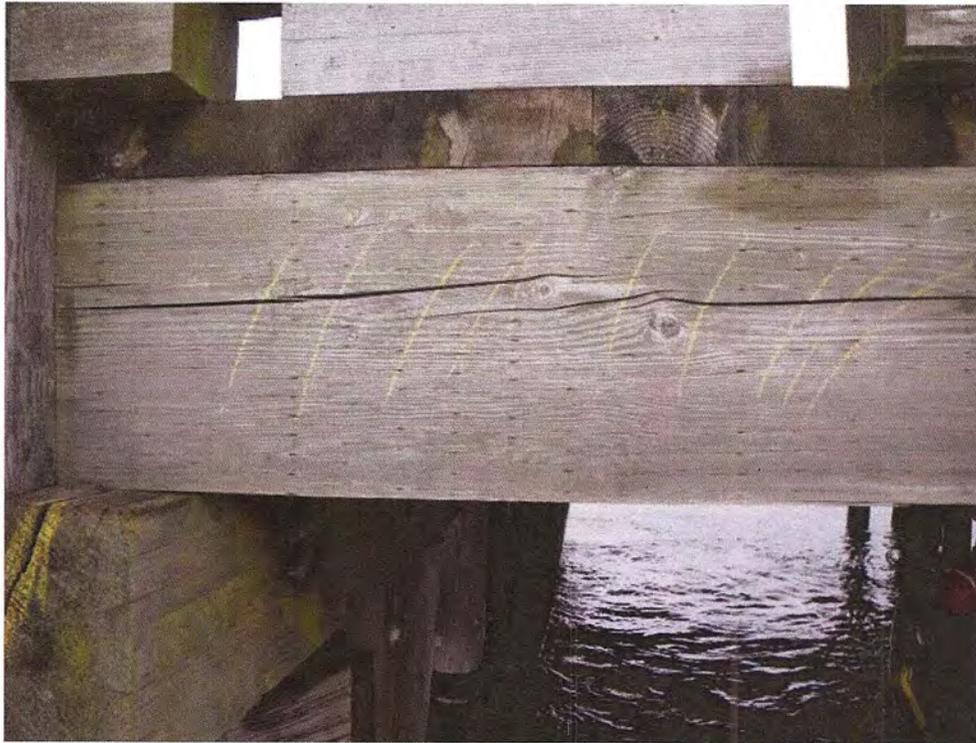
The timber stringers exhibit minor shakes and checks which are typically 1/8" wide with isolated stringers checked up to 5/16" wide (**see photo 7**). There is minor collision damage (scrapes and gouges) to the underside of the stringers in the bascule span (span 8) (**see photo 8**).

**Photo 7:** Up to 5/16" checks in timber south fascia stringer in span 4.

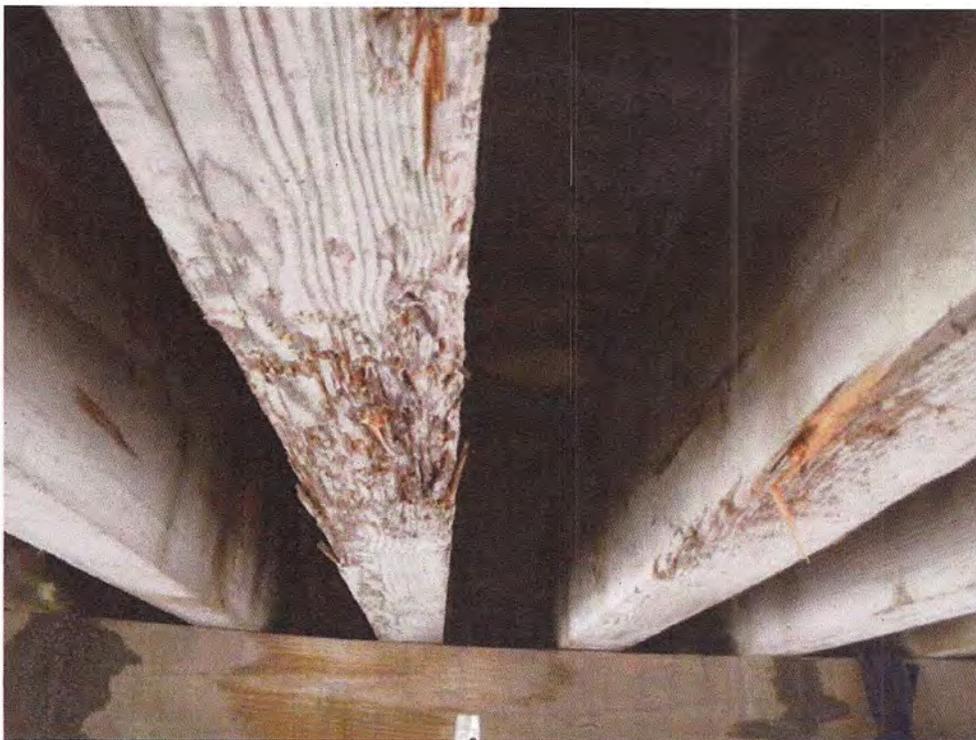
**Photo 8:** Collision damage to the underside of the bascule span (span 8) stringers.

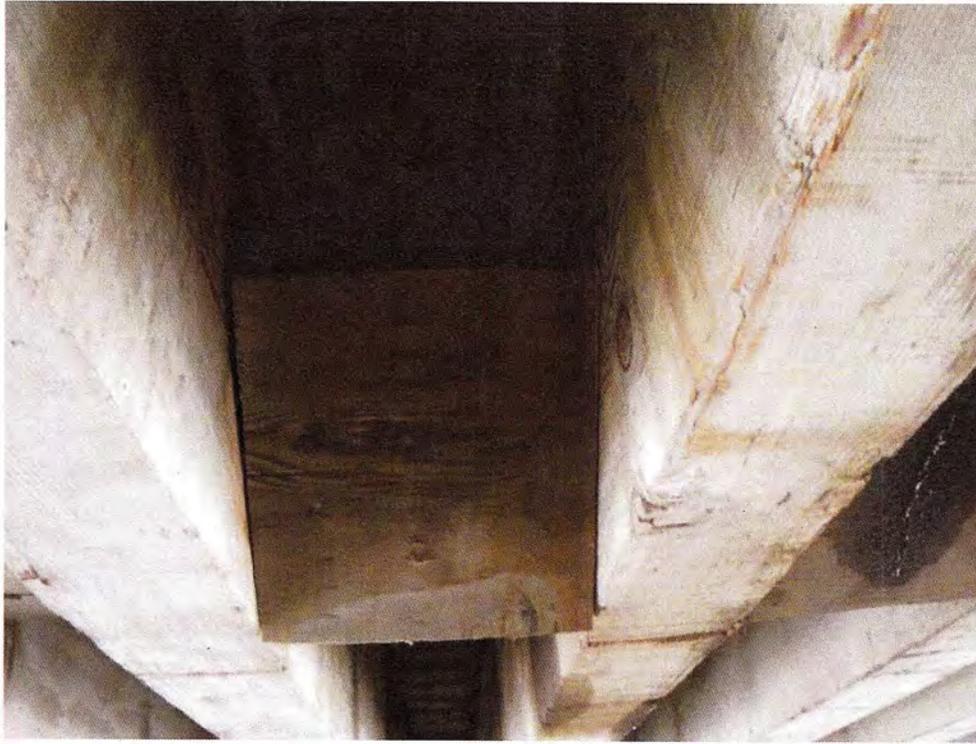
Many of the timber spacer blocks between the stringers are loose and/or have rotated (**see photo 9**). Random blocks exhibit minor shakes and checking. There is an isolated spacer block in span 12 which exhibits severe deterioration between the third and fourth stringers from the south.

**Photo 9:** Typical loose and rotated spacer block in span 8.

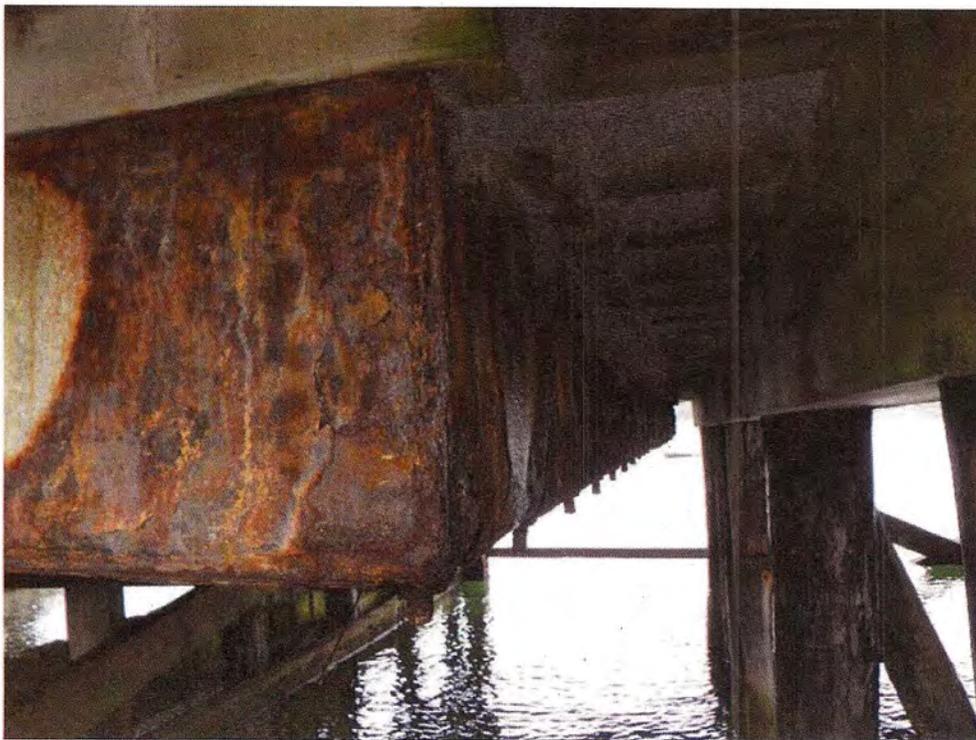
**Photo 10:** Failed galvanized coating at the east end of the counterweight steel shell.

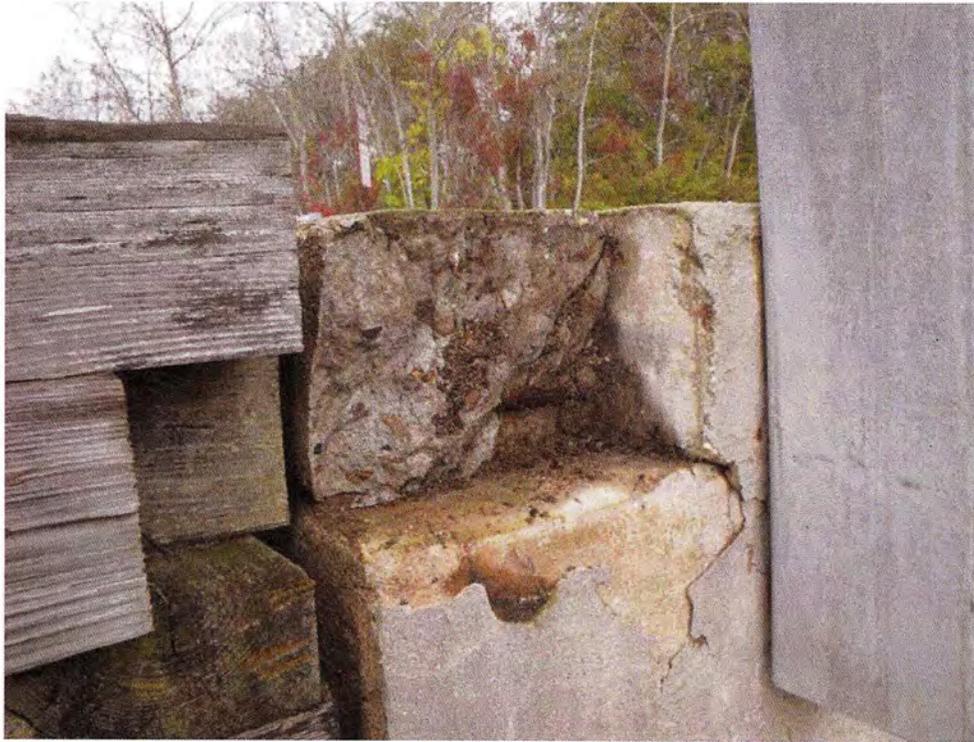
Photo 11: 12" wide by 9" high by 6" deep spall at the south end of the east abutment backwall.

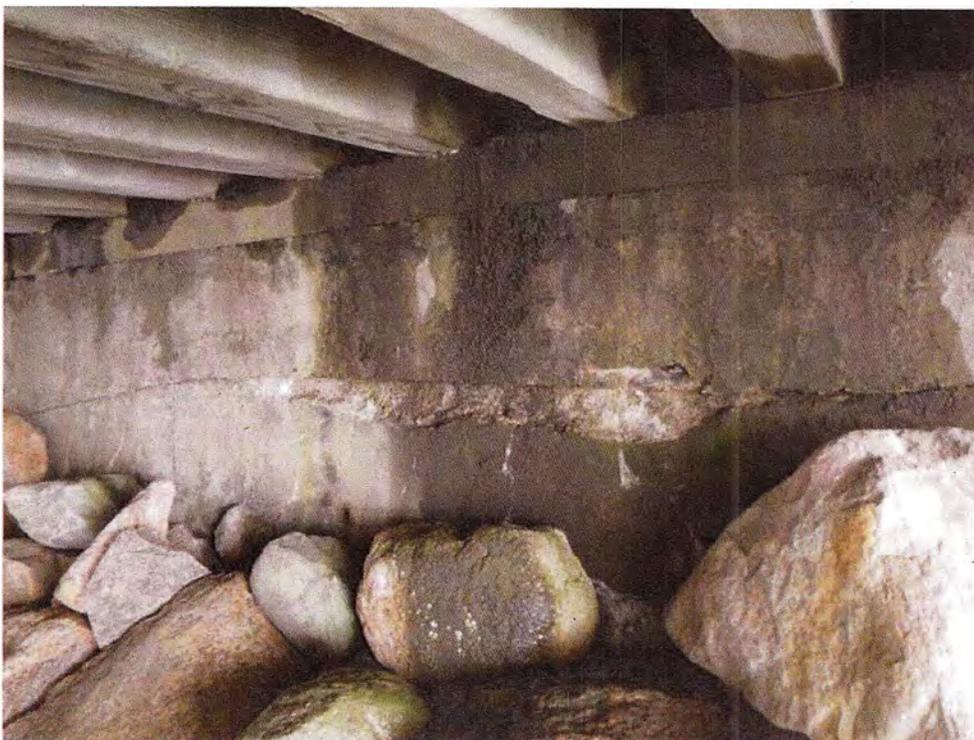
Photo 12: 1/8" wide crack with 4'-6" wide by 5" high by 2" deep spall at east abutment breastwall.

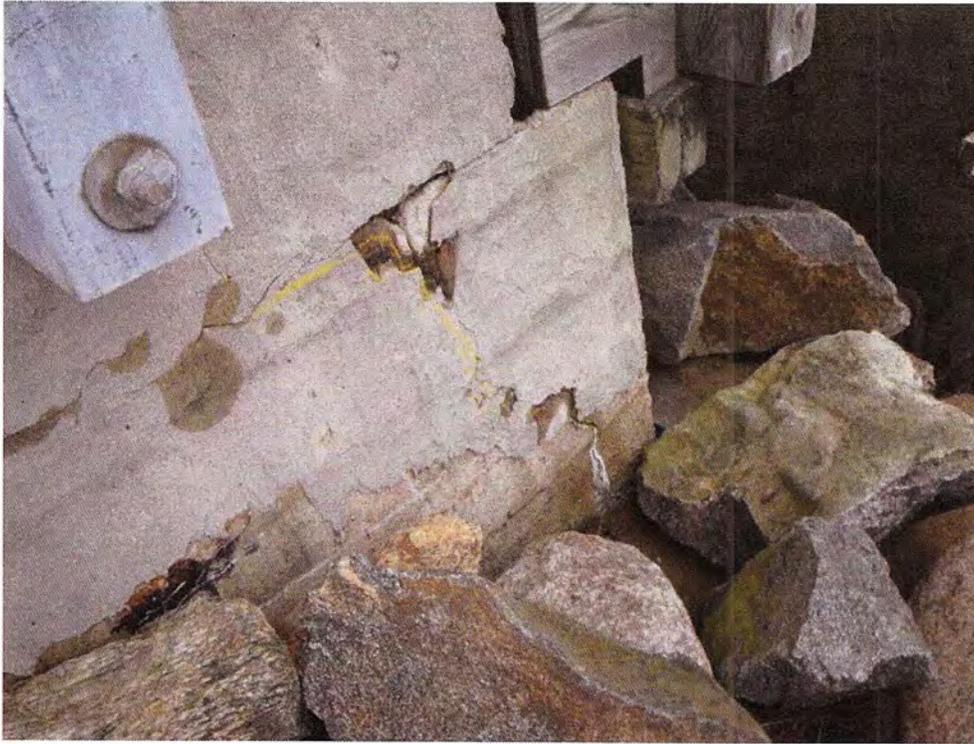
**Photo 13:** Up to 1/8" wide horizontal and vertical cracks at the east end of the southwest wingwall.

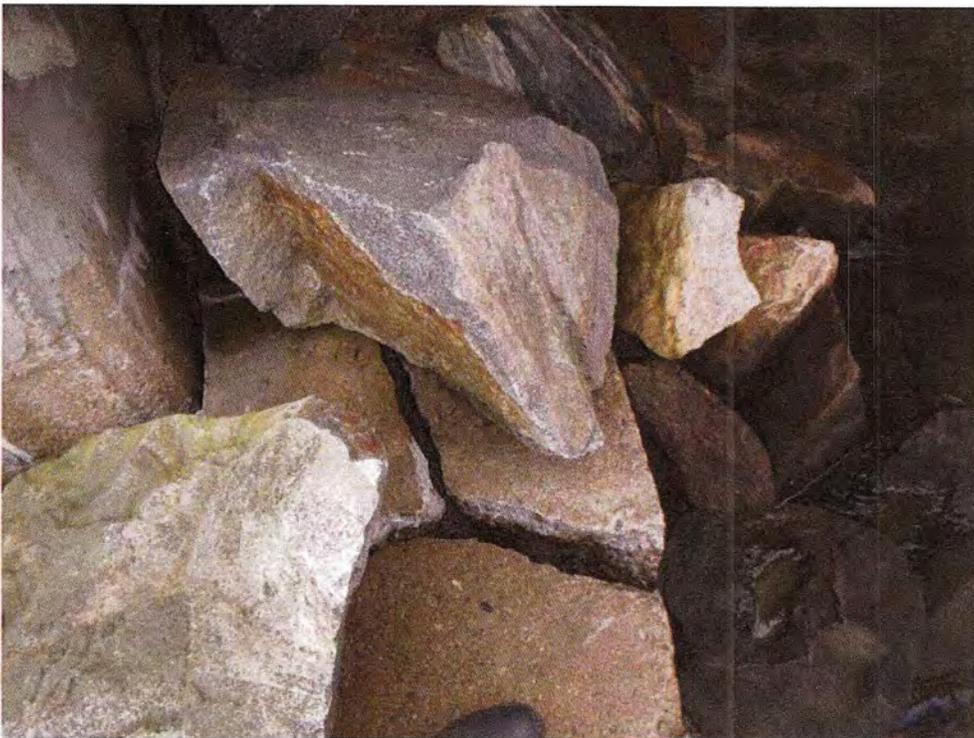
**Photo 14:** Major 3" wide crack/split in concrete fender wall at south end of west abutment.

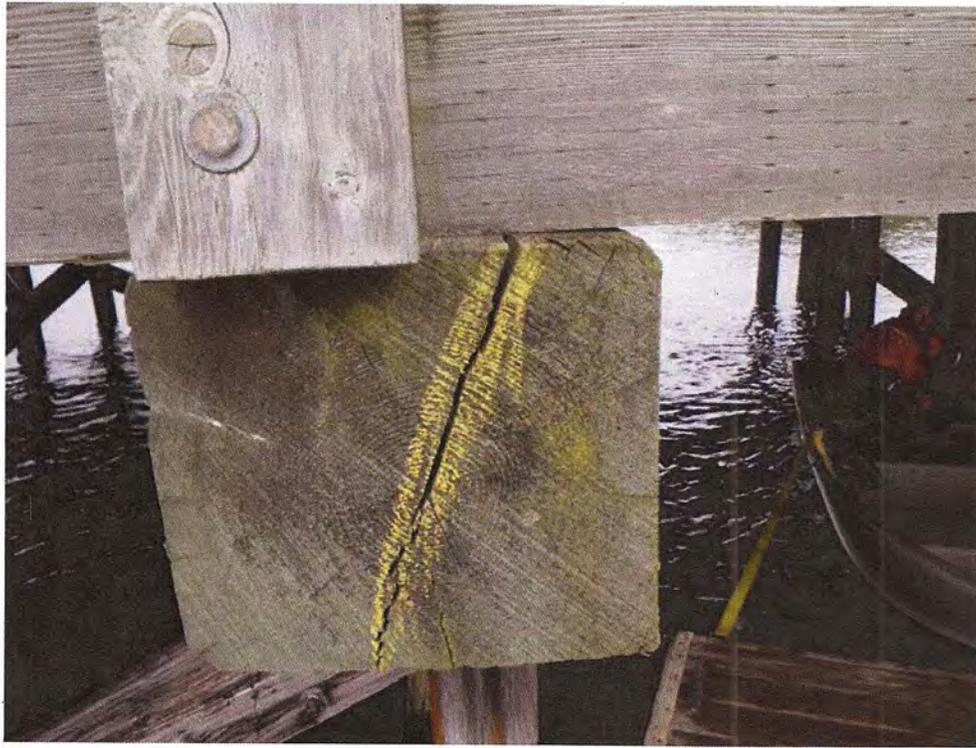
**Photo 15: Full height diagonal split at south end of bent 3 pile cap.**

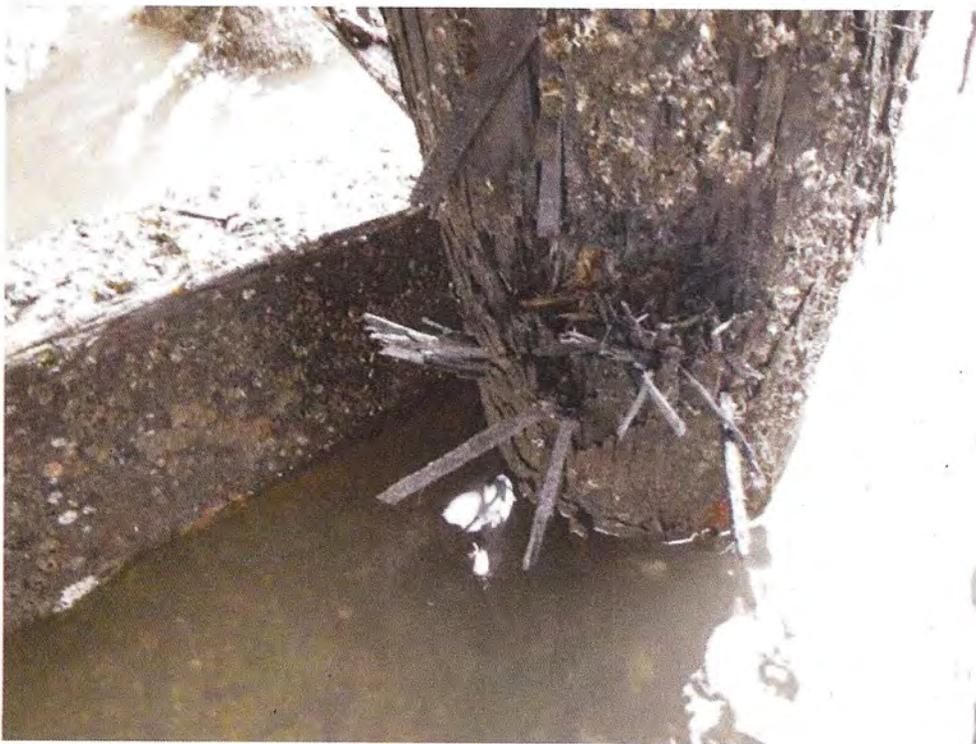
**Photo 16: Heavy brooming and advanced section loss to the northernmost pile at bent 1.**

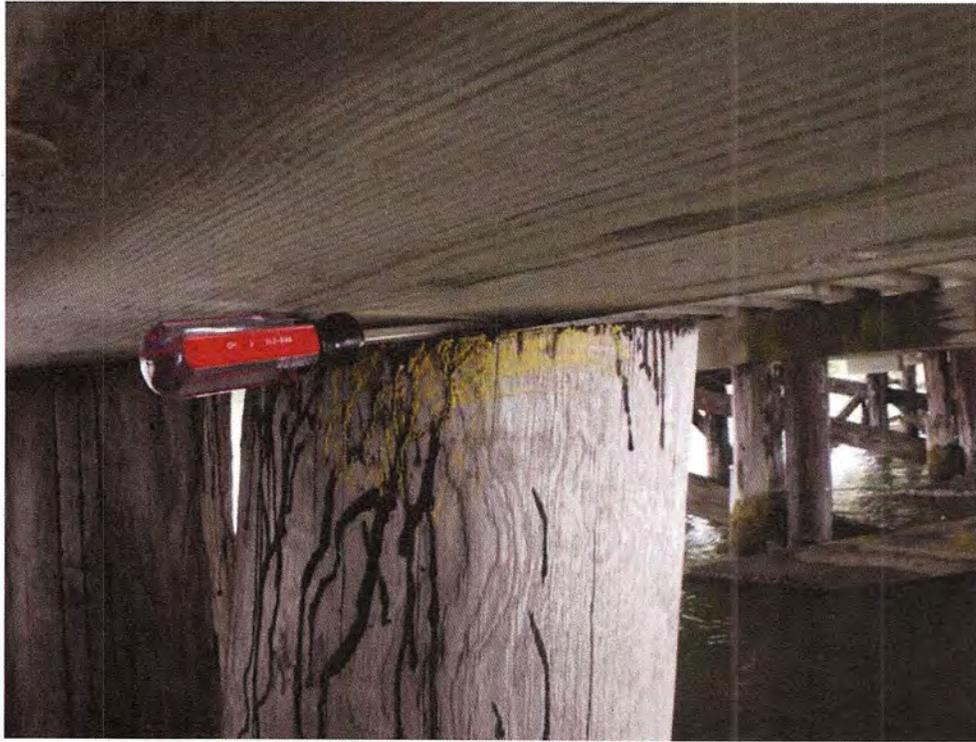
Photo 17: 3/4" gap between top of 5th pile from south and pile cap at bent 2.

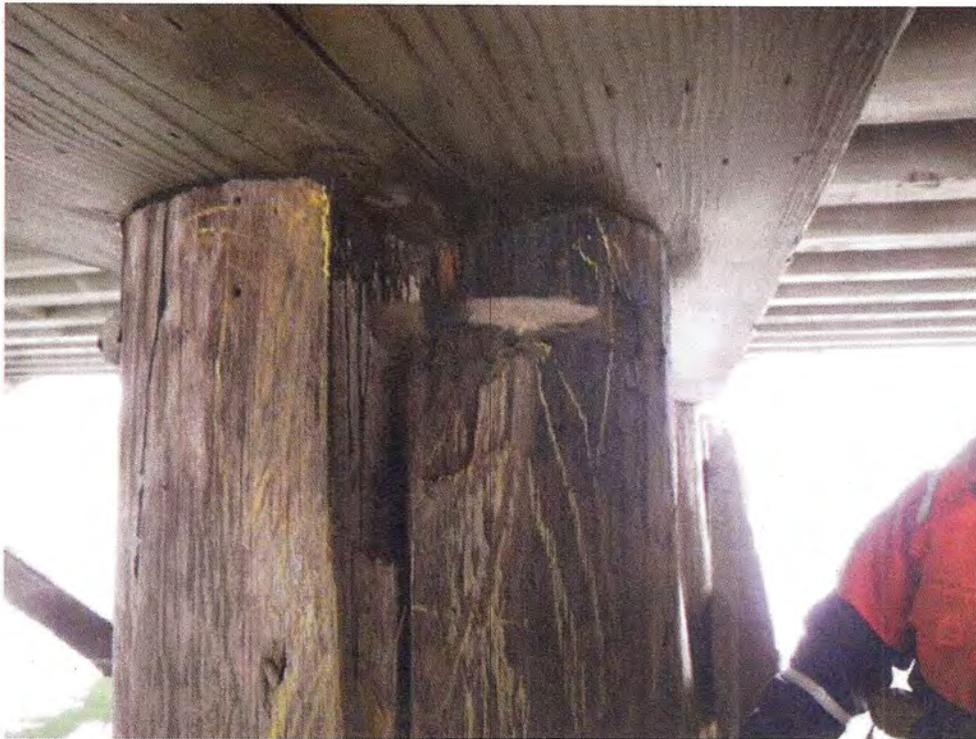
Photo 18: Section loss and full depth vertical split at 6th pile from south end of bent 2.

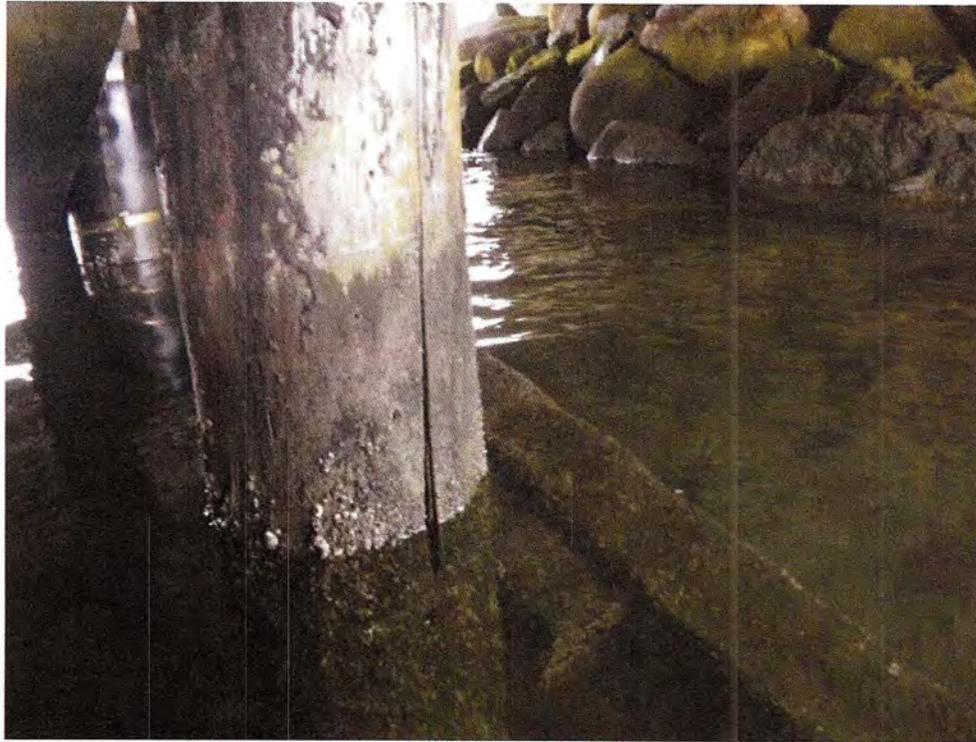
Photo 19: Full depth by full height split on third pile from south end of bent 1.

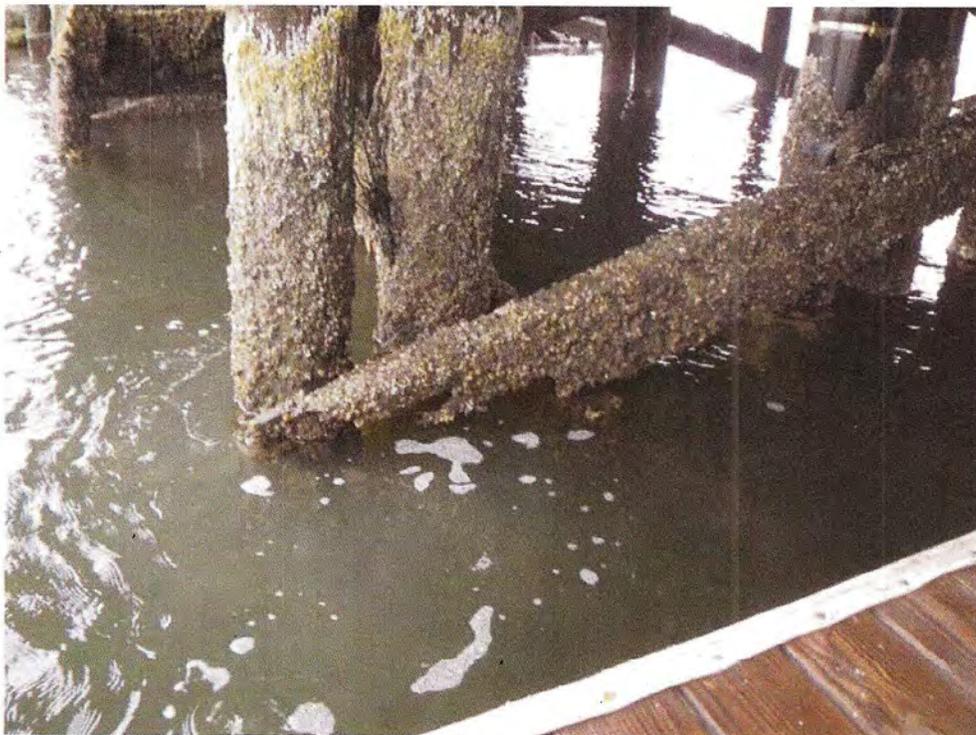
Photo 20: 100% loss to diagonal bracing at south end of bent 3.

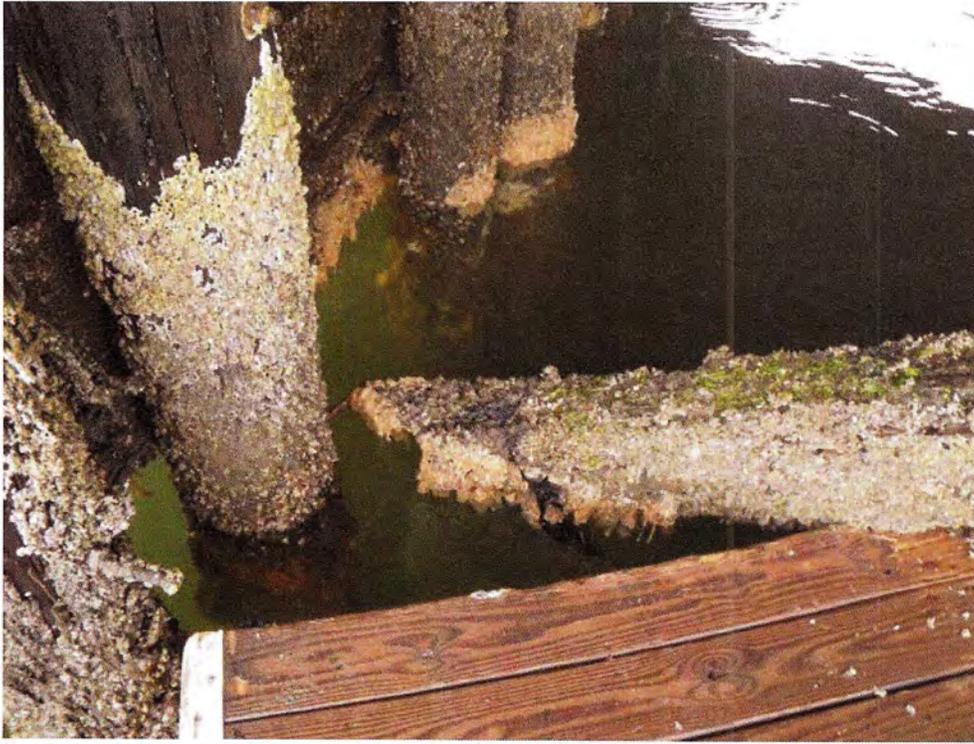
**Photo 21:** 100% loss to horizontal bracing between bents 8 and 9 at the south end of bent 8.

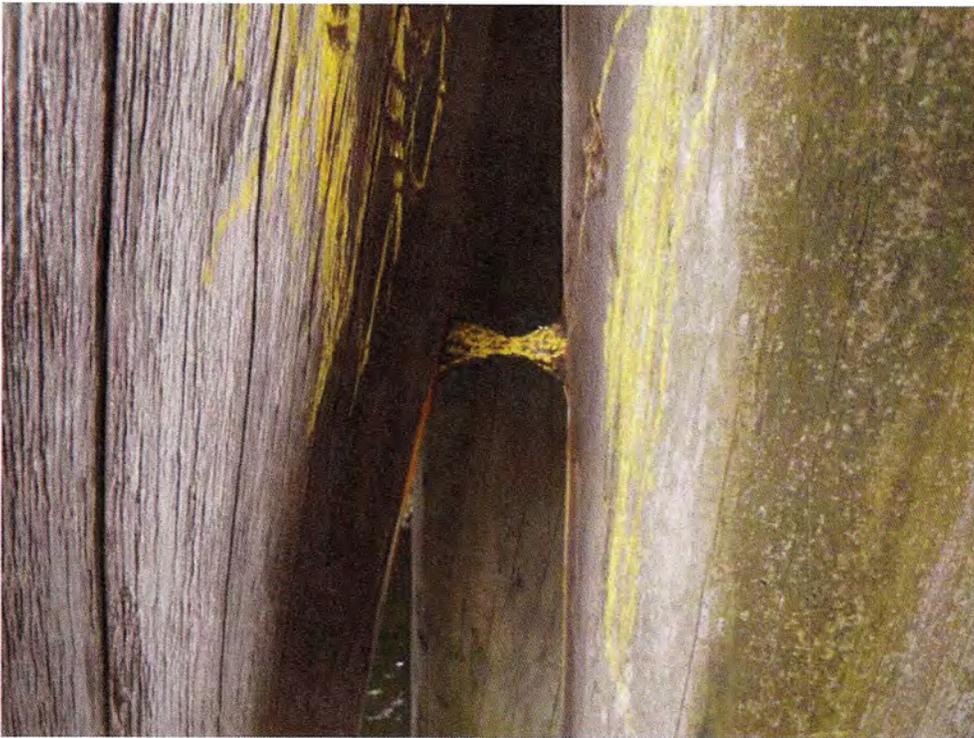
**Photo 22:** Heavy rust and losses to substructure connection bolt at bent 9.

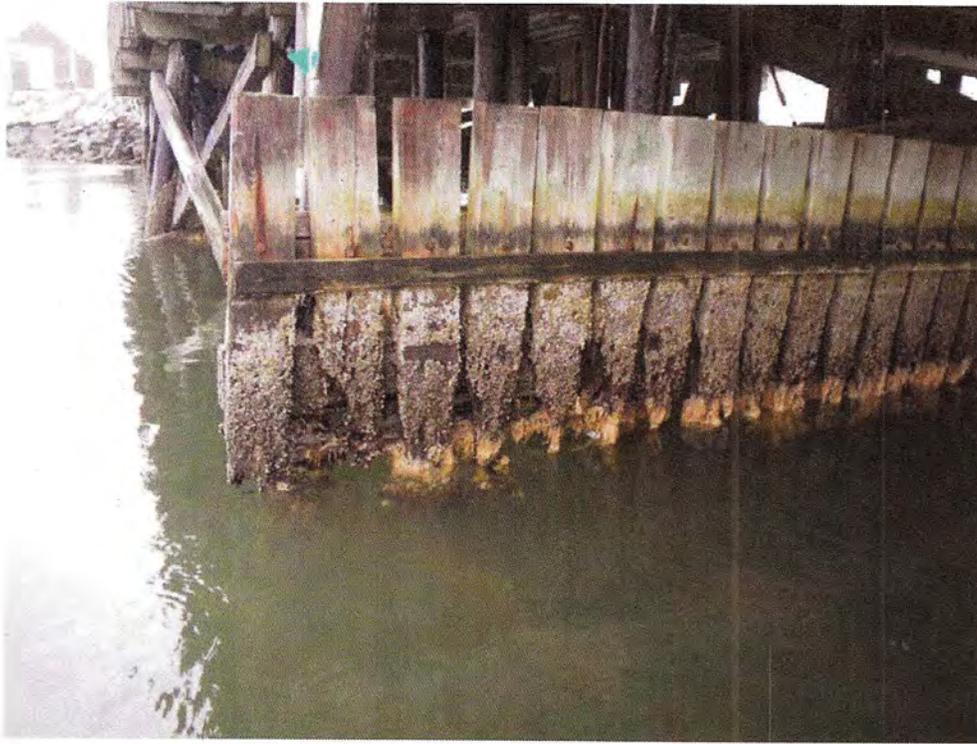
**Photo 23:** Heavy marine growth with up to 100% section loss to vertical bracing members at bent 7a fender.

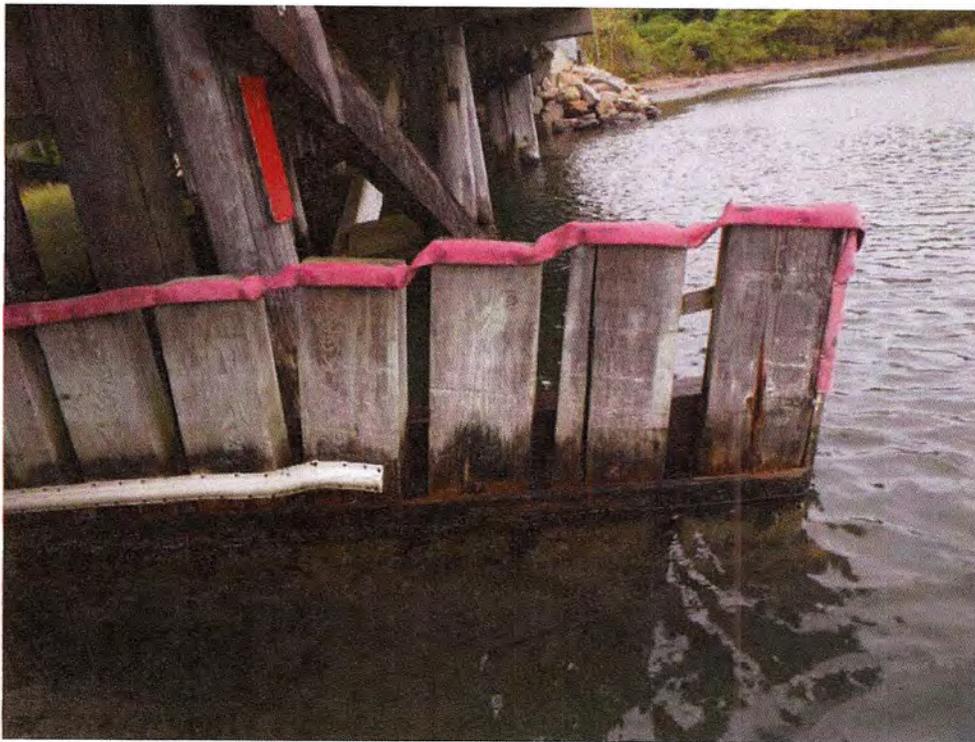
**Photo 24:** Collision damage at the south end of the bent 8 fender.

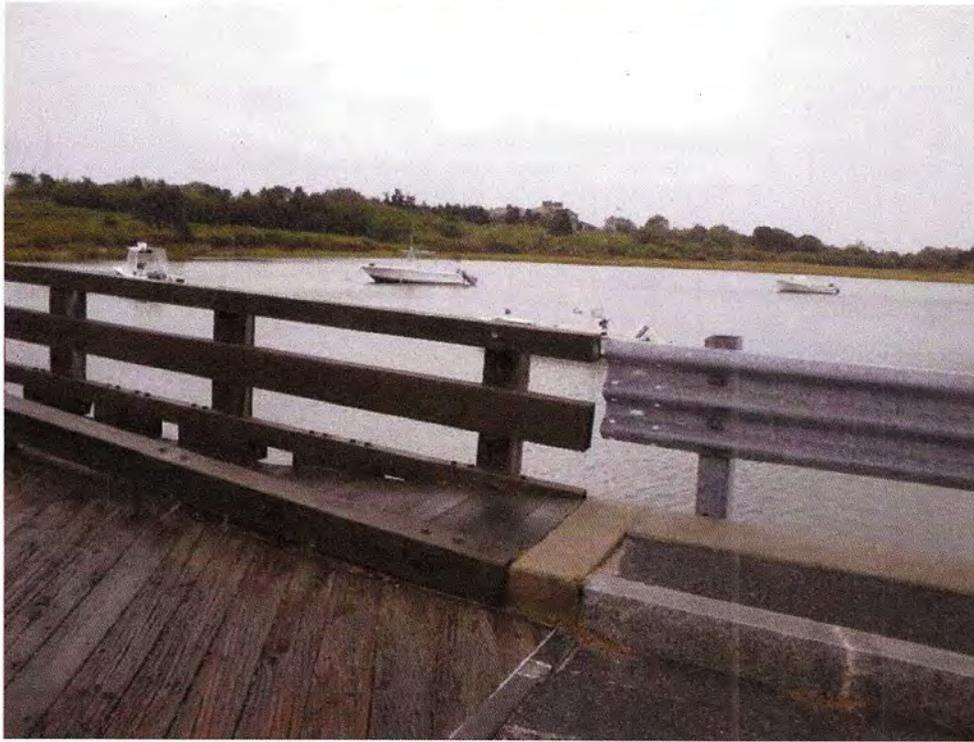
**Photo 25:** Lack of transition between bridge rail and approach rail at southwest corner of bridge.

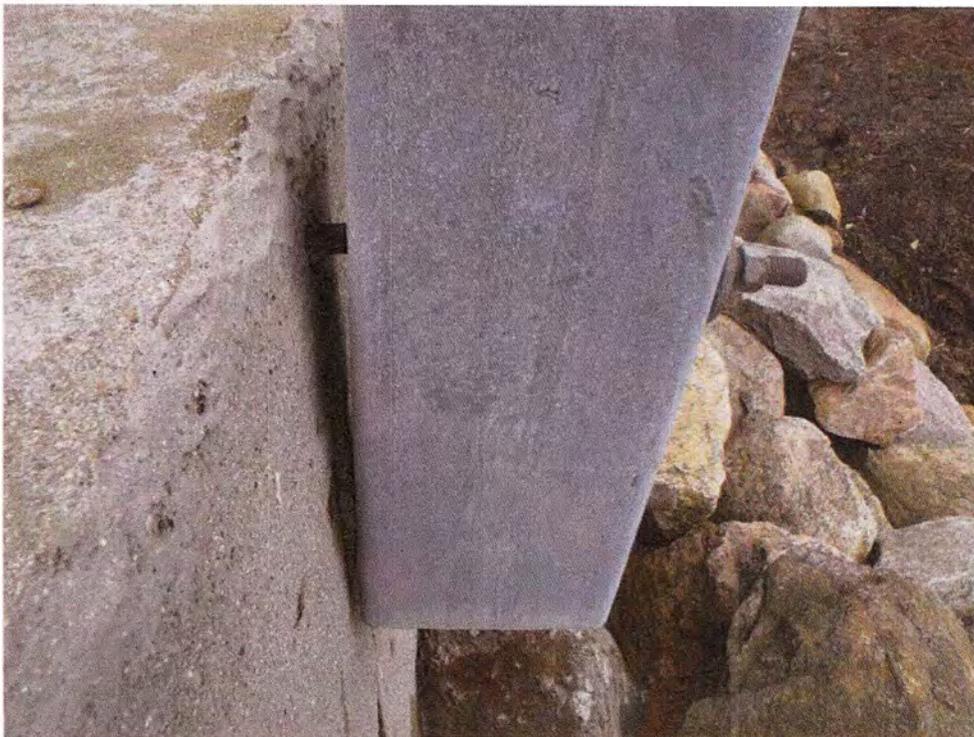
**Photo 26:** 1 1/2" gap between the southeast approach guardrail posts and the face of the wingwall.

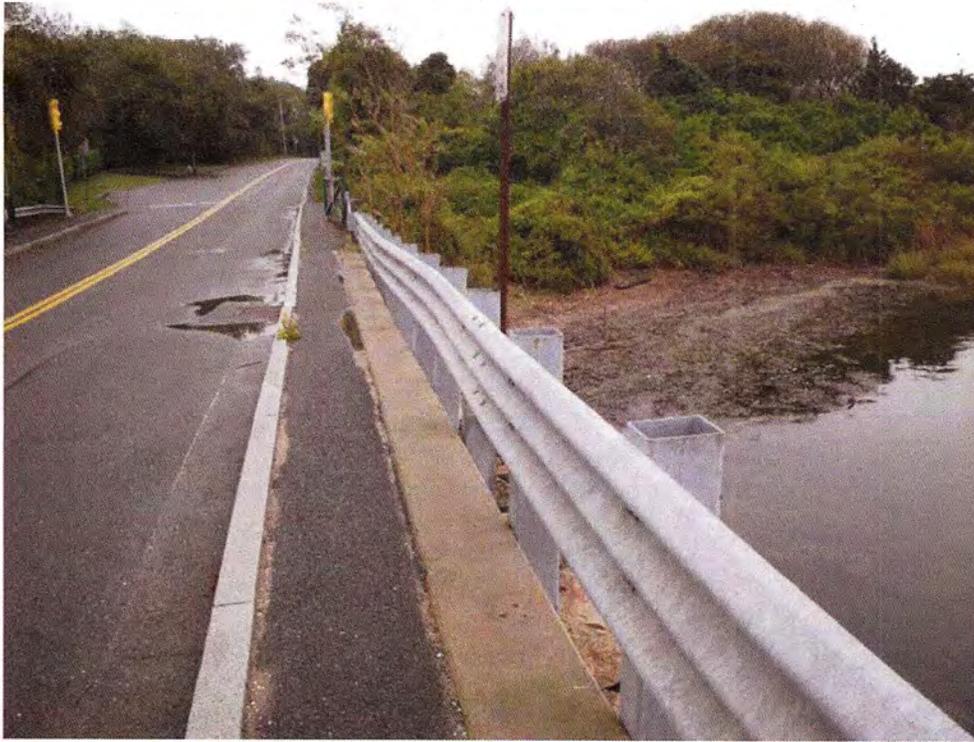
**Photo 27: Outward rotation of southeast approach guardrail posts due to loose anchor bolts.**

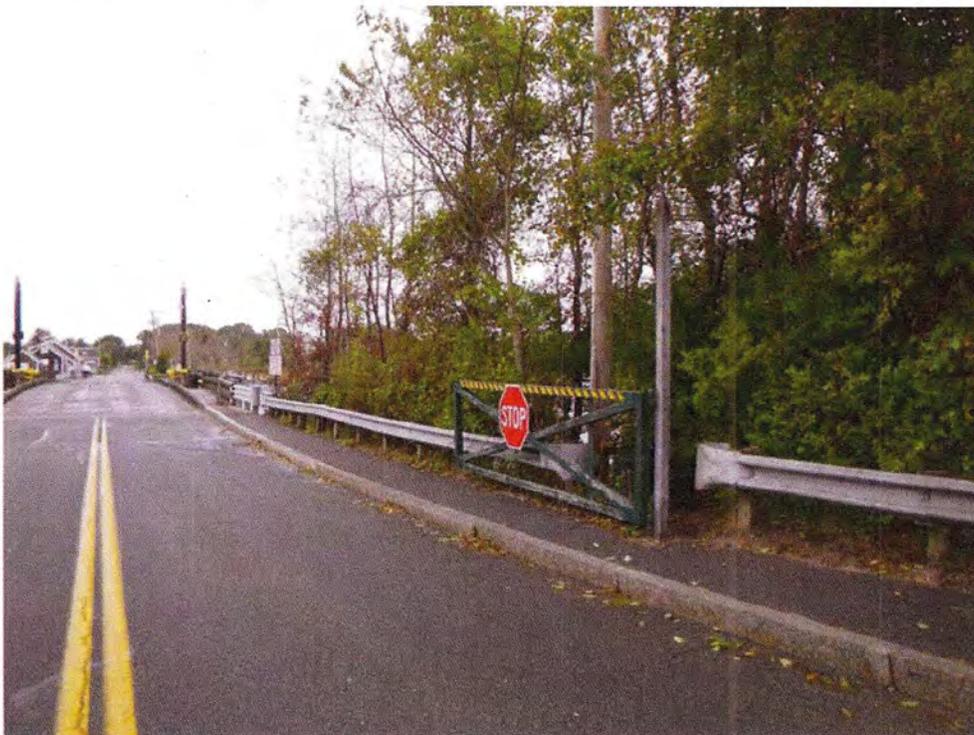
**Photo 28: Multiple non-standard guardrail types at northeast approach.**
