STRUCTURES INSPECTION FIELD REPORT

2-DIST
05

B.I.N.
437

ROUTINE INSPECTION

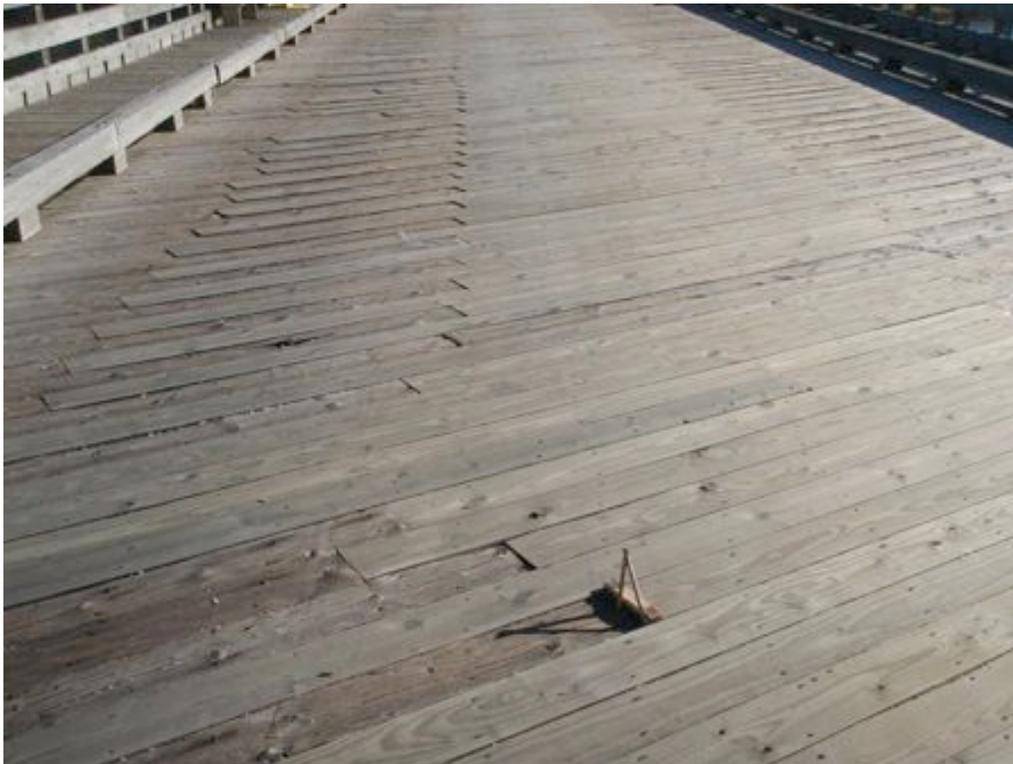
(Fair): The timber wearing surface exhibits moderate wear with slight punkiness, warped planks, splits, and checks throughout. The knots in the wood and the fastener heads generally protrude above the surface of the roadway creating an uneven riding surface. Several wearing surface planks have been replaced throughout the deck. These replacement planks do not sit flush with the remaining worn planks creating up to 1/2" of vertical differential between adjacent planks (**see photo 2**). Isolated wearing surface planks are loose or have deteriorated with areas of up to 100% loss (**see photo 3**). There is a 10'-0" wide by 5'-0" long area of loose and deteriorated planks at the south end of span 8 adjacent to the joint at bent 7A.

Photo 2: Typical uneven wearing surface planks (spans 1-7, looking east shown).

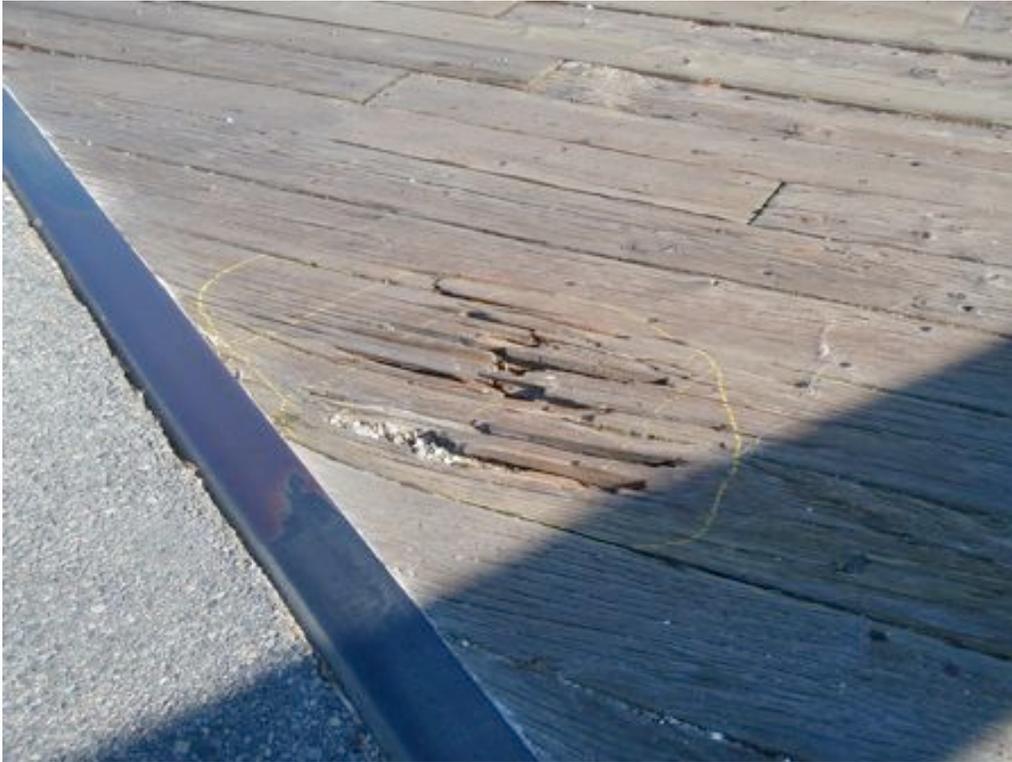
Photo 3: Area of 100% loss to wearing surface planks at the south side of span 1 at the west abutment.

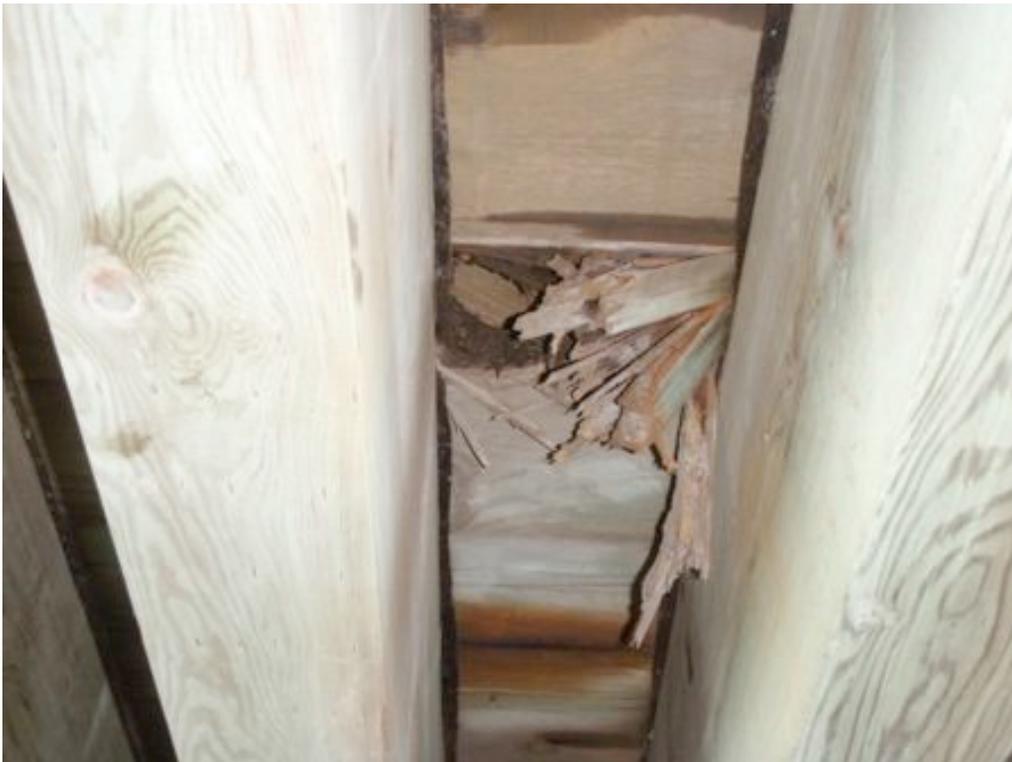
(Fair): The underside of the timber deck typically exhibits some scattered areas of rot with slight punkiness and checks. There is an area of 100% loss by 10" wide by 7" long to the timber deck plank between beams 10 and 11 near bent 3 in span 4 (**see photo 4**).

Photo 4: Area of 100% loss to the timber deck plank between stringers 10 and 11 near bent 3 in span 4.

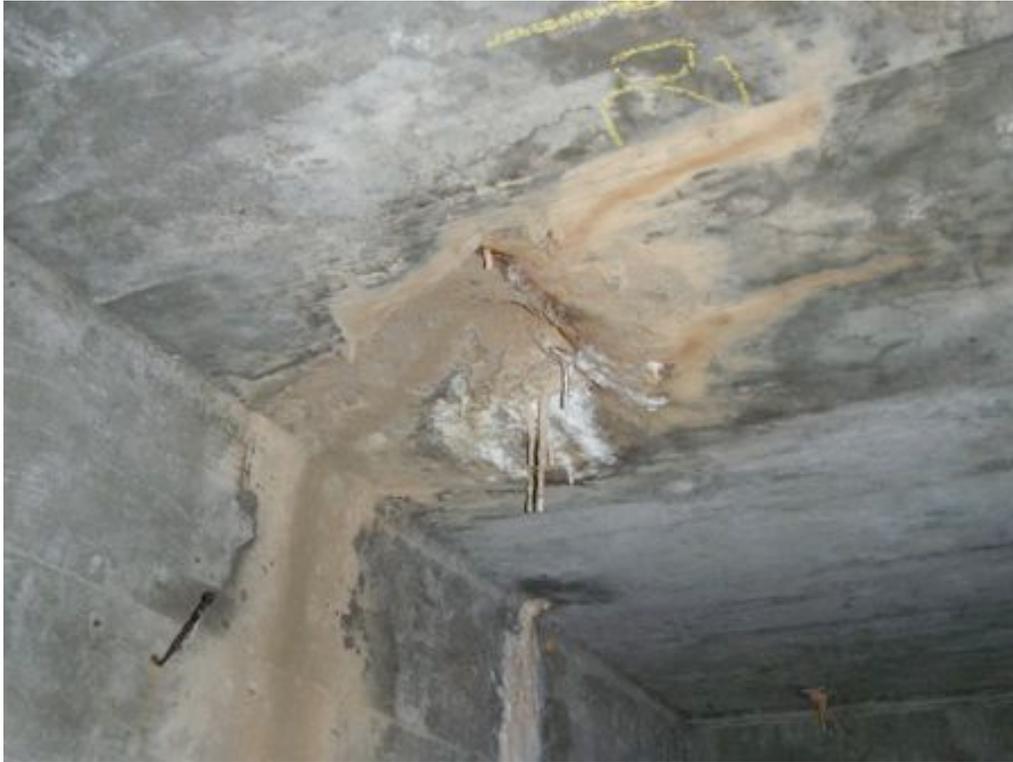
There is a 1'-0" diameter by 2" deep spall around a weep hole with heavy efflorescence and stalactites on the underside of the concrete deck at the east abutment span (**see photo 5**). There is also a full depth core hole through the concrete deck near midspan of the east abutment span.

Photo 5: Spall around a weep hole with heavy efflorescence on the underside of the concrete deck at the east abutment span.

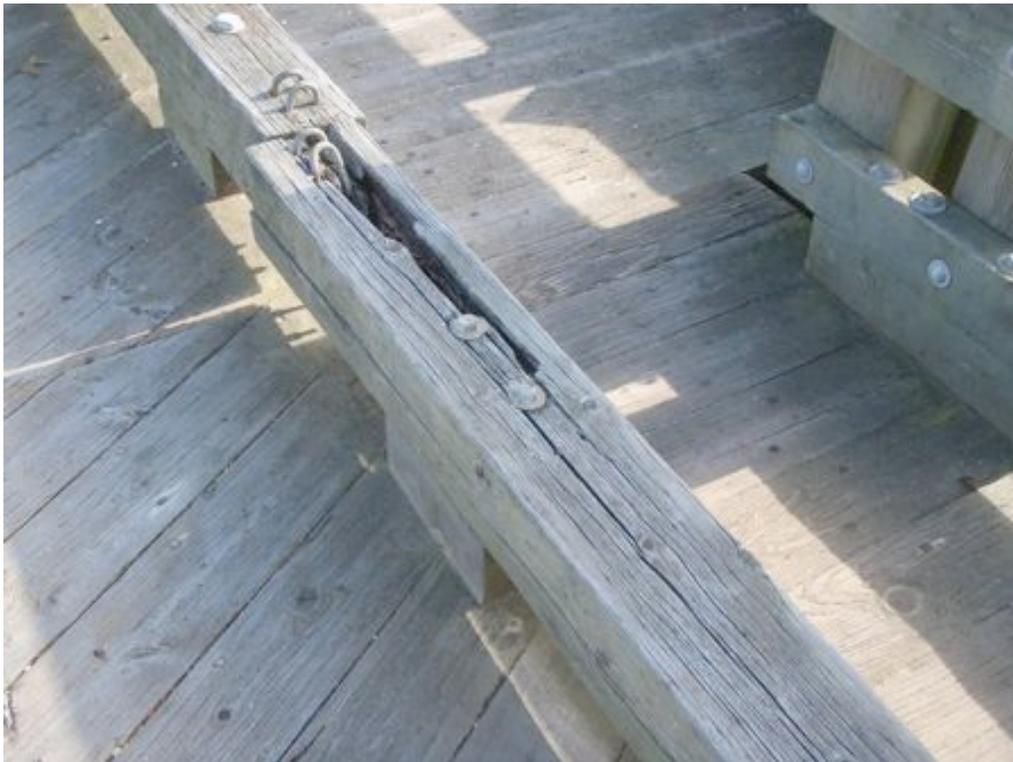
(Fair): The 1'-1" high timber curbs, which also act as a traffic rail, typically have minor deterioration, splits, and checks throughout. The worst case is a 3'-0" long area of rot to the south curb at the east end of the bascule span (span 8) (**see photo 6**). At several locations, the curbs exhibit minor collision damage and transverse misalignment of up to 1 1/2". In addition, there is a damaged/missing section of the blocking for the curb which exposes the anchor bolt at the misaligned north curb at the west end of span 3 (**see photo 7**).

Photo 6: A 3'-0" long area of rot to the south curb at the east end of the bascule span (span 8).

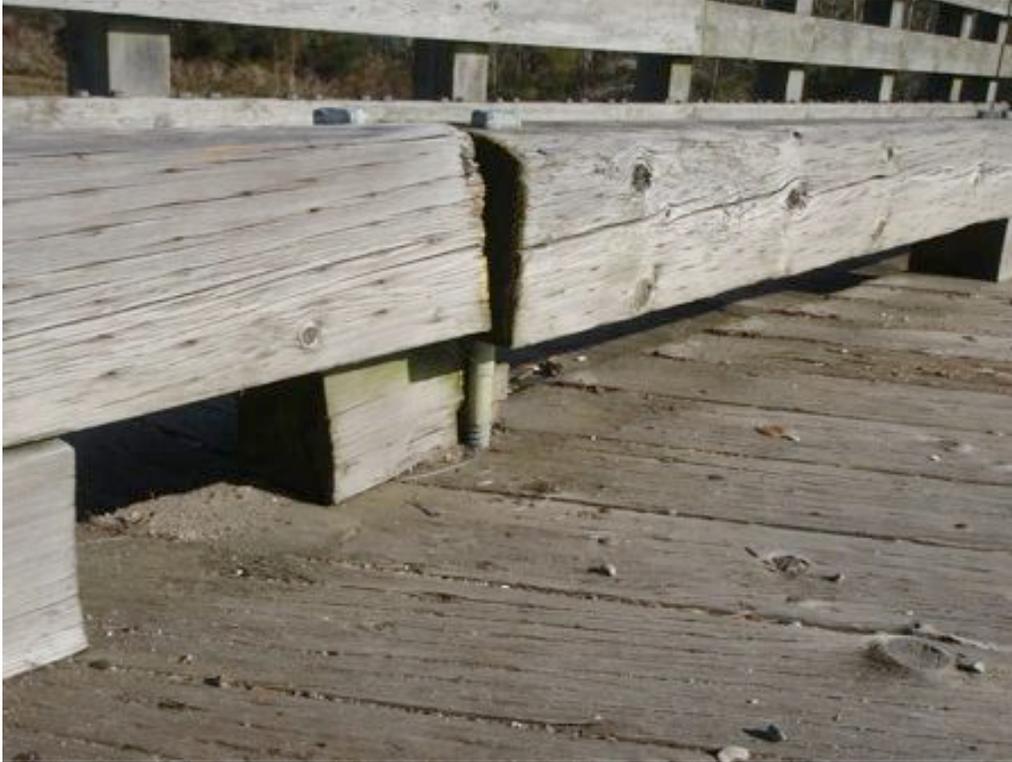
Photo 7: Misaligned curb and exposed anchor bolt at the north curb at the west end of span 3.

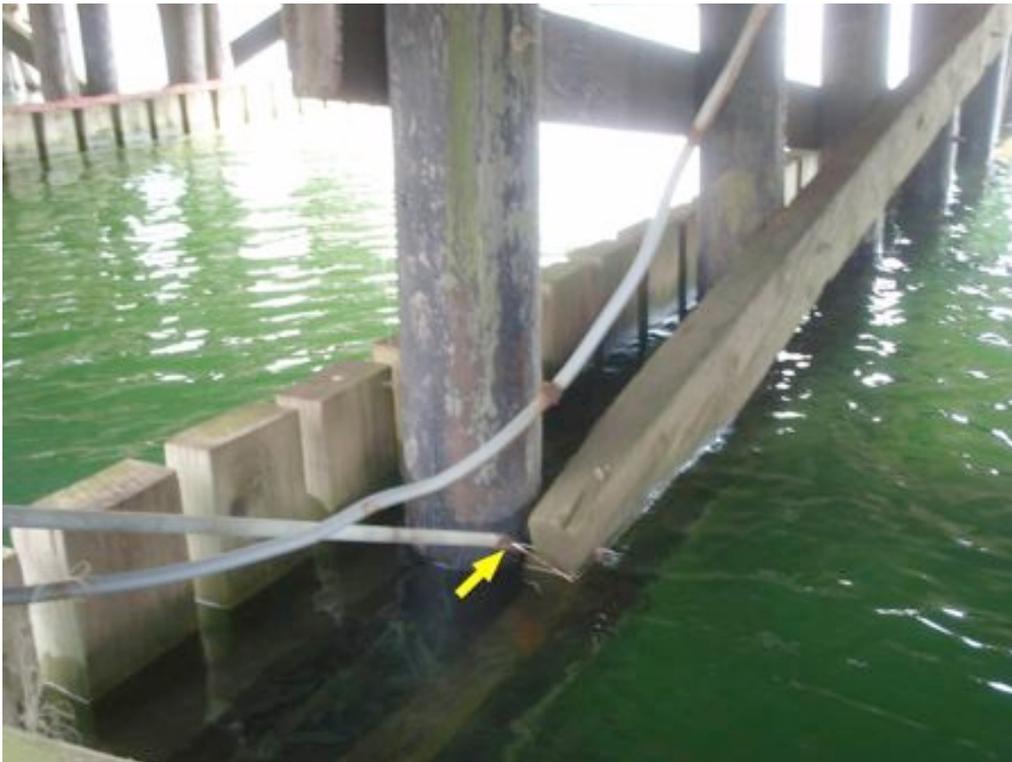
(Fair): There are several deteriorated, broken, loose or missing support brackets for the metal electrical conduit along the north side of the bridge in spans 9 through 12. At the east end of span 10, the conduit has been temporarily fastened with rope. In addition, there are deteriorated, broken and loose electrical conduits with exposed wiring, which appear abandoned along the west side of bents 5 and 7A (**see photo 8**).

Photo 8: Deteriorated and broken electrical conduit with exposed wires at the west face at the north end of bent 7A.

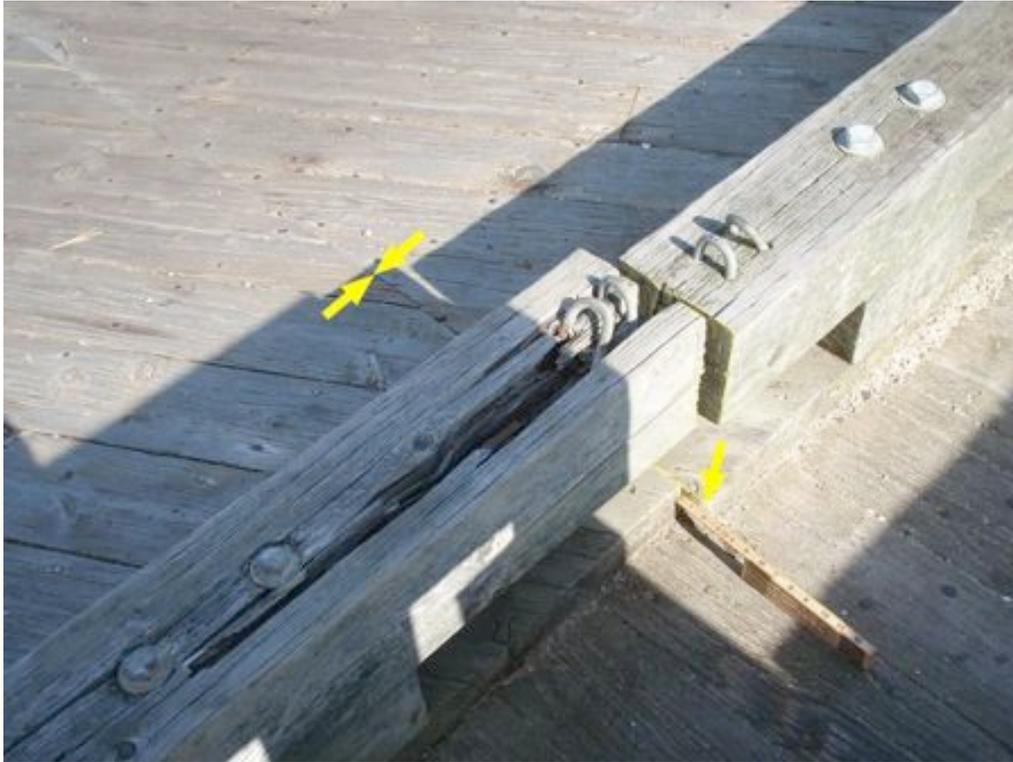
Photo 9: Lateral misalignment of the bascule span (span 8) on the south end of the toe of the bascule span at bent 8. (Note: Tight joint.)

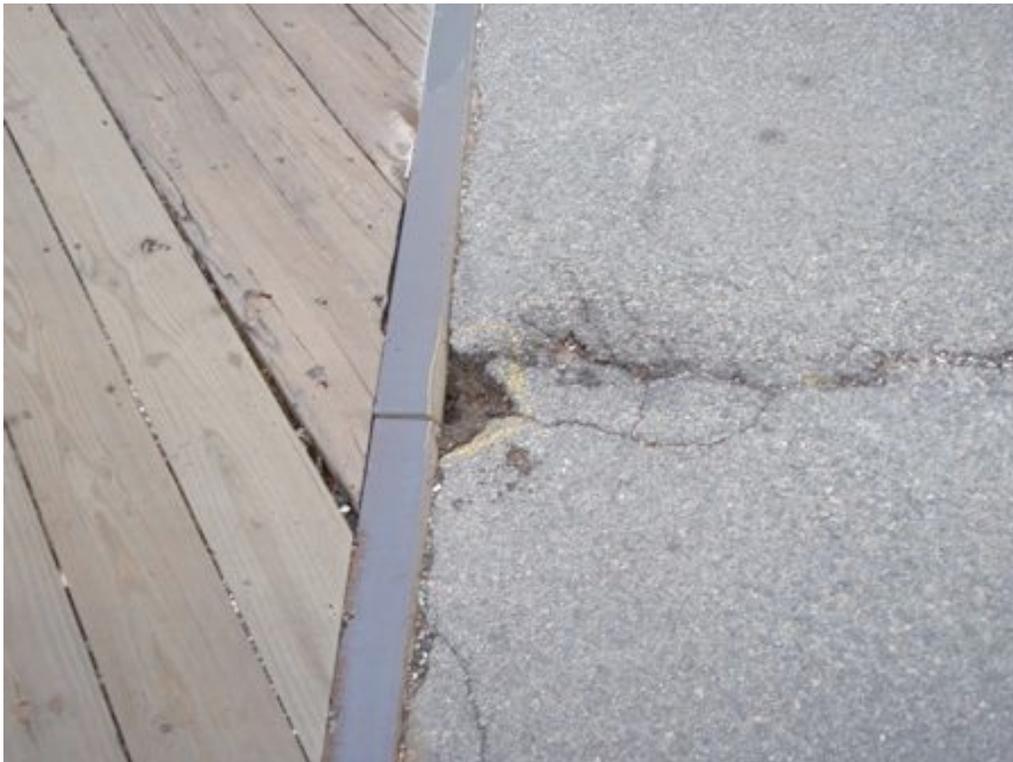
(Fair): The bituminous pavement at both approaches exhibits longitudinal and transverse cracks up to 1" wide. Previously sealed cracks in the east approach have opened up. There is a 9" wide by 5" long by 2" deep spall at the center of the west approach roadway at the west abutment deck joint (**see photo 10**).

Photo 10: Spall at the west approach roadway adjacent to the west abutment deck joint.

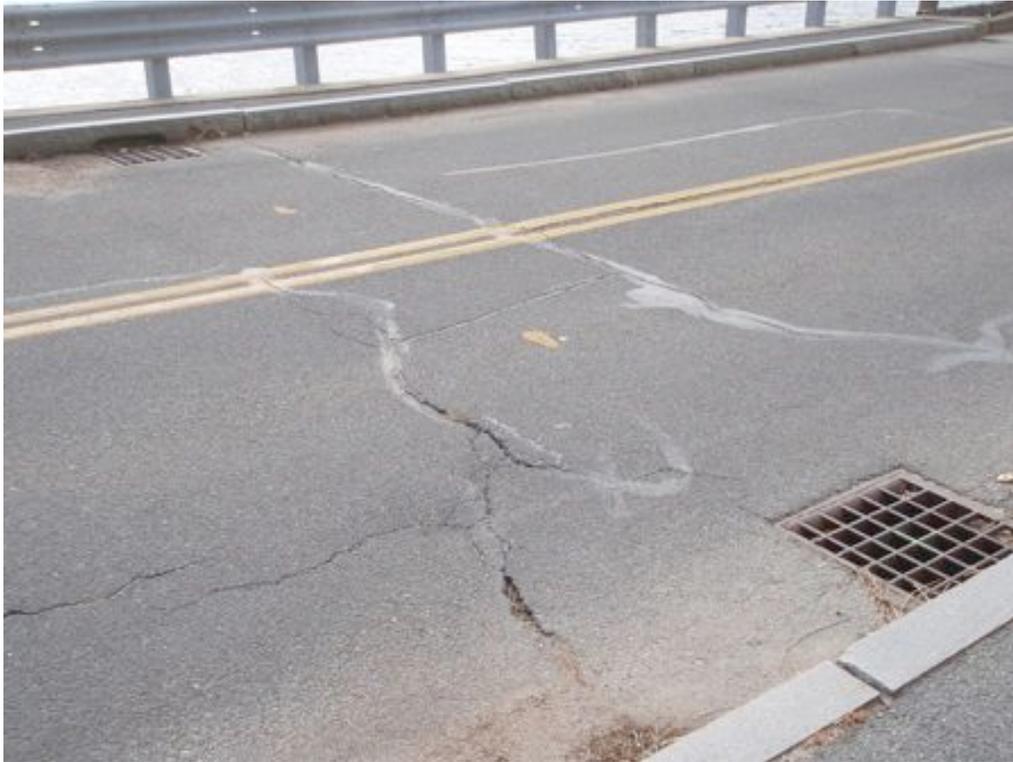
(Fair): There is up to 1" settlement of an 8'-0" wide by 16'-0" long bituminous patch in the westbound lane of the west approach. There is moderate cracking up to 1/2" wide, with up to 1" of settlement, adjacent to the north drainage scupper on the east approach (**see photo 11**). There is up to 1/2" deep wheel line rutting in the east and west approach roadway pavement.

Photo 11: Moderate cracking with up to 1" of settlement adjacent to the north drainage scupper on the east approach, looking south.

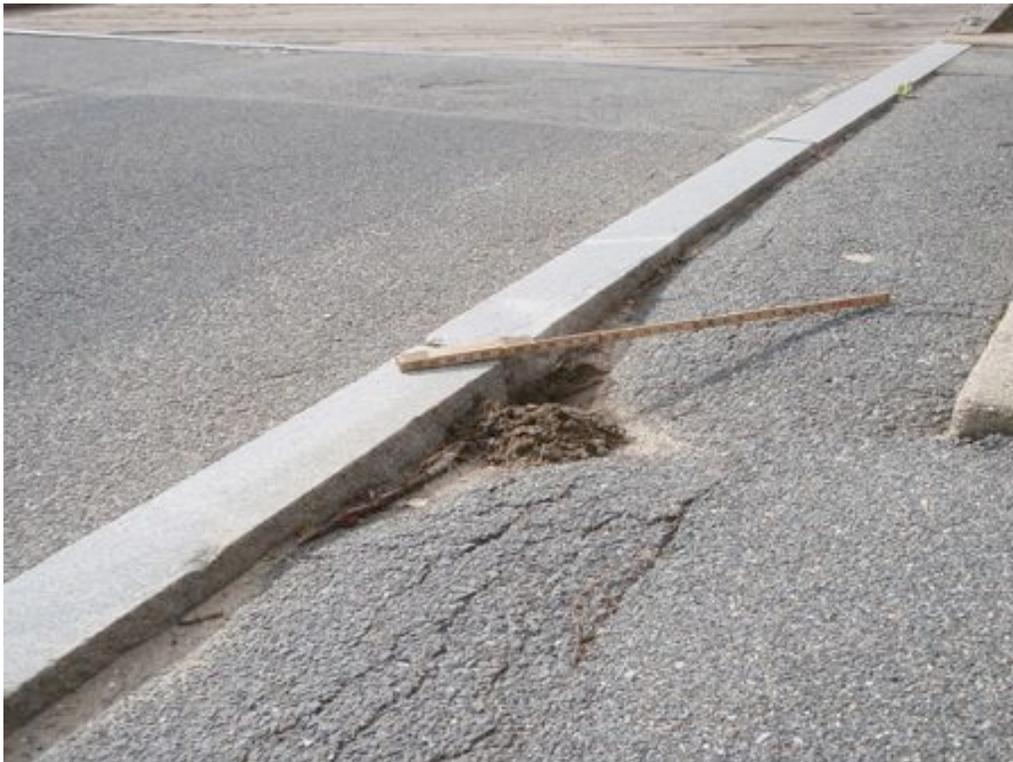
Photo 12: Settlement of the northeast approach sidewalk along the curb, looking west.

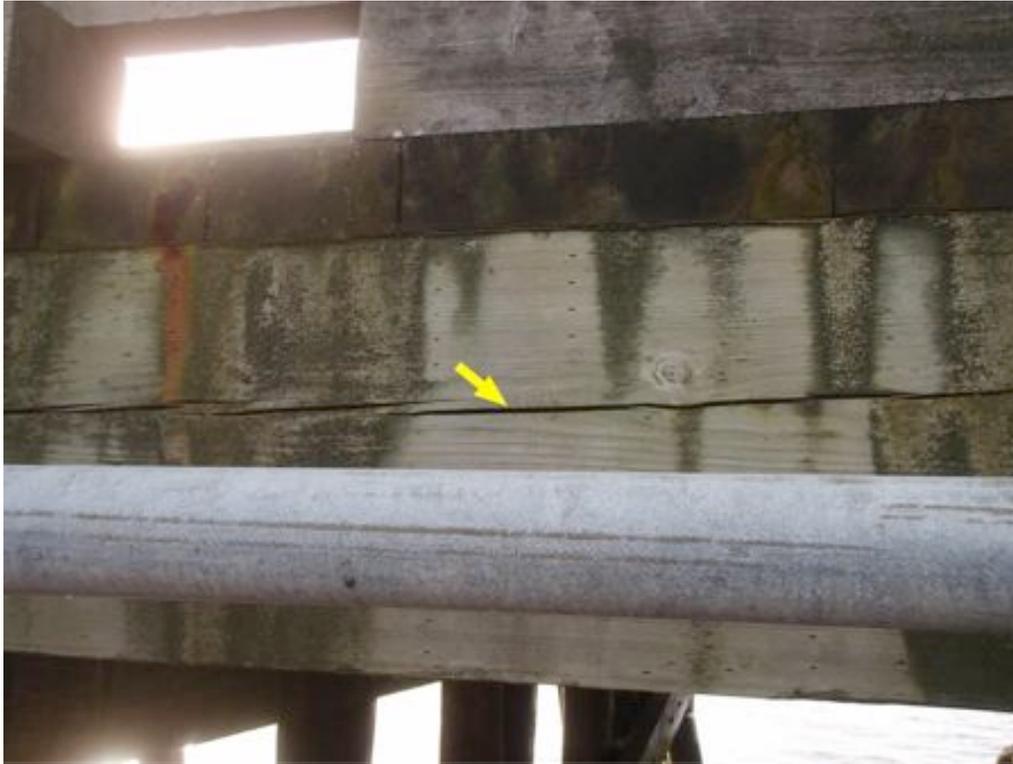
(Satisfactory): The timber beams exhibit minor shakes and checks which are typically 1/8" wide located along the vertical faces (**see photo 13**). Isolated beams exhibit checks up to 5/16" wide. In addition, there are isolated areas of minor mold/fungal growth on the beams throughout the bridge. There is minor collision damage consisting of scrapes and gouges on the underside of beams 1, 10 and 11 in the bascule span (span 8) (**see photo 14**).

Photo 13: Horizontal check of the north fascia beam in span 1.

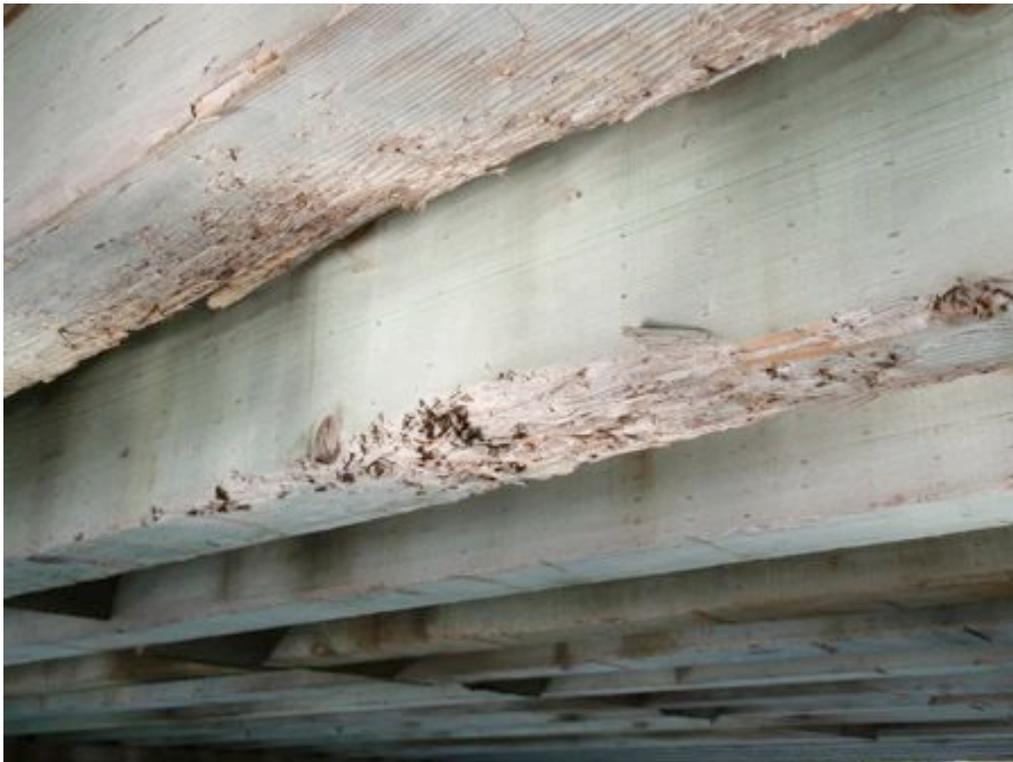
Photo 14: Minor collision damage to the underside of beams 10 and 11 in the bascule span (span 8).

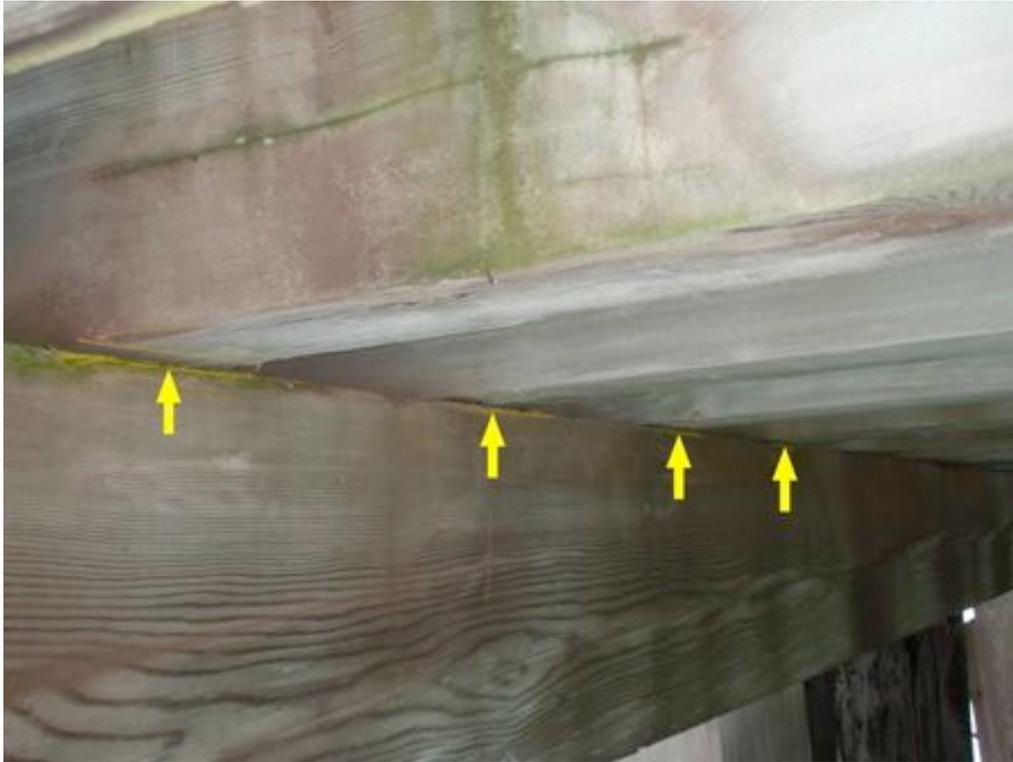
Photo 15: Up to 1/4" gap between beams 5 through 8 and the pile cap at bent 10.

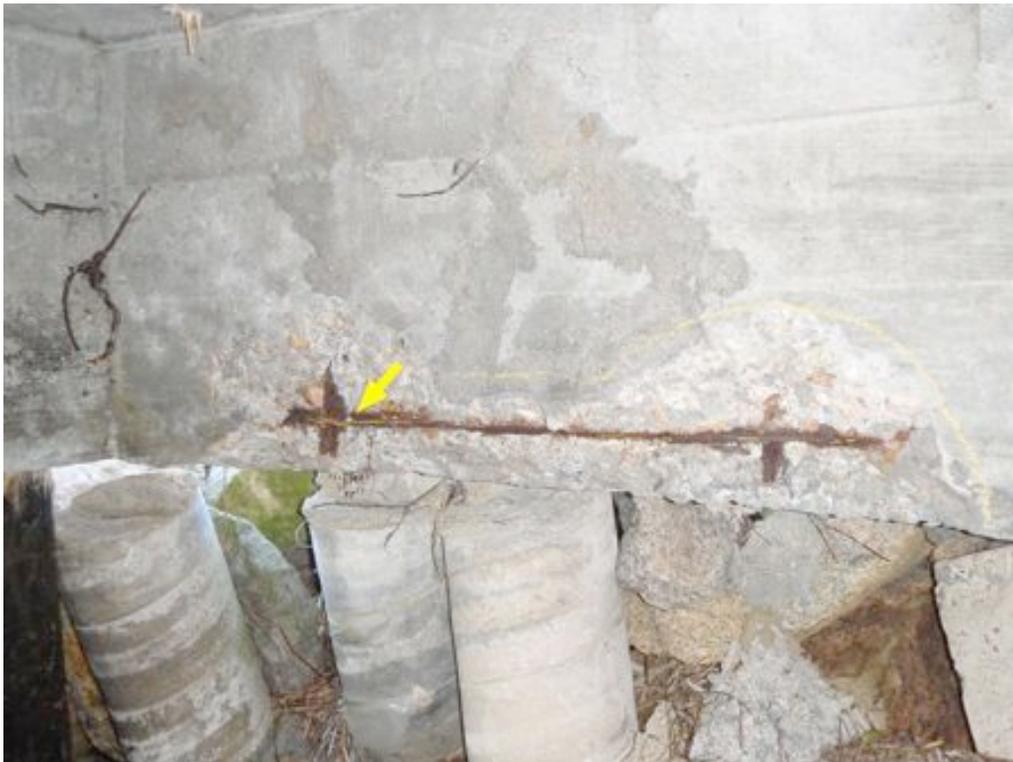
There is a 3'-1" long by 8" high by 3" deep spall with exposed reinforcing and one broken bar on the south side of the northern concrete beam of the east abutment span (**see photo 16**).

Photo 16: Spall with exposed and one broken reinforcing bar on the south side of the northern concrete beam of the east abutment span.

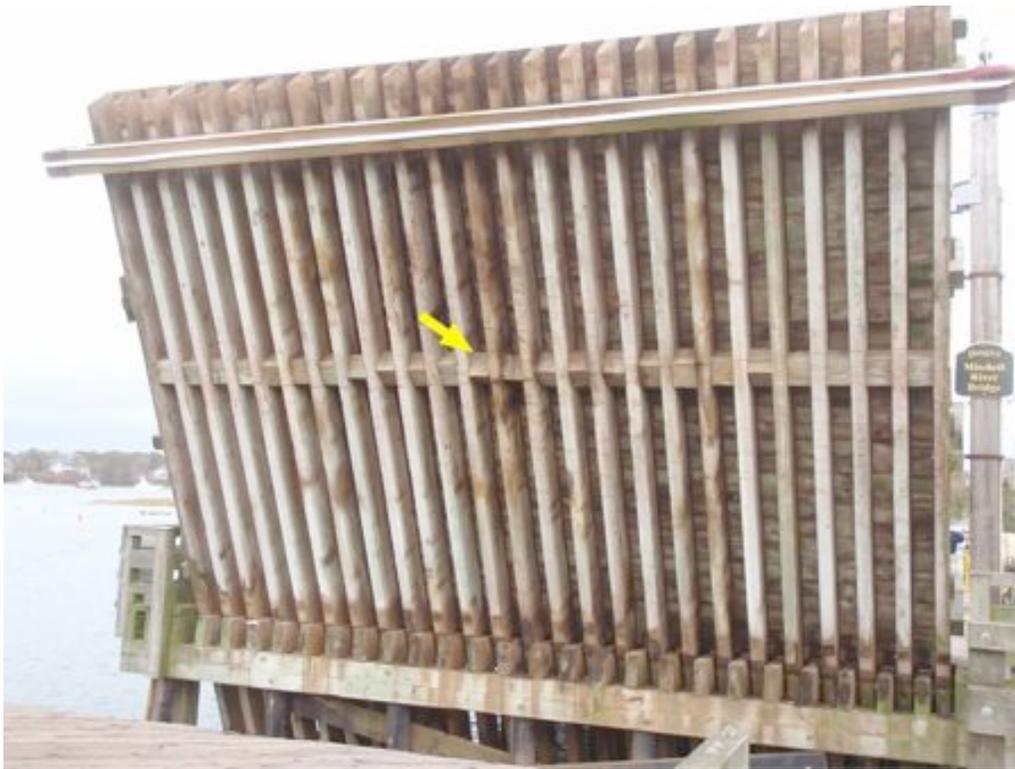
(Satisfactory): Many of the timber spacer blocks between the beams are loose and have rotated (**see photo 17**). Random blocks exhibit minor shakes and checks. There is severe deterioration with areas of up to 100% loss to the spacer block between beams 2 & 3 and 3 & 4 in span 12.

Photo 17: Typical loose and rotated spacer blocks on the underside of the bascule span (span 8) during a bridge opening.

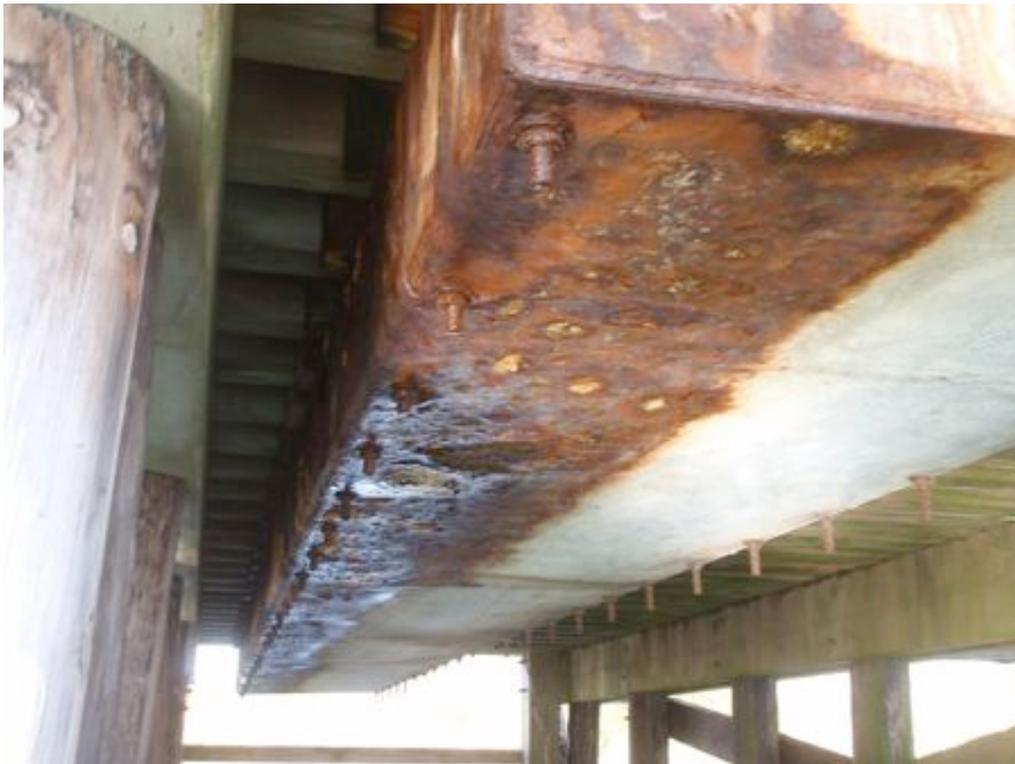
(Fair): The bascule span (span 8) counterweight steel shell galvanized coating (located in span 7) exhibits moderate to heavy corrosion and minor section loss along the west end of the counterweight (**see photo 18**).

Photo 18: Failed galvanized coating on the underside of the counterweight steel shell, looking north.

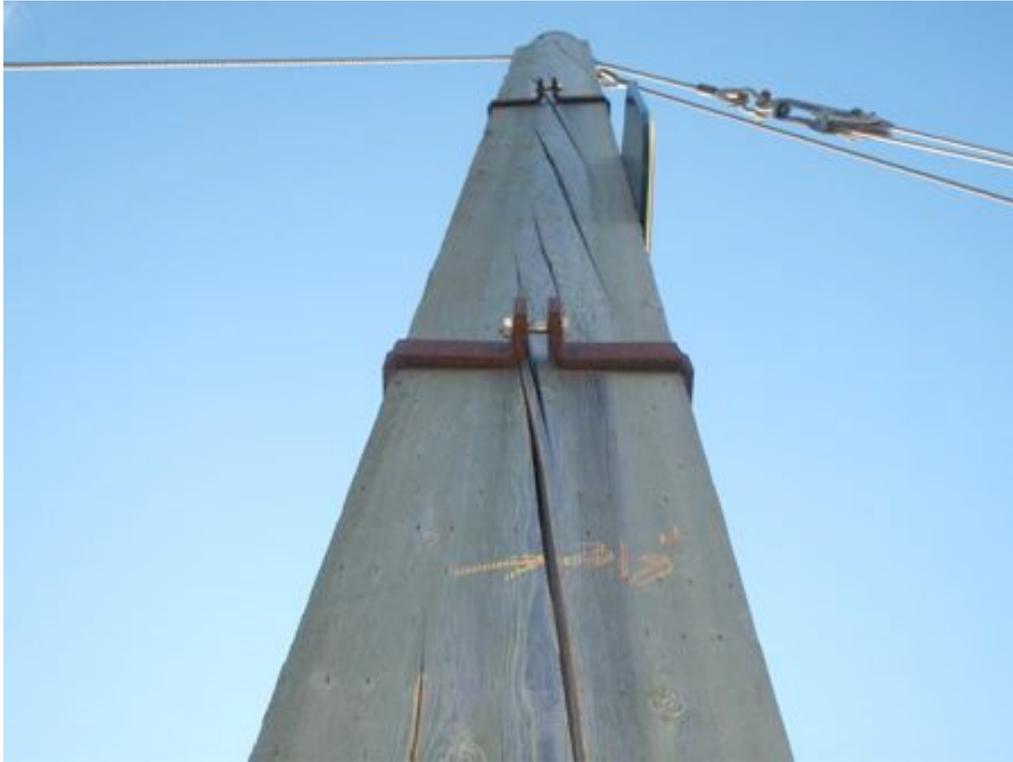
Photo 19: Up to 3/8" wide checks in the north face of the bascule span south king post.

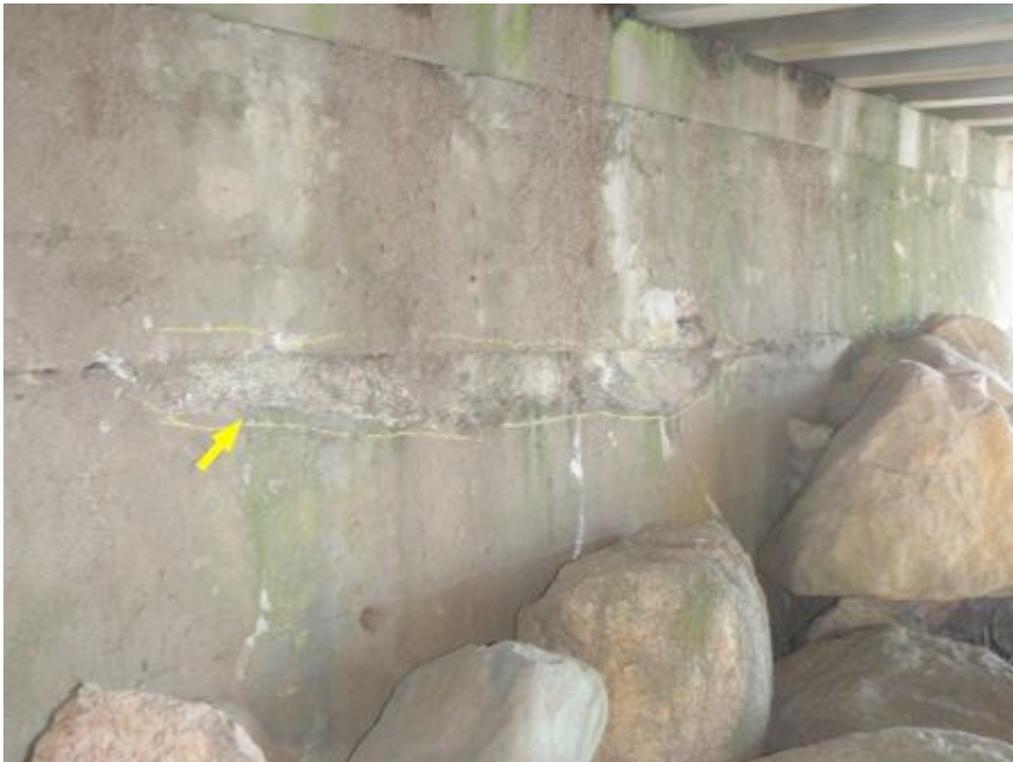
(Satisfactory): There is a 1/8" wide horizontal crack along the south half of the east abutment breastwall. In addition, there is a 4'-4" wide by up to 4 1/2" high by 2 1/2" deep spall along the crack near the center of the east abutment breastwall (**see photo 20**). Both the east and west abutment breastwalls exhibit hairline cracks with efflorescence as well as delaminations and peeling of the concrete skim coat. The timber sill beam on the west abutment breastwall exhibits minor checks.

Photo 20: Spall and cracking in the east abutment breastwall.

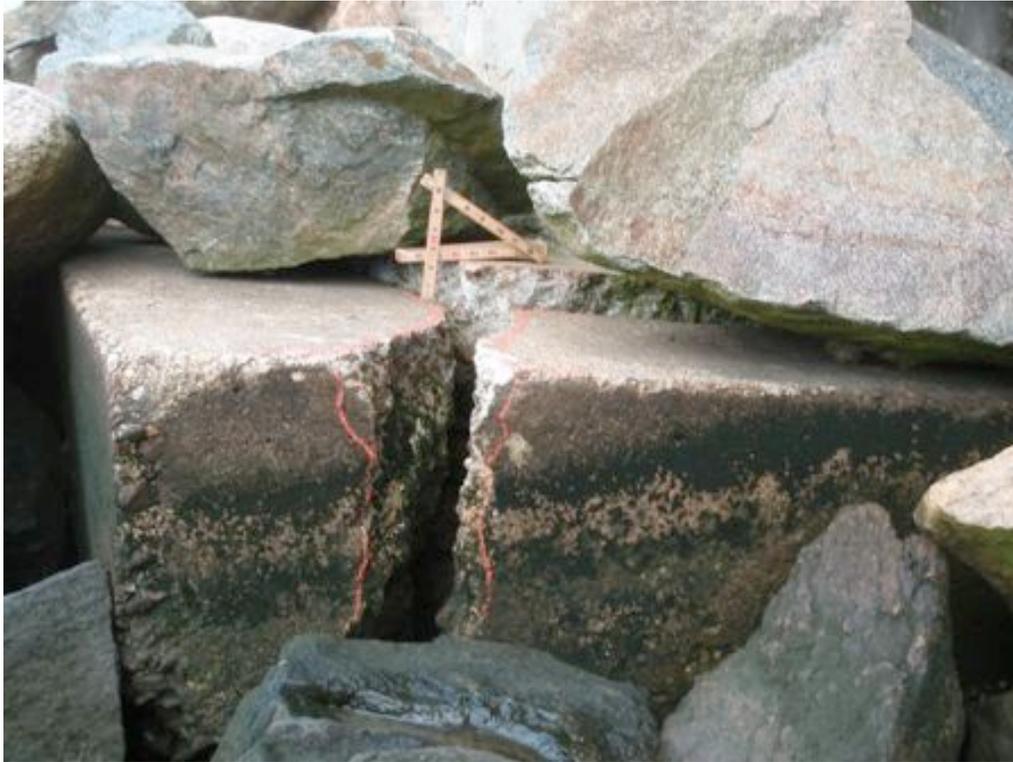
(Fair): The concrete footings are partially exposed through the rip-rap stones at the south end of both abutments. These abutment footings appear to function as a concrete apron/fender wall to the abutment. There is up to a 4" wide crack in the southeast corner of the concrete footing/apron of the west abutment. In addition, the corner of this concrete footing/apron is undermined up to 1'-6" deep and exhibits up to 2" of settlement at this location (**see photo 21**).

Photo 21: A 4" wide crack with settlement of the exposed concrete footing/apron at the south end of the west abutment.

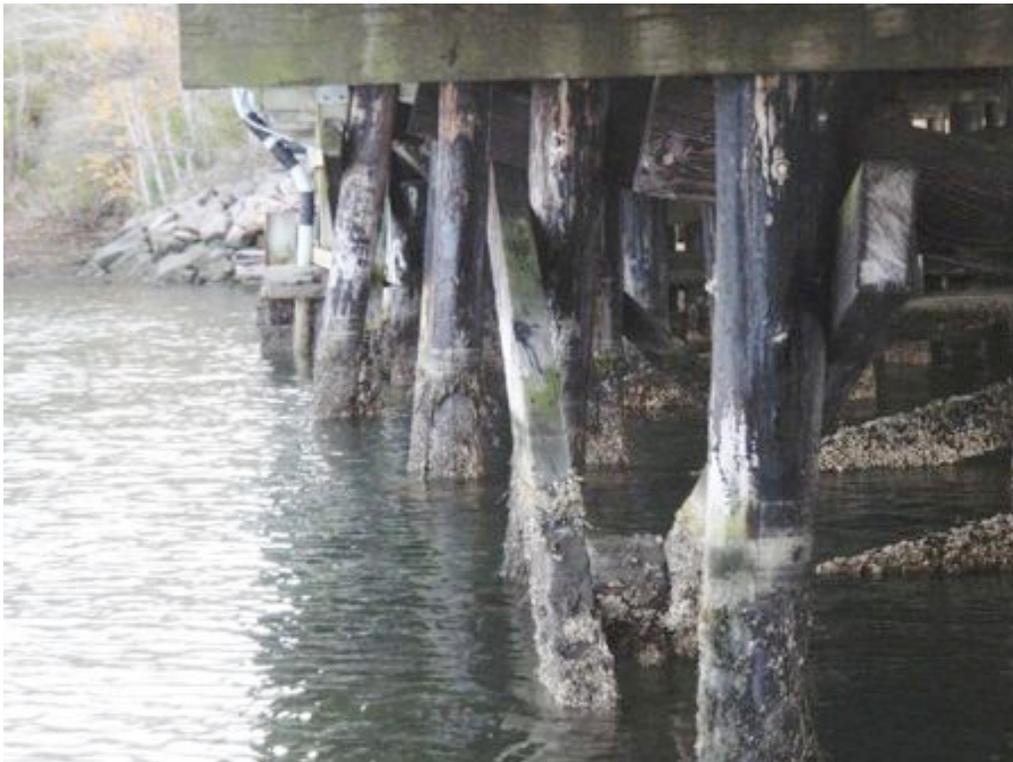
(Poor): (**DEFICIENCY/URGENCY OF REPAIR=S/A**) The diagonal timber bracing for each individual pile bent generally exhibits moderate to severe deterioration and section loss in the tidal zone (**see photo 22**). **The worst cases are at the south end of bent 3 and the north end of bent 5 (see photo 25) where there are 5'-0" long sections of the bracing which have completely deteriorated.** In addition, the diagonal bracing members exhibit moderate pigeon debris scattered throughout.

Photo 22: Typical condition of the timber piles and bracing members in the tidal zone (north end of bents 2 - 5 shown).

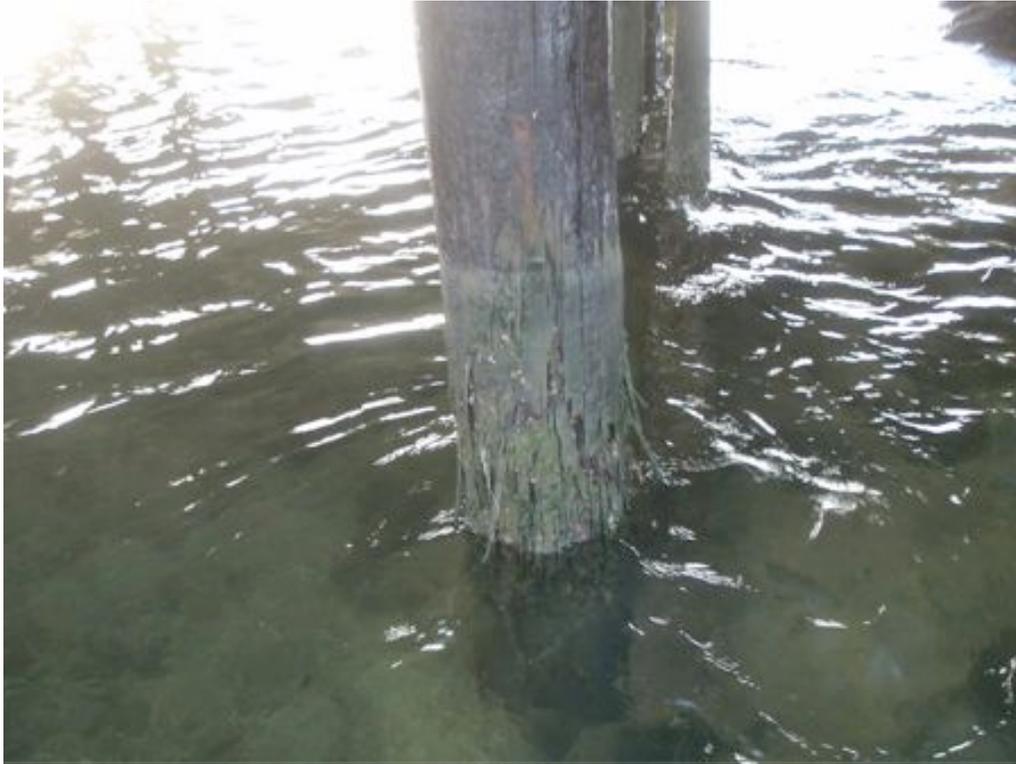
Photo 23: Heavy deterioration, marine growth, and brooming of pile 10 at bent 1.

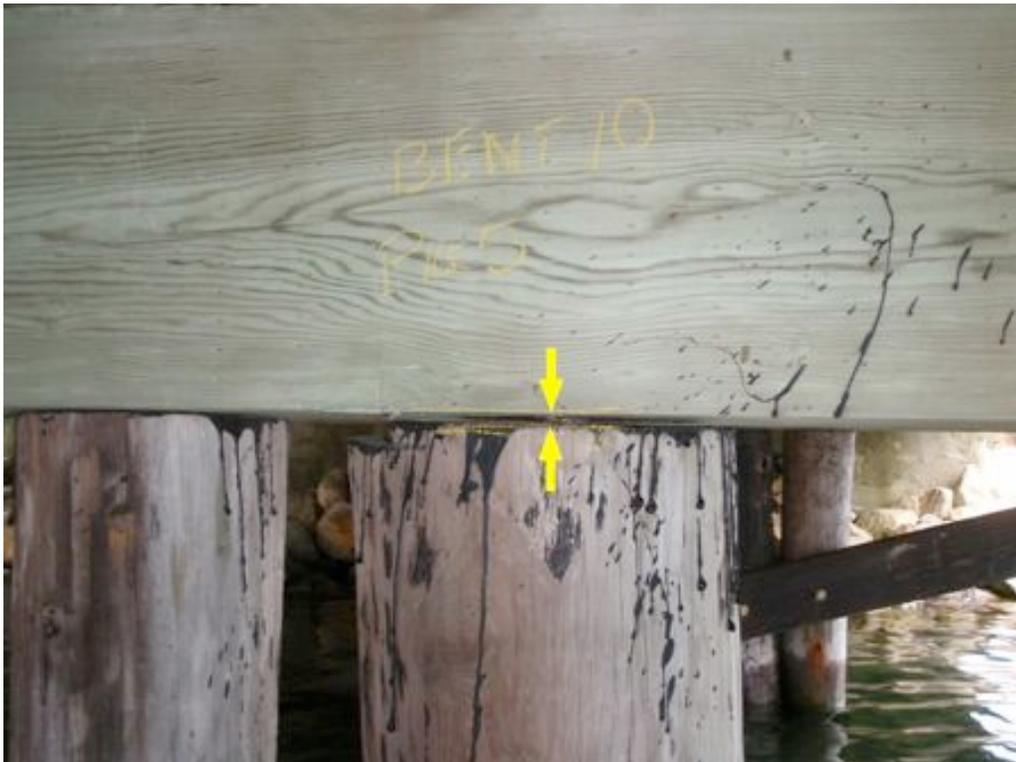
Photo 24: Gap between pile 5 and the pile cap at pile bent 10 (east face shown).

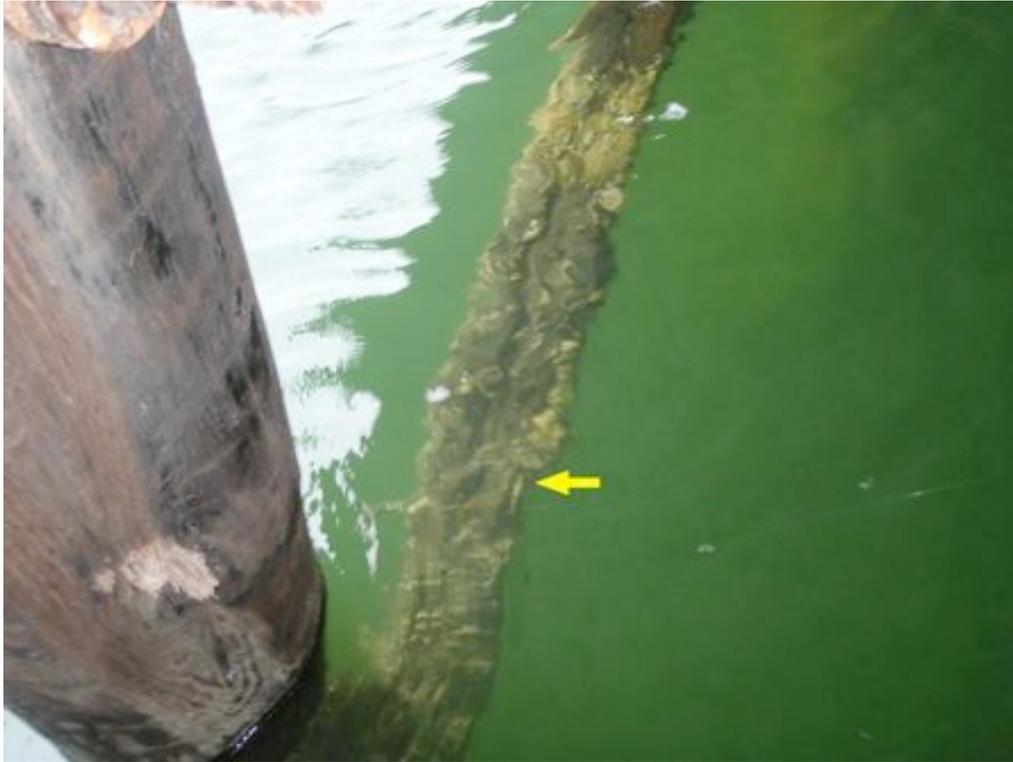
Photo 25: Diagonal bracing member with severe deterioration at the north end of bent 5.

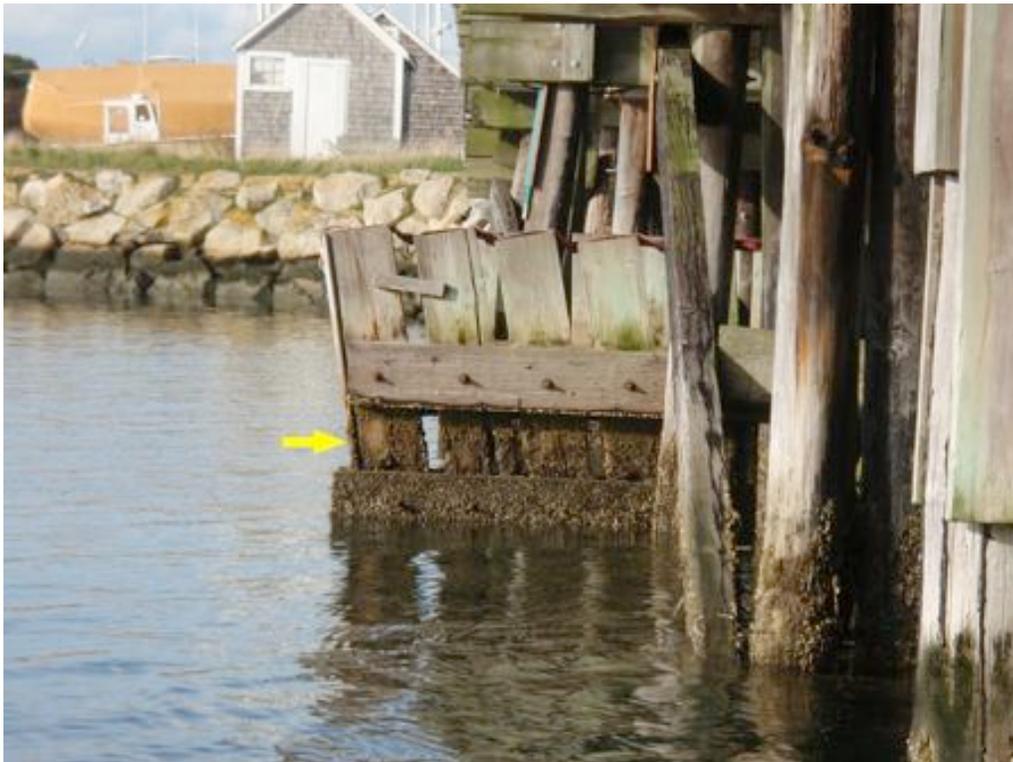
(Serious): **(DEFICIENCY/URGENCY OF REPAIR=S/A)** The timber fender system is directly attached to the piles at bents 7A and 8. The vertical and horizontal timber members generally exhibit moderate splitting and checking above the tidal zone. **In the tidal zone, these members exhibit heavy marine growth with moderate to heavy deterioration and up to 100% loss (see photo 26).**

The east fender exhibits moderate collision damage at the north and south ends with several vertical timber members leaning/rotated (**see photo 26**). The west fender exhibits moderate collision damage, and the south end of the top horizontal member has failed. The vertical member at this location is displaced up to 1 1/2" to the west (**see photo 27**).

Photo 26: Collision damage and deterioration to the south end of the fender (east face) at bent 8.

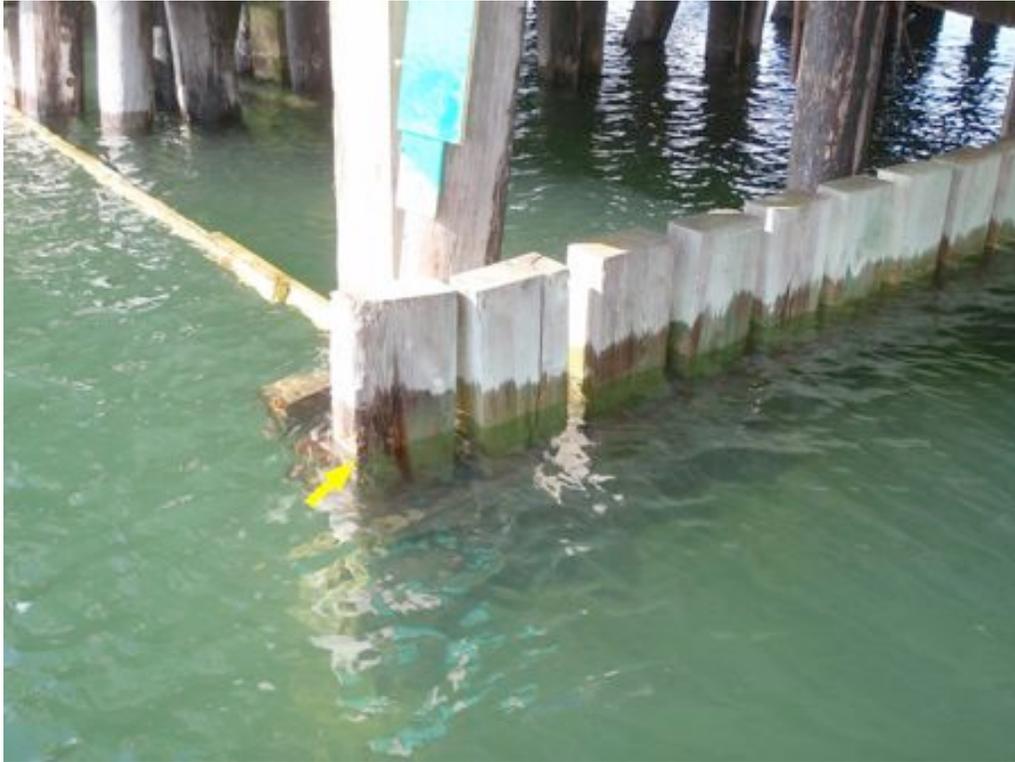
Photo 27: Collision damage to the south end of the fender (east face) at bent 7A.
