STRUCTURES INSPECTION FIELD REPORT

2-DIST
05

B.I.N.
437

ROUTINE INSPECTION

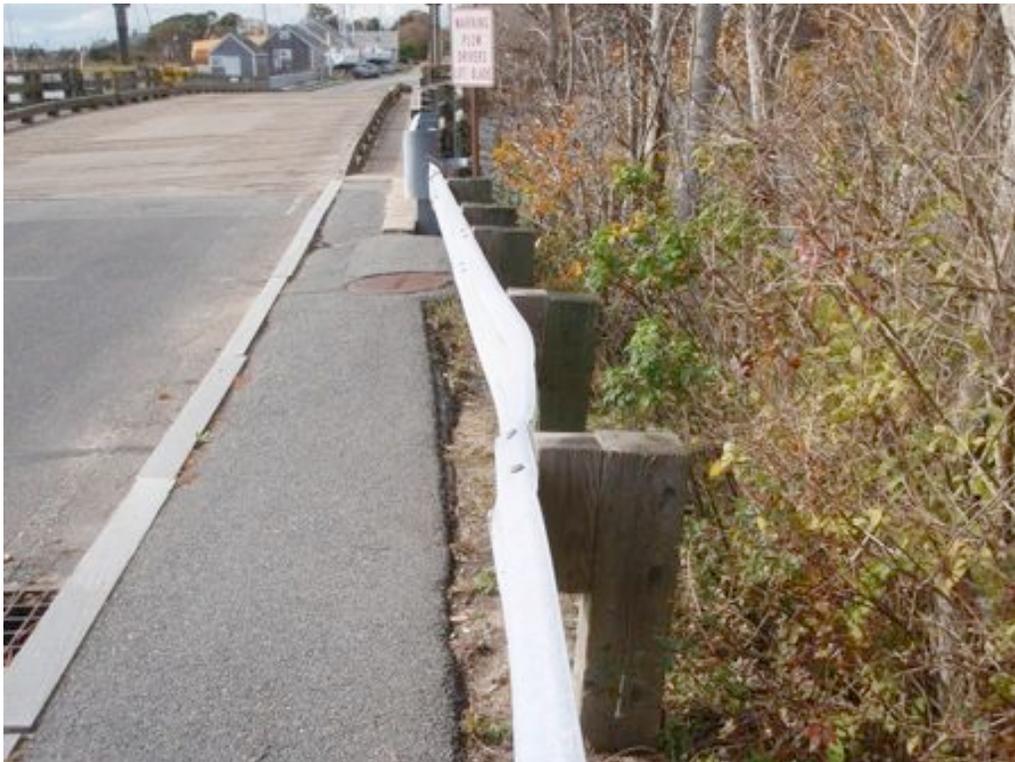
(Fair): The approach guardrails consist of three beam and w-beam which are not continuous for the entire length at each approach. There are five posts for the south guardrail at the east approach with loose anchor bolts and up to a 1 1/2" gap between the east abutment wingwall and the posts. This guardrail leans up to 3" to the south. There is moderate collision damage to the north guardrail at the east and west approaches. These guardrails and posts lean up to 3" to the north (**see photo 28**). The approach guardrails do not conform to the current standards.

Photo 28: Moderate collision damage causing the northwest approach guardrail and posts to lean up to 3" to the north.
