***Subject: Chatham, MA – Mitchell River Bridge Project  
Bridge Repair/Rehabilitation Feasibility Study***

**BRIDGE REPAIR/REHABILITATION FEASIBILITY**  
**STUDY**

**BRIDGE STREET**

**BRIDGE NO. C-07-001 (437)**

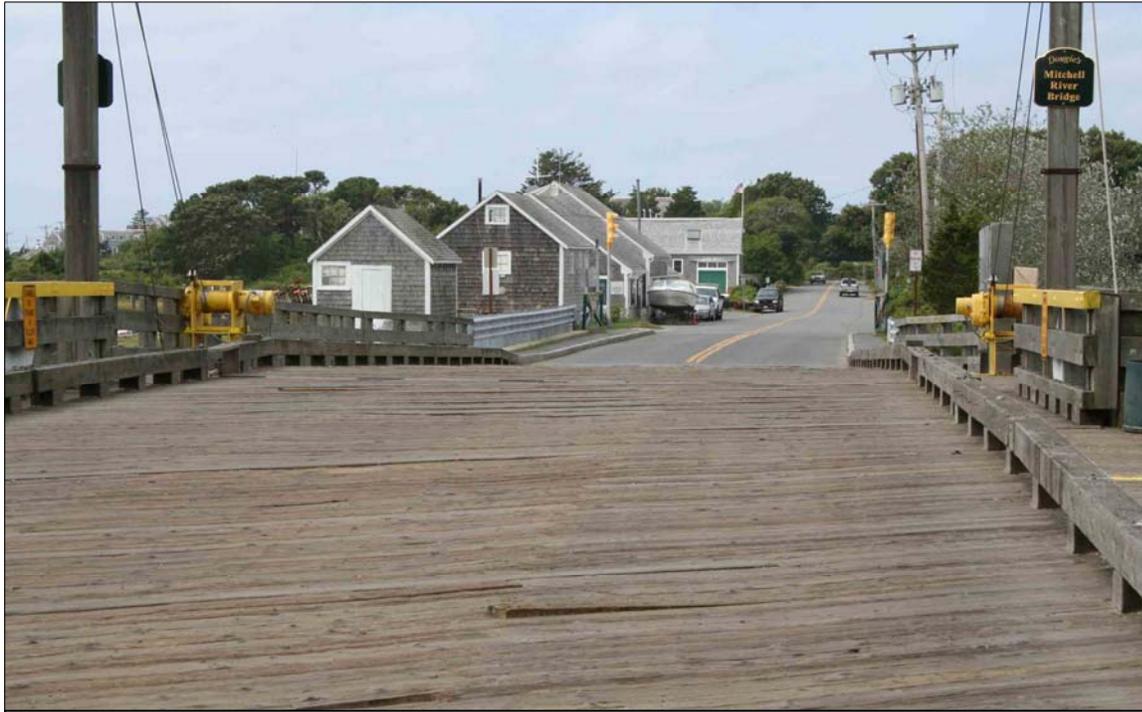
Photo 4 - Timber Wearing Surface

promotes growth in the number and size of splits and checks in the wood, which further increases moisture absorption and provides an avenue for fungal spores to enter the wood. The significant volumetric change in the wood also acts to work nails loose. Increased water absorption also promotes decay by providing the required source of moisture required by fungi that feed on the wood. Larger splits and checks retain a greater amount of moisture. Water retained in the checks in splits freezes during winter months increasing damage to the wood. Timber planks with significant checks and splits eventually splinter under traffic loading.

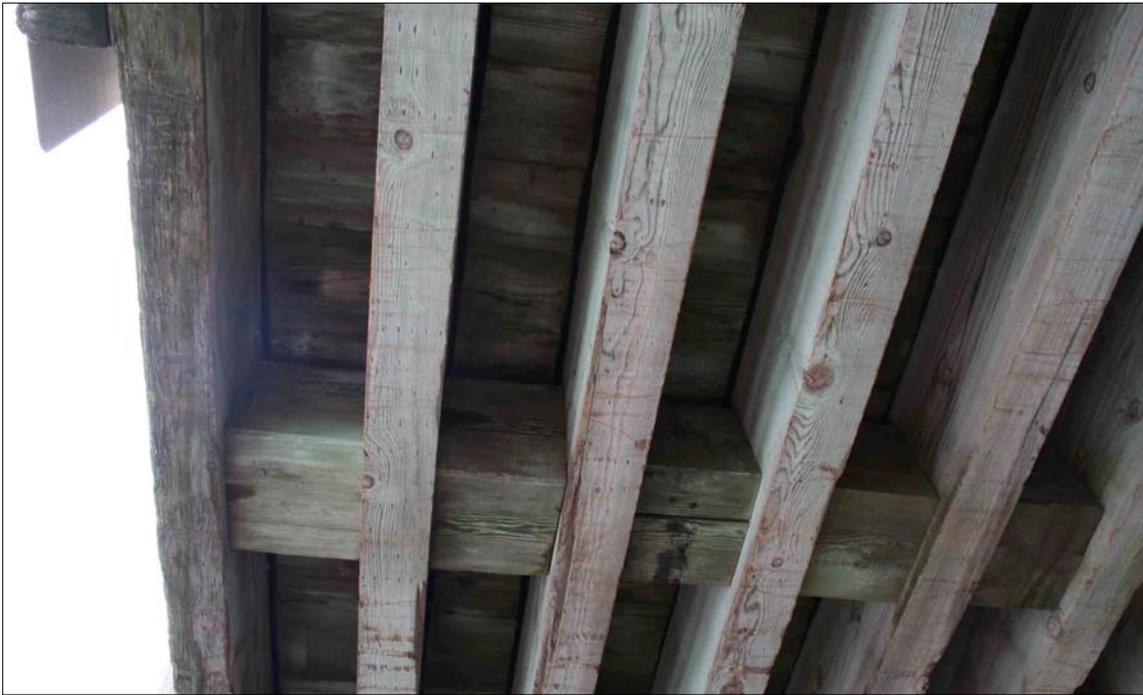
Photo 5 - Stringer and Diaphragms

There is minor impact damage to the underside of the stringers in the bascule span.

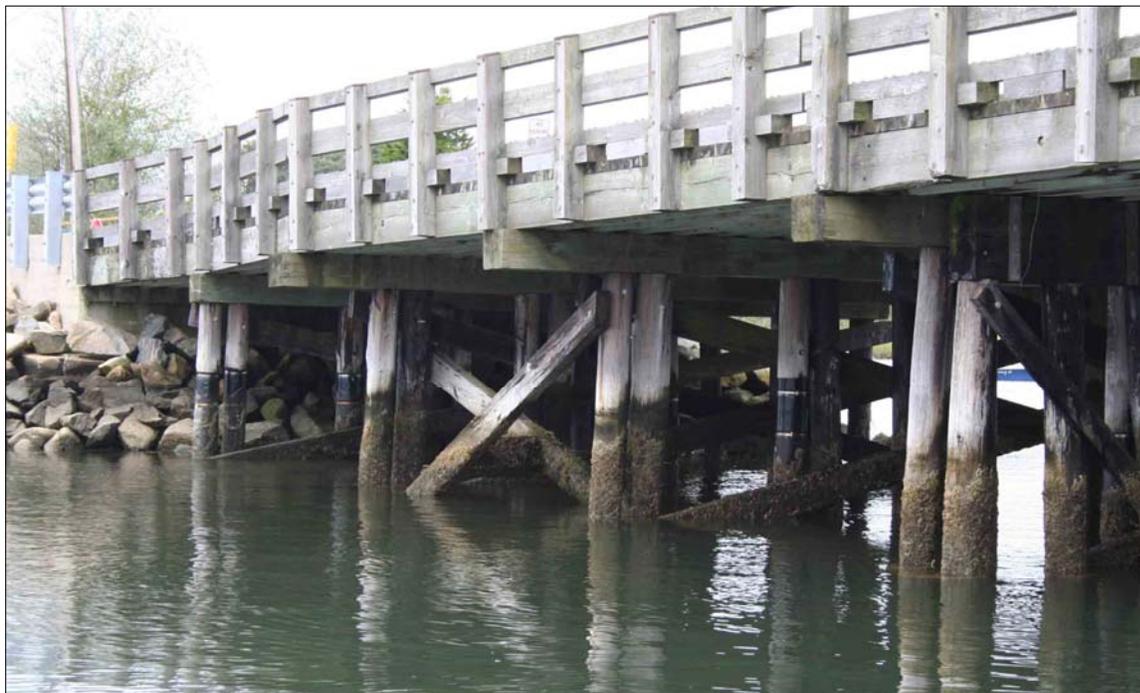
Photo 8 - Piles and Bracing

Several piles in Bent 10 include addition of a 12x12 timber build-ups at the top of the pile that was spliced in line with the pile. Based on the appearance of these pile build-ups, which is similar to the piles, they are likely the same age as the piles and were likely added when those piles were originally installed to add length to the pile or to replace a damaged section of the tops of the piles.

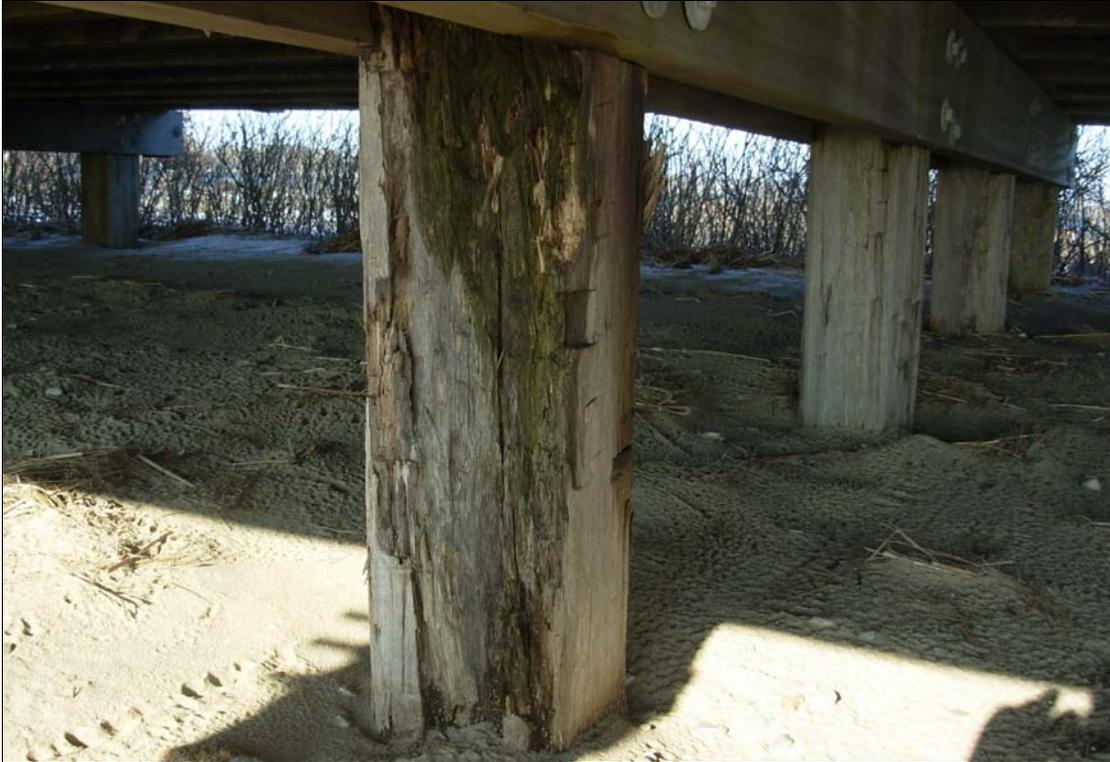
Photo 9 - Powder Point Bridge - Pile Condition

- The Powder Point Bridge in Duxbury, Massachusetts (a 2200 foot long, 133-span timber bridge over the Back River at Duxbury Bay) illustrates this concern (see Appendix B.) The bridge was reconstructed in 1987 using piles made from Basralocus. Although Basralocus reportedly is considered highly resistant to decay, the piles exhibited significant decay and deterioration after only 25 years of use. Based on the referenced statements above and the disappointing performance on the Powder Point Bridge, there are reasons for concern with the use of these materials. Ultimately, there is insufficient evidence to support that tropical timber can be used to significantly increase the service life of the piles at this site.

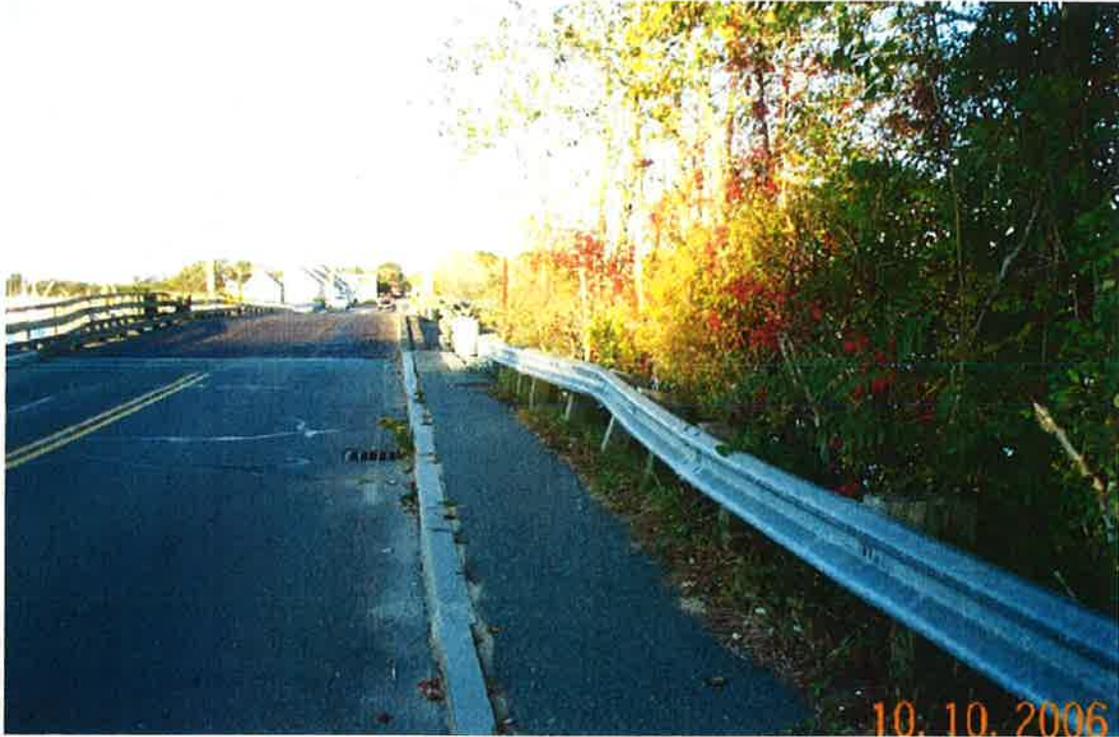
**Photo 1: Impact damage to the northeast approach guardrail, looking west.**

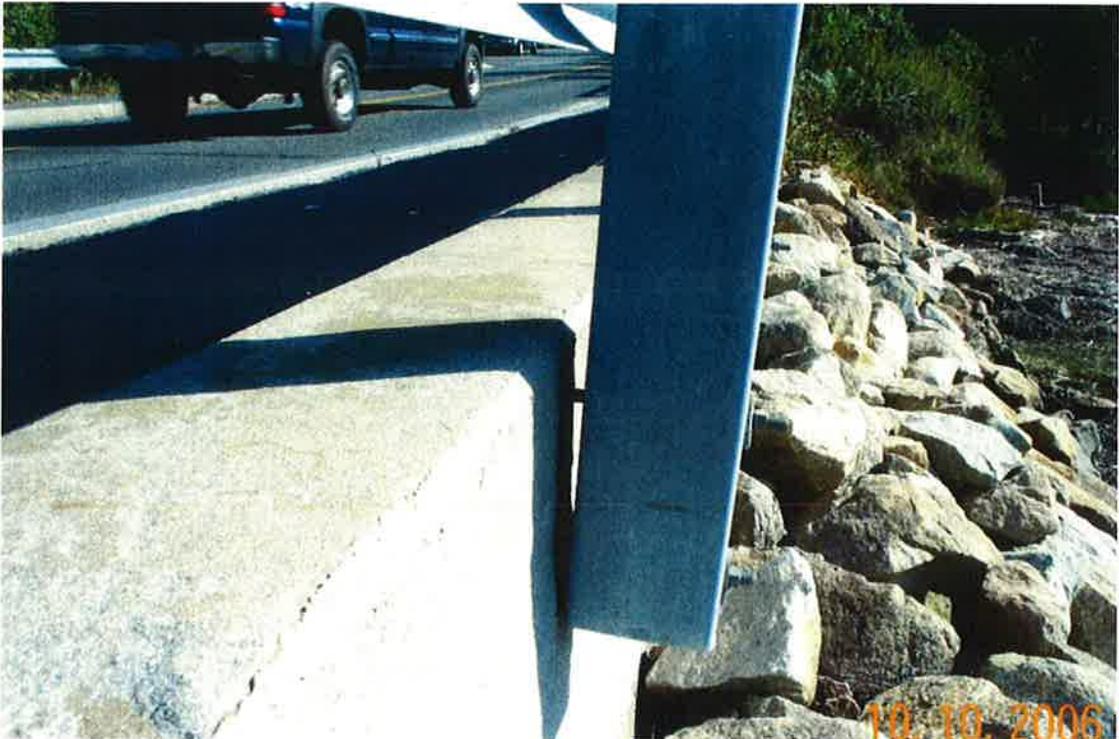
**Photo 2: 1 1/4" gap between the southeast approach guardrail post and wingwall, looking east.**

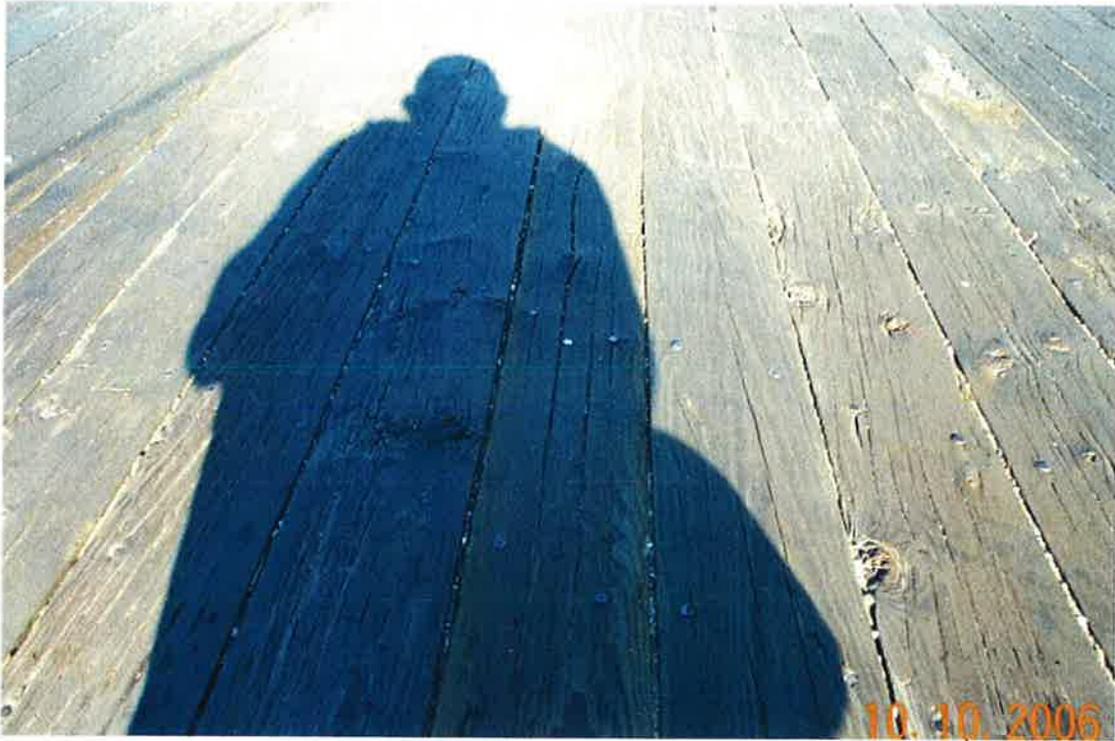
**Photo 3:** Typical condition of the timber wearing surface in Span 6, looking northwest.

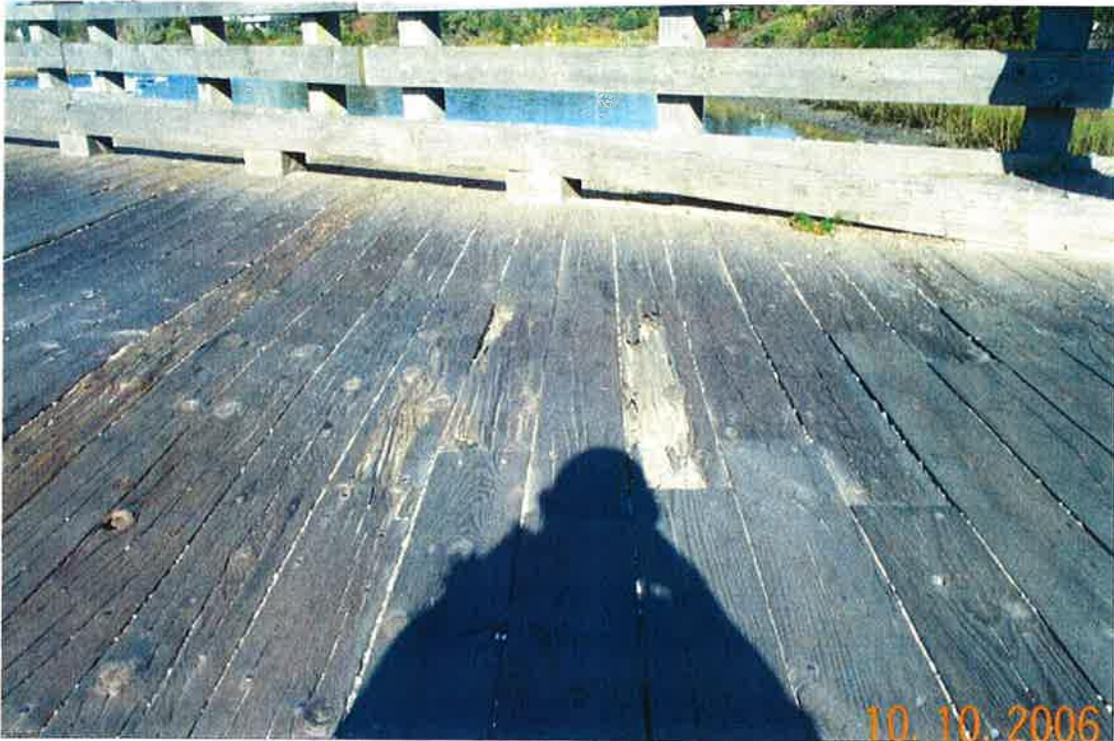
**Photo 4:** Moderate to heavy deterioration of the timber wearing surface in Span 12, looking northwest.

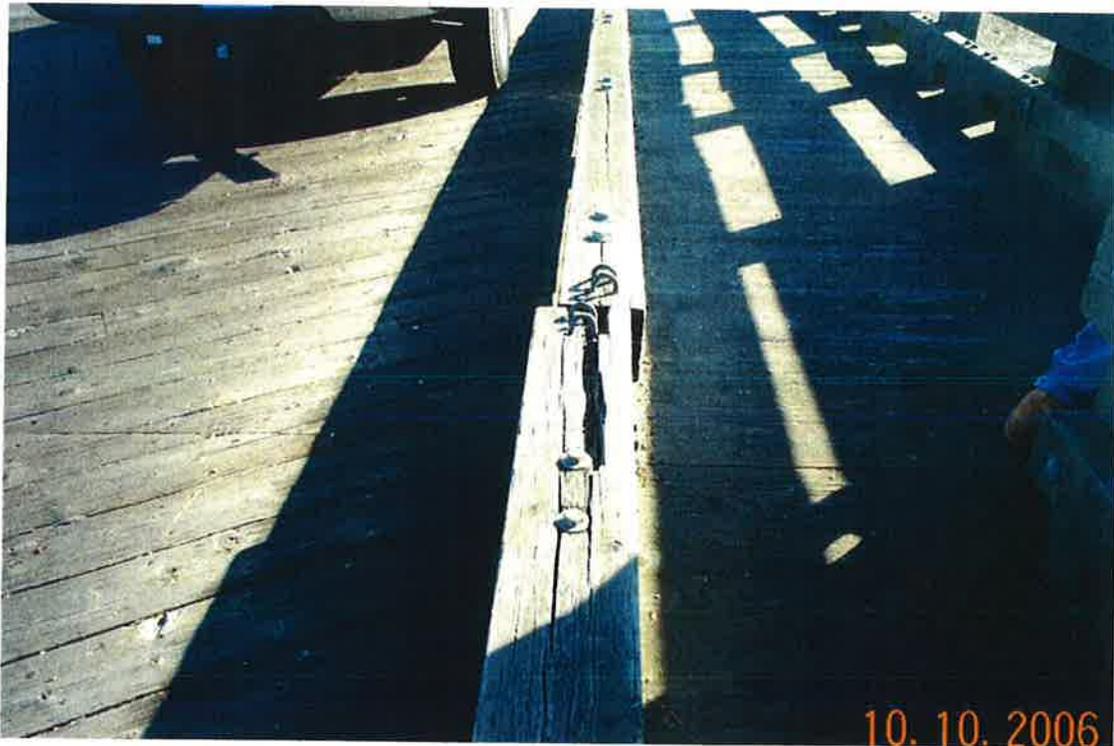
**Photo 5:** Mod/hvy deterioration of curb in bascule span at toe, looking east. Note tight deck joint & 1 1/2" shift of bascule span toe to north.

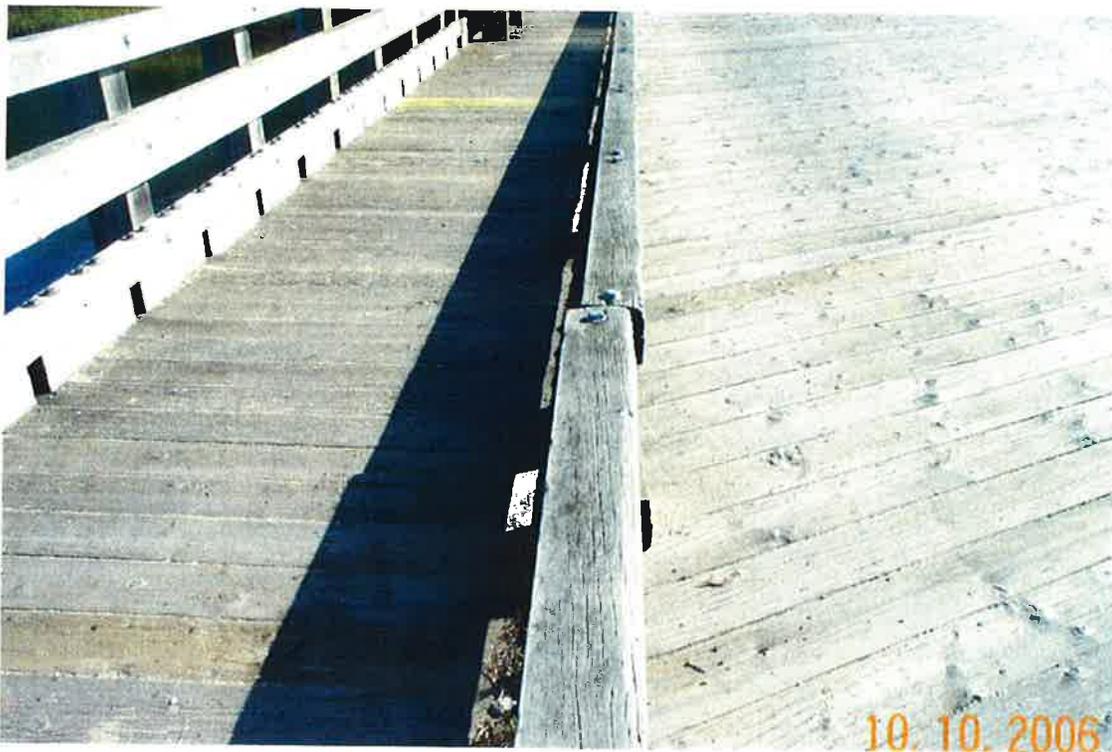
**Photo 6:** Transverse misalignment of the north curb at the east end of Span 12, looking west.

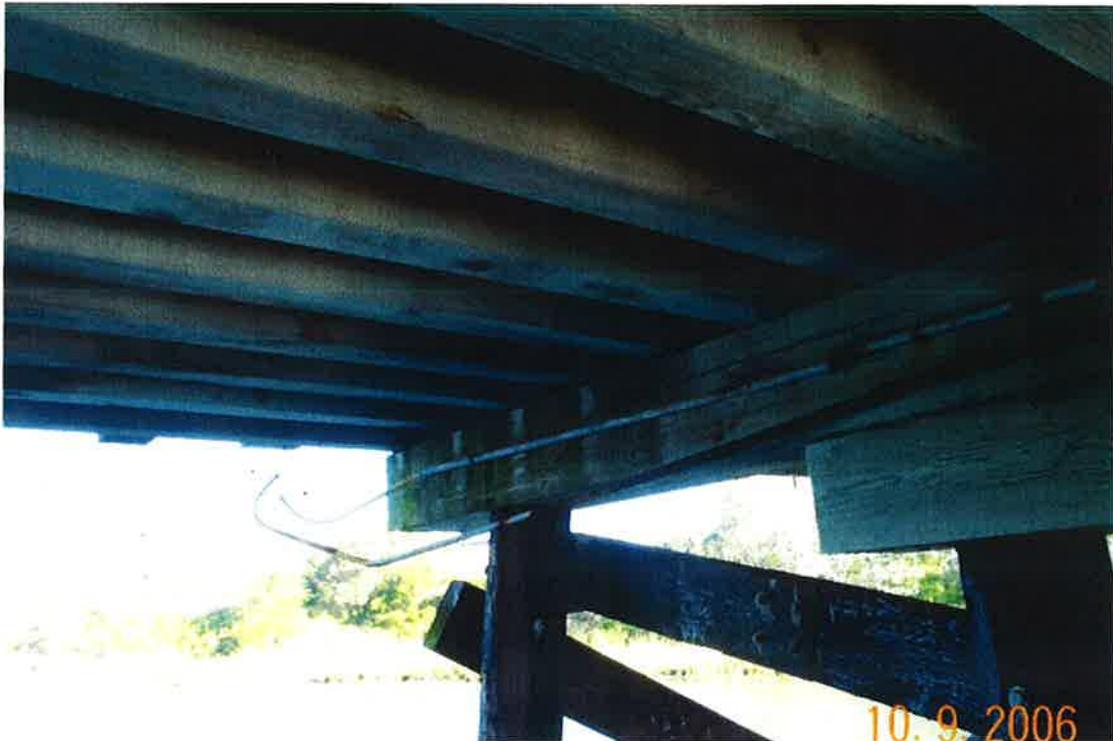
**Photo 8:** Deteriorated, broken & loose electrical conduit with exp. wiring on west side of Bent 5 at north end, looking northeast.

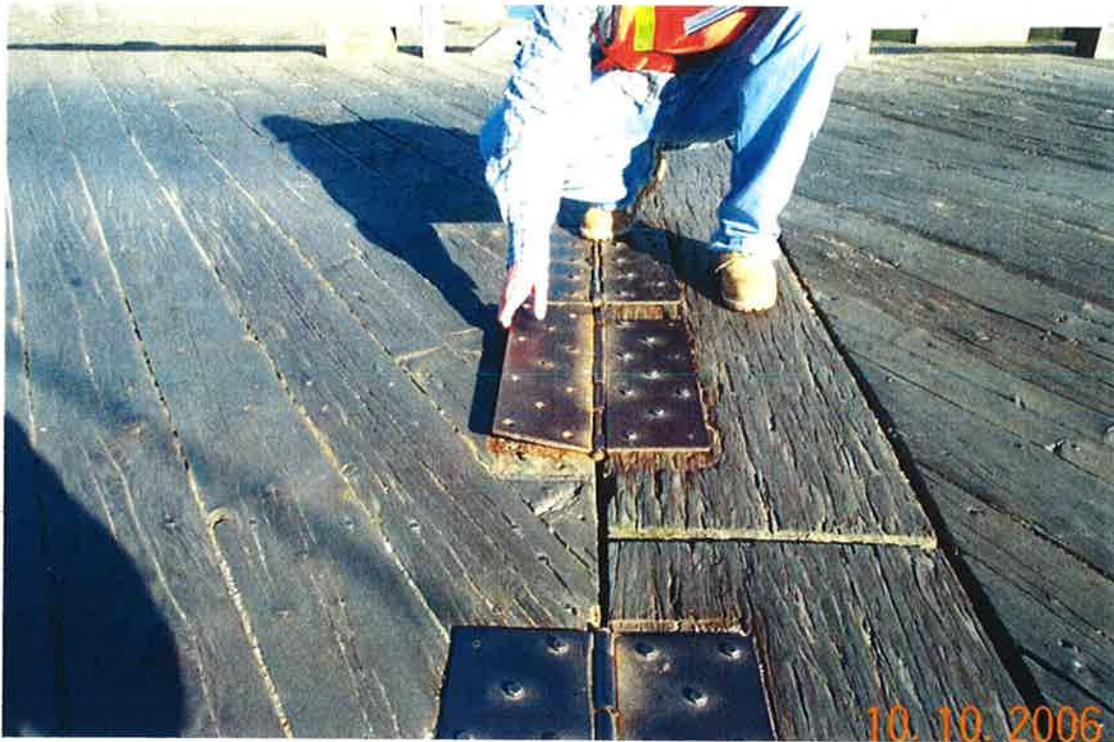
**Photo 9:** Loose steel hinge plate for the deck joint at the west end of the bascule span (Span 8), looking north.

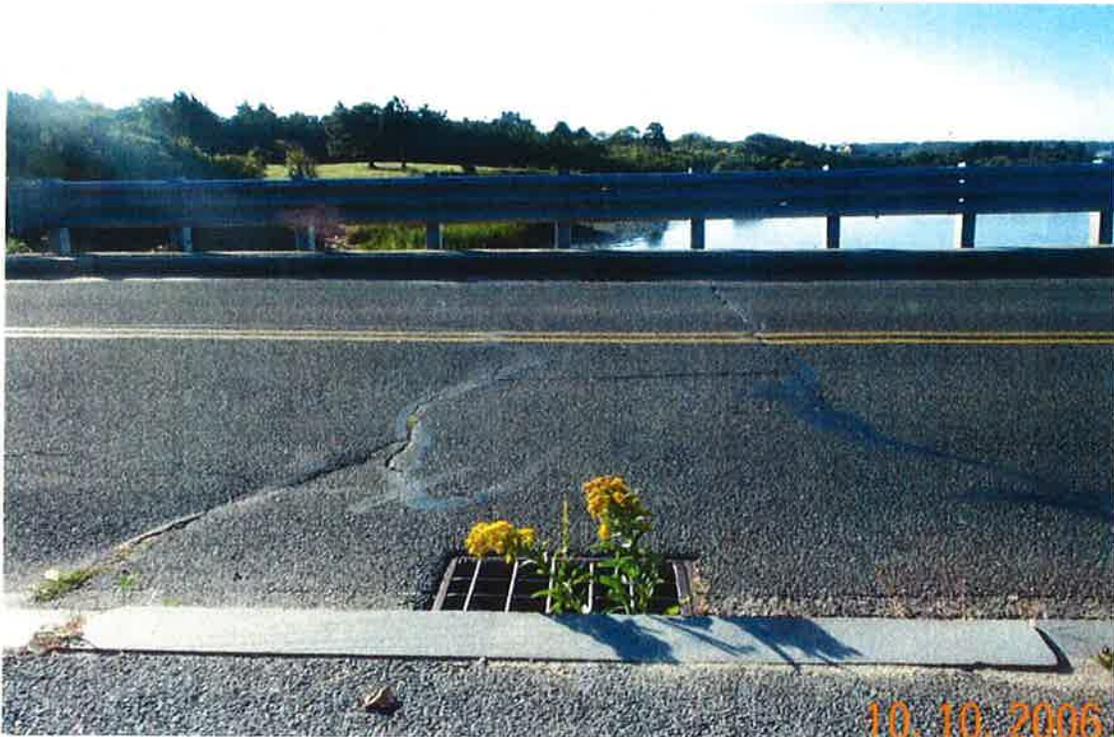
**Photo 10:** Minor cracking and settlement at the east approach, looking south.

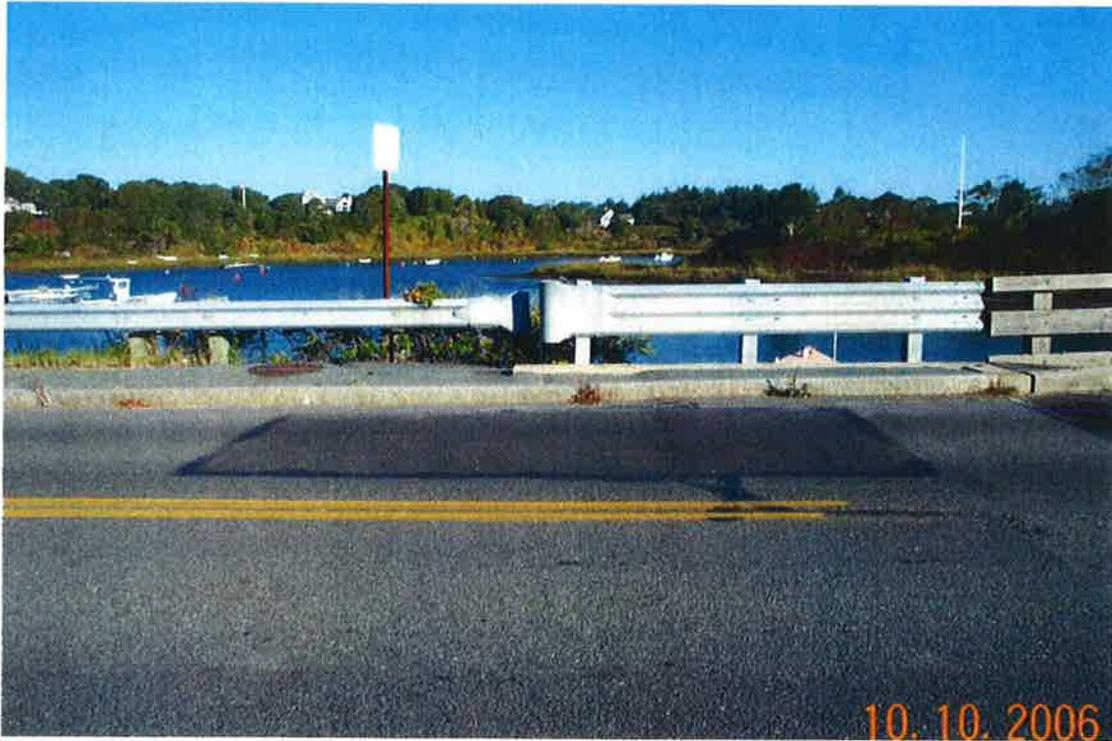
**Photo 11:** Apparent repair to the westbound lane of the west approach, looking north.

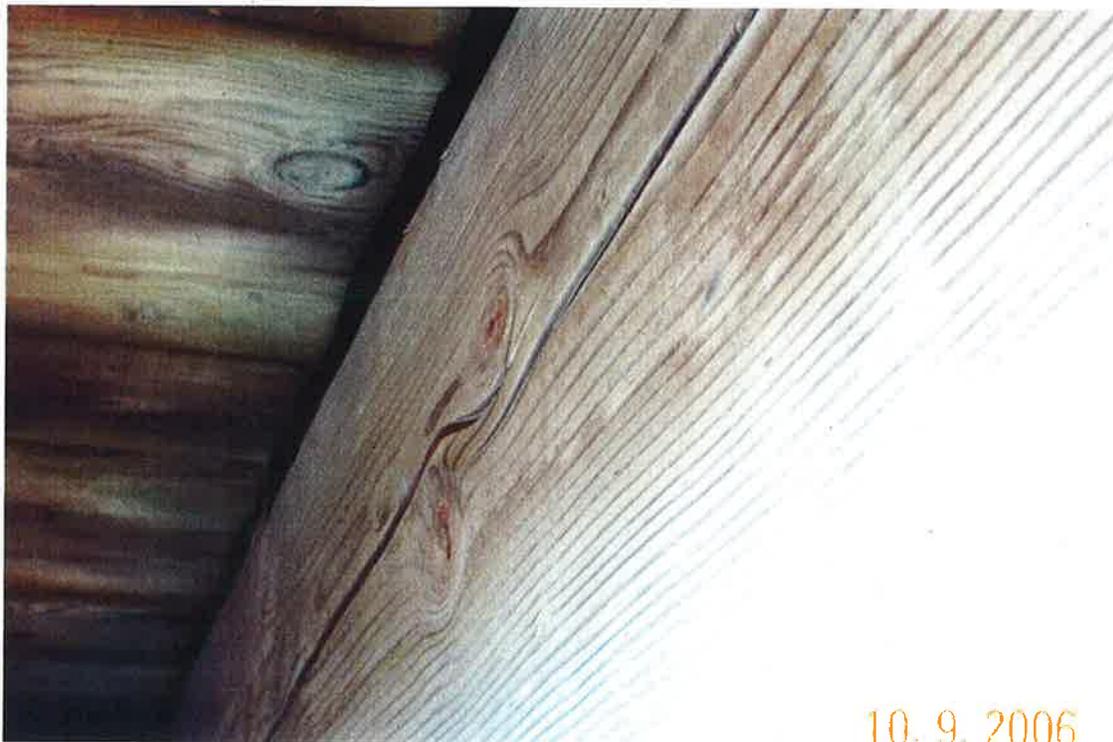
**Photo 12:** 5/16" wide by 5'-0" long check on the north side of Stringer 9 from the south in the bascule span (Span 8), looking southeast.

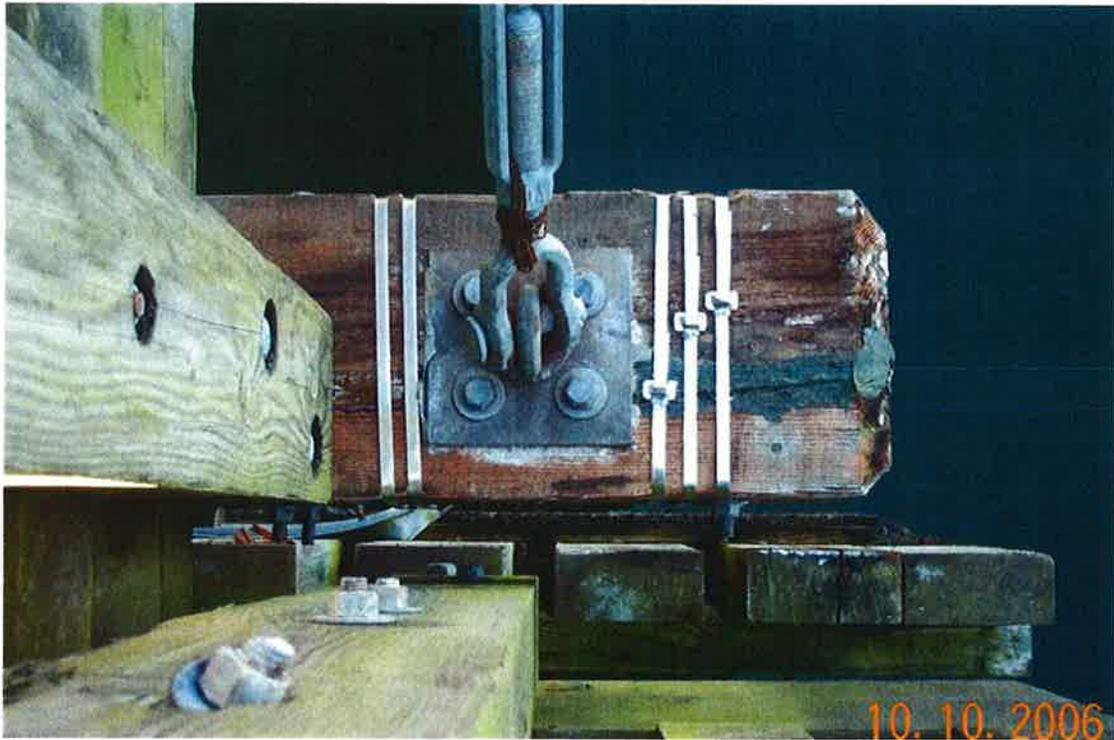
**Photo 13:** Temporary repair to the north end of the bascule span (Span 8) timber lifting beam, looking west and down.

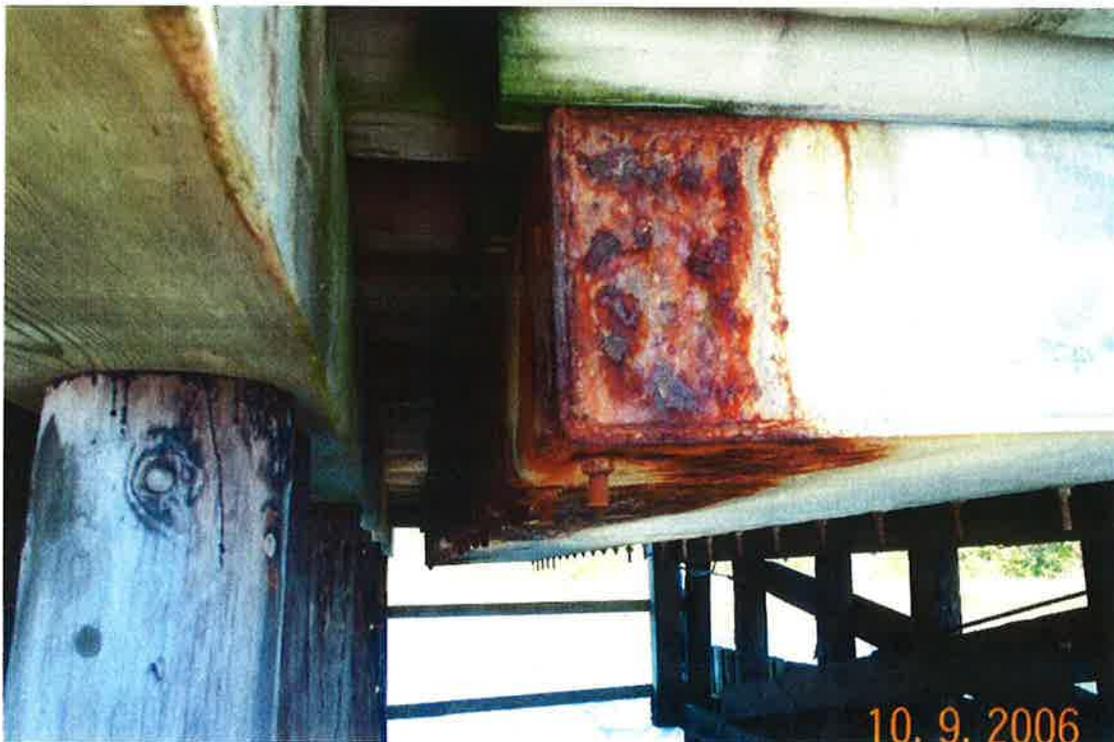
**Photo 14:** Mod/hvy corrosion of bascule span cntwrght steel shell & connection bolts (Span 7), looking north. Note steel welds ok.

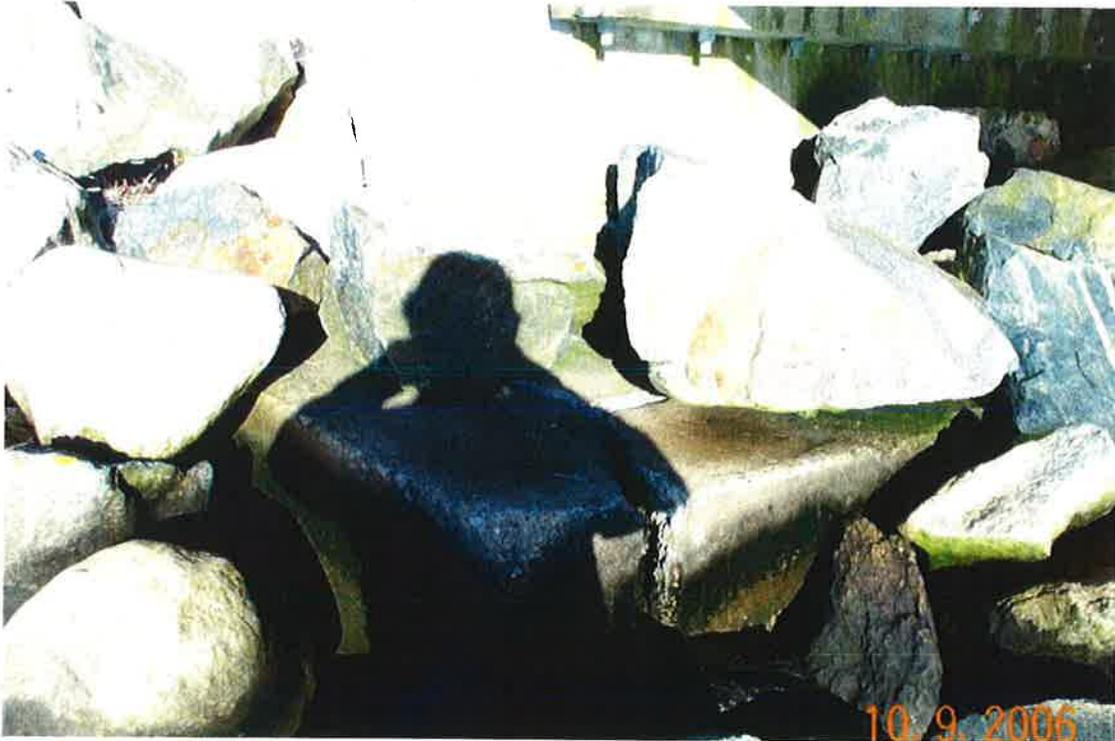
**Photo 15:** 2" wide cracks through the south corner of the west abutment footing, looking northwest.

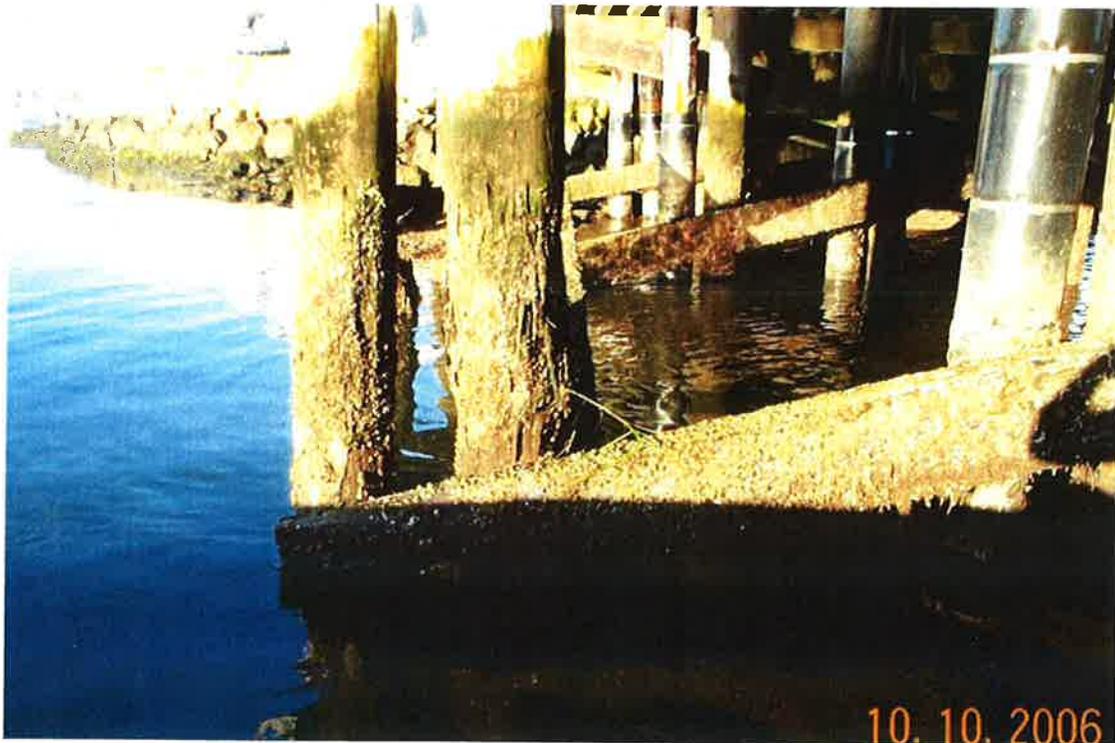
**Photo 16:** Typ. condition of timber piles/bracing, south end of Bent 3, looking west. Note protective sleeve repairs on other piles in view.

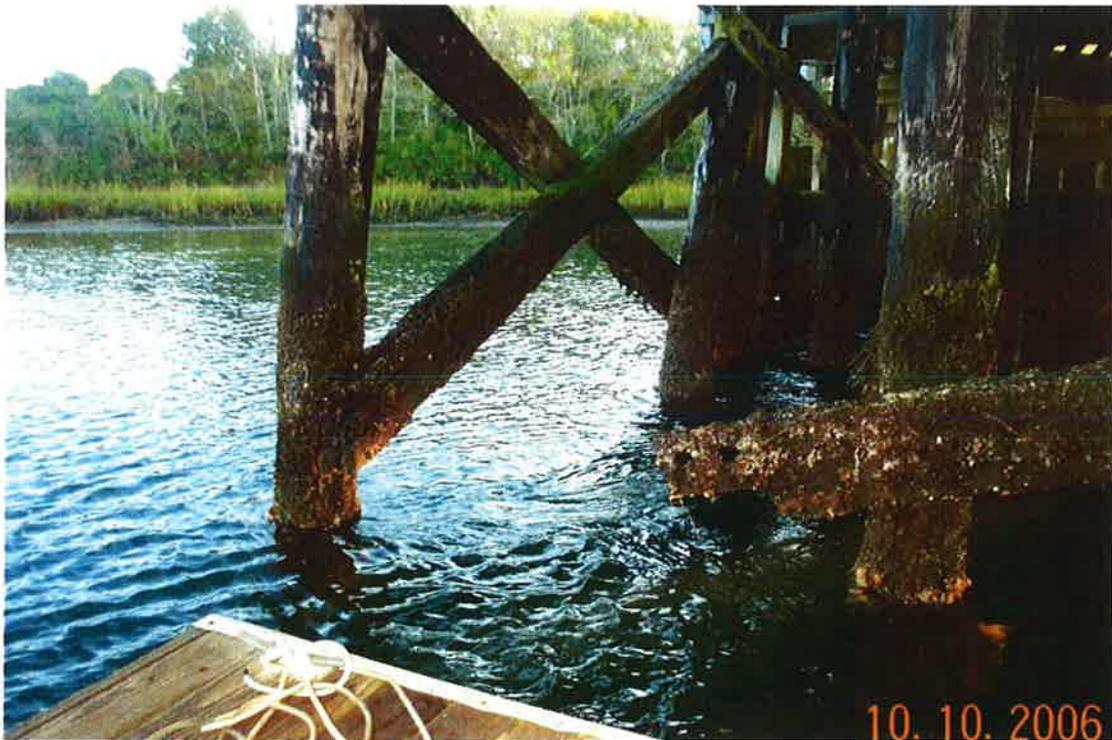
**Photo 17: Missing sect. of diag. bracing, north end of Bent 5, looking NE.  
Note condition of fasteners on remaining portion at pile.**

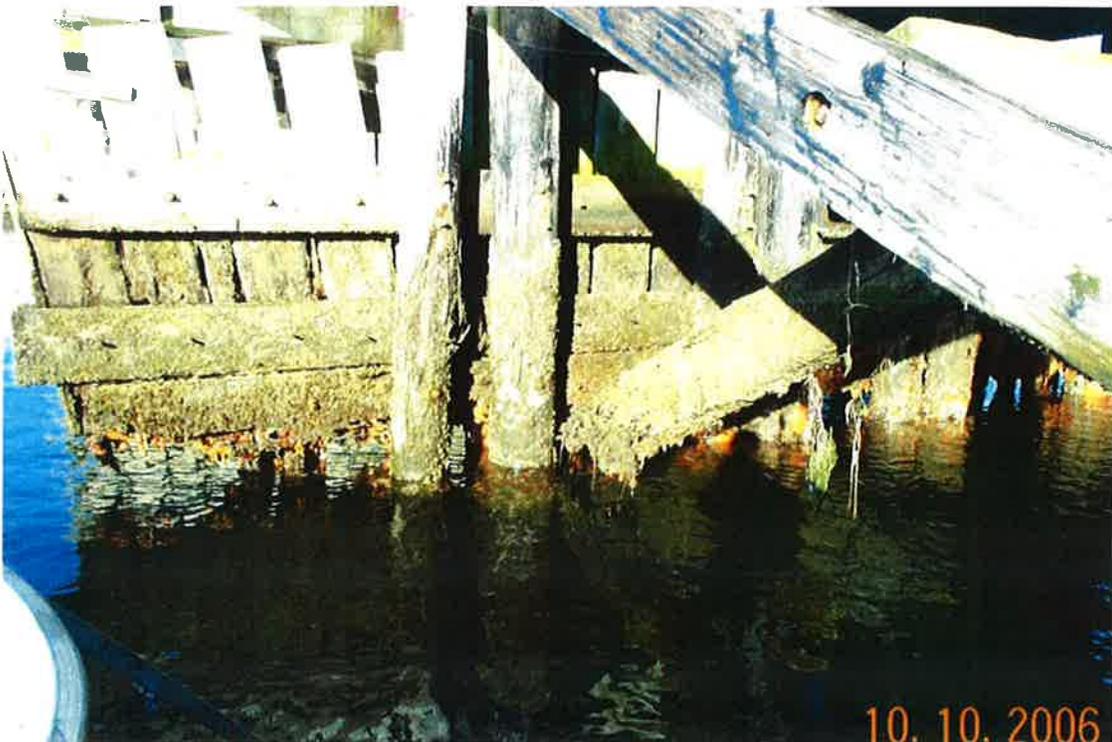
**Photo 18: Missing sect. of horiz. bracing, south end of Bent 8, looking NW.  
Note cond. of fasteners on remaining portion & fender walers.**

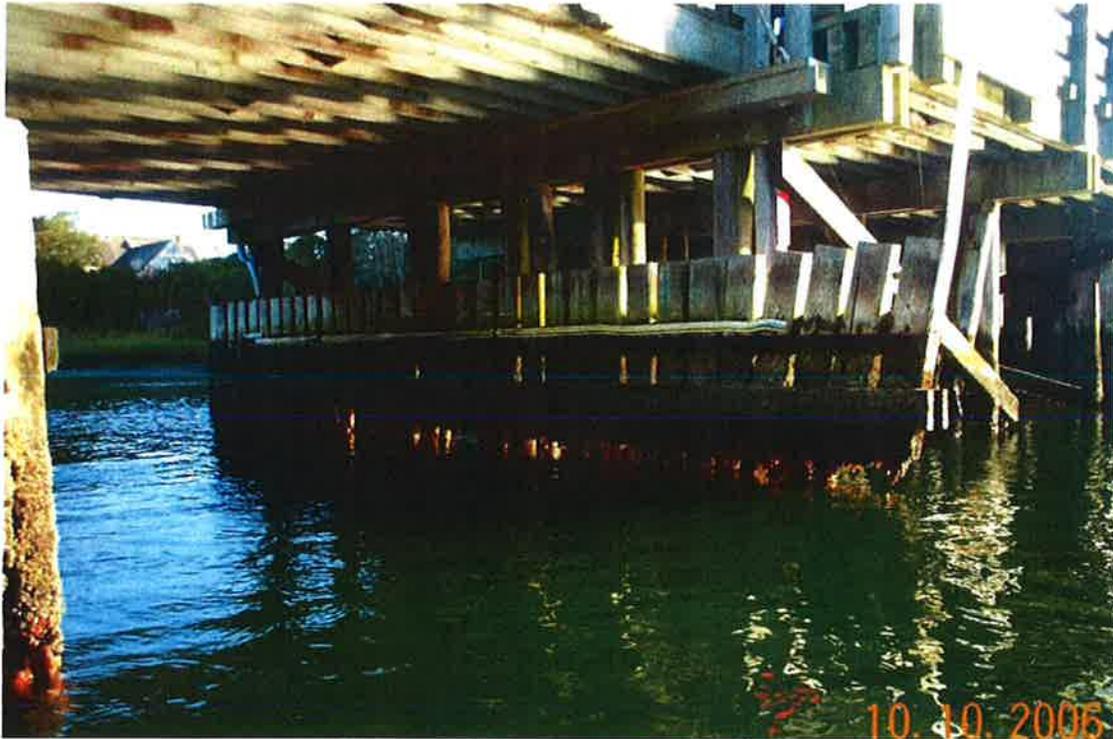
**Photo 19:** Typical condition of the vertical timber members of the fender at Bent 8, looking northeast. Note the impact damage at both ends.

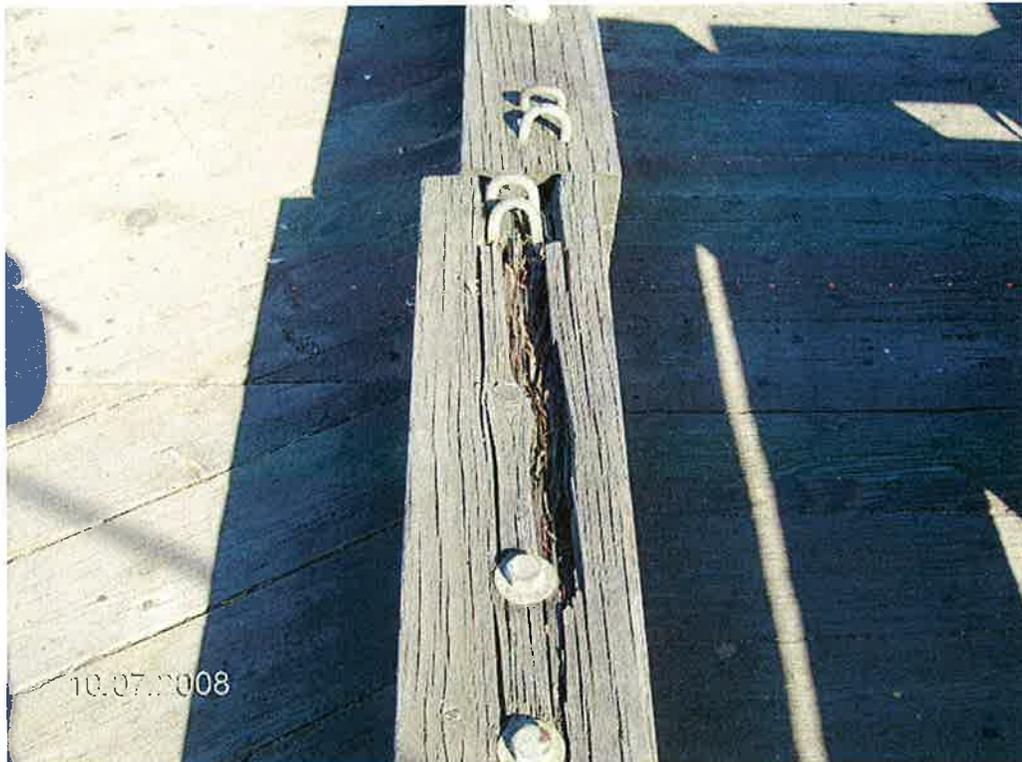
**Photo 2:** Deterioration of the south curb/traffic rail at the east end of span 8.

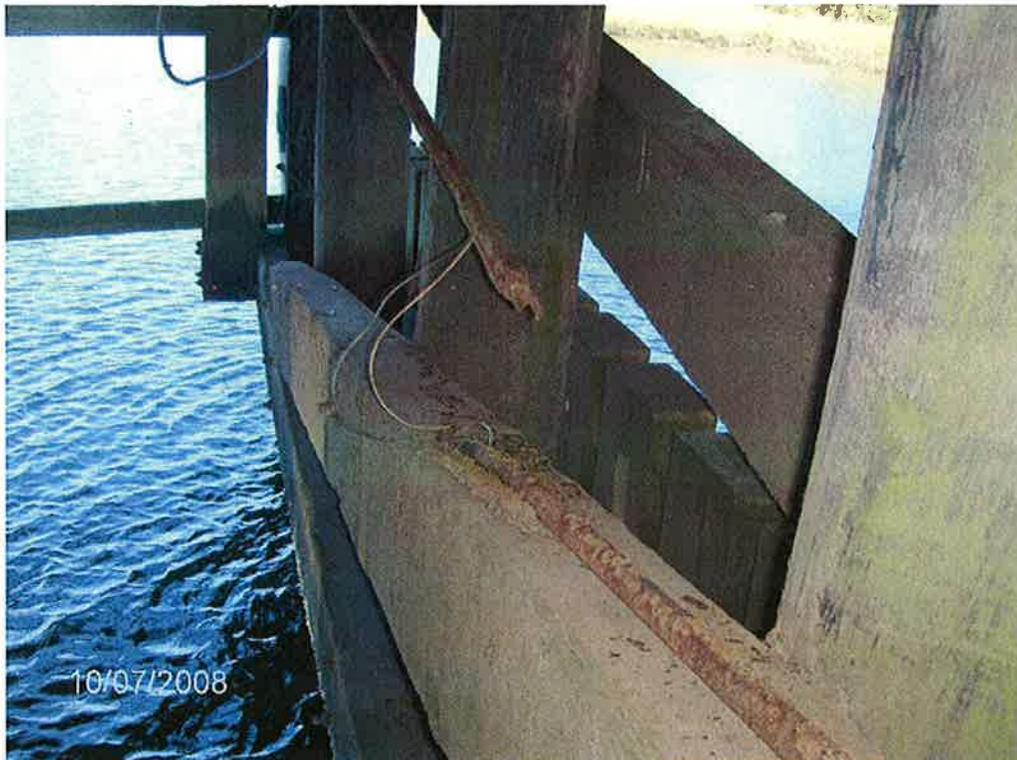
**Photo 4: Deteriorated utility conduit with exposed wires at bent 7A.**

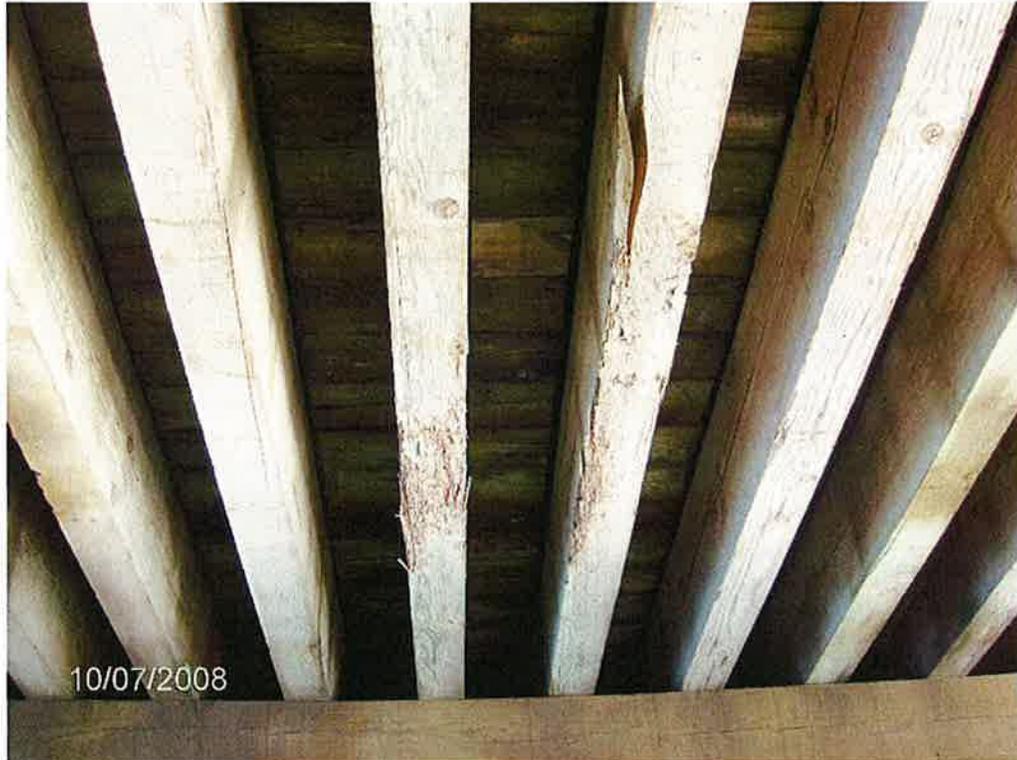
**Photo 9: Collision damage to the underside of the bascule span (span 8) stringers.**

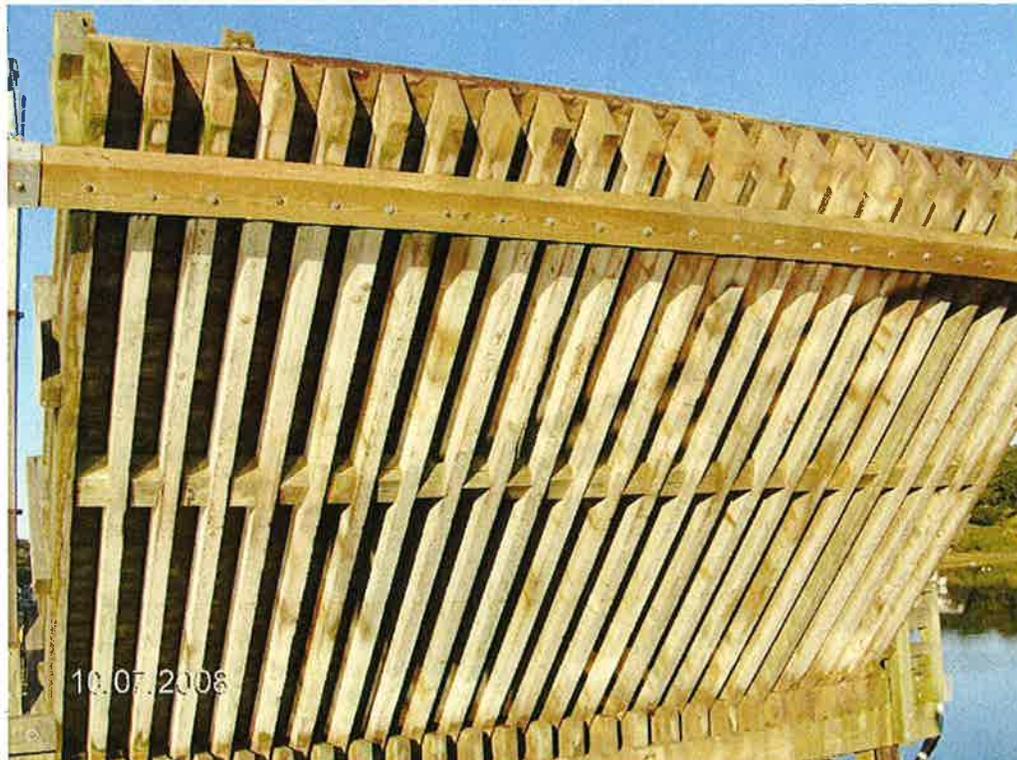
**Photo 10: New bascule span lifting beam.**

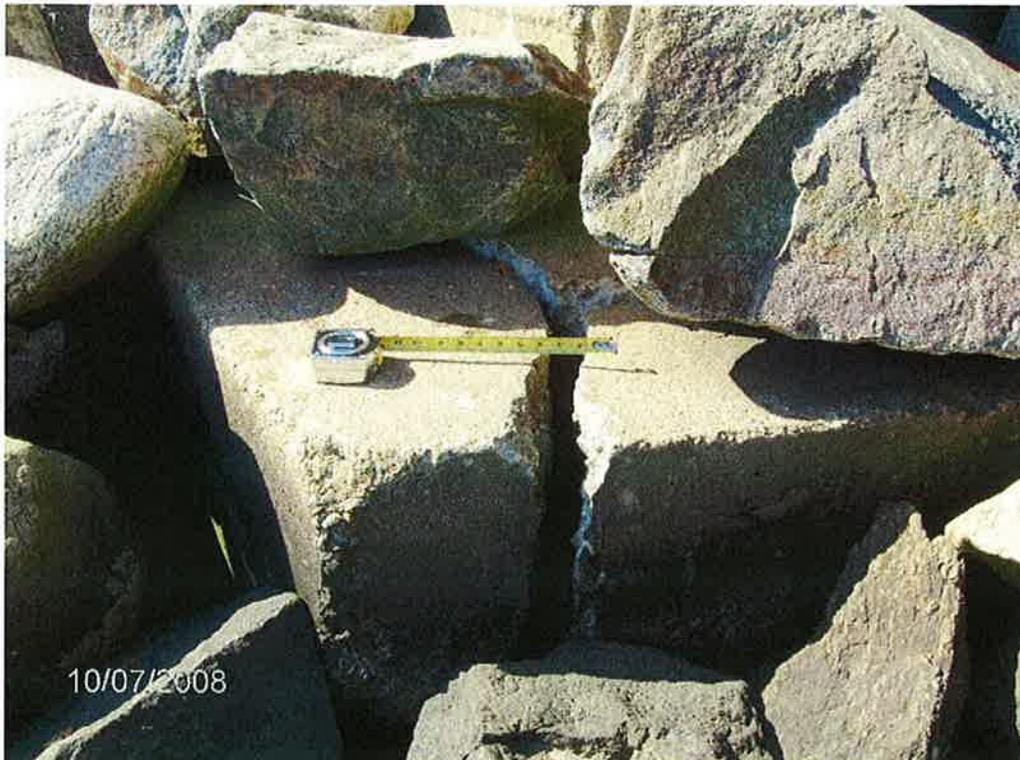
**Photo 14: 3" wide crack in the south end of the west abutment footing/apron.**
