***Subject: Chatham, MA – Mitchell River Bridge Project  
Bridge Repair/Rehabilitation Feasibility Study***

**BRIDGE REPAIR/REHABILITATION FEASIBILITY**  
**STUDY**

**BRIDGE STREET**

**BRIDGE NO. C-07-001 (437)**

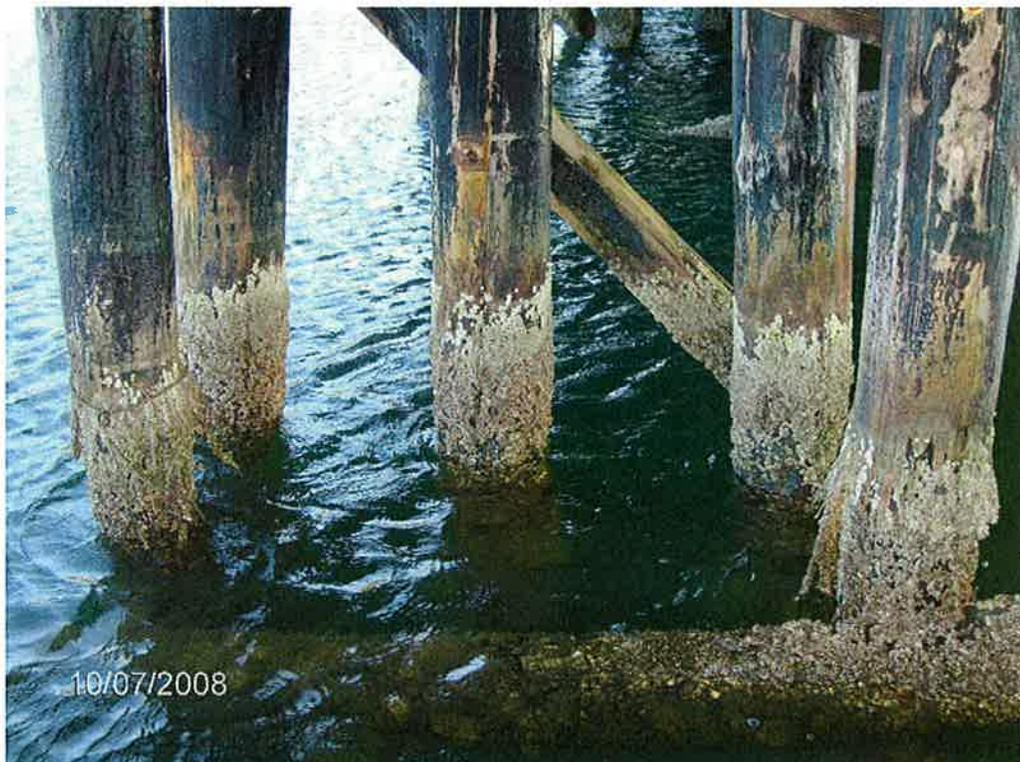
**Photo 16: Typical condition of timber piles/bracing in the tidal zone (north end of bent 4 shown).**

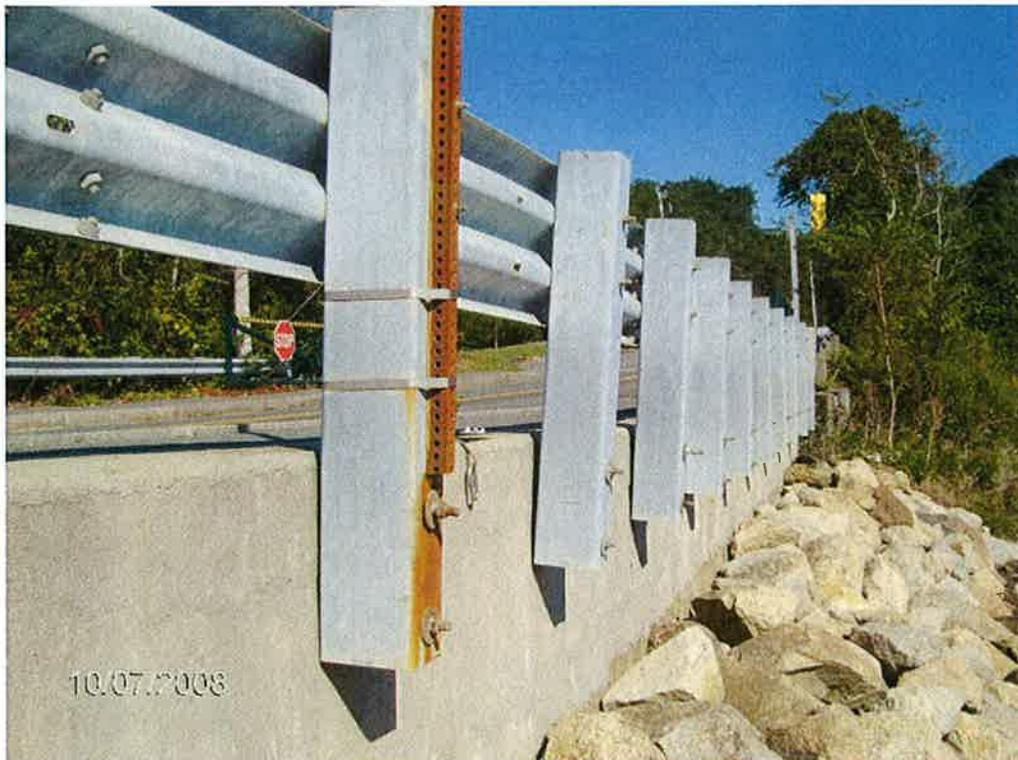
**Photo 18: 1 1/2" gaps between the southeast approach guardrail posts and the face of the wingwall.**

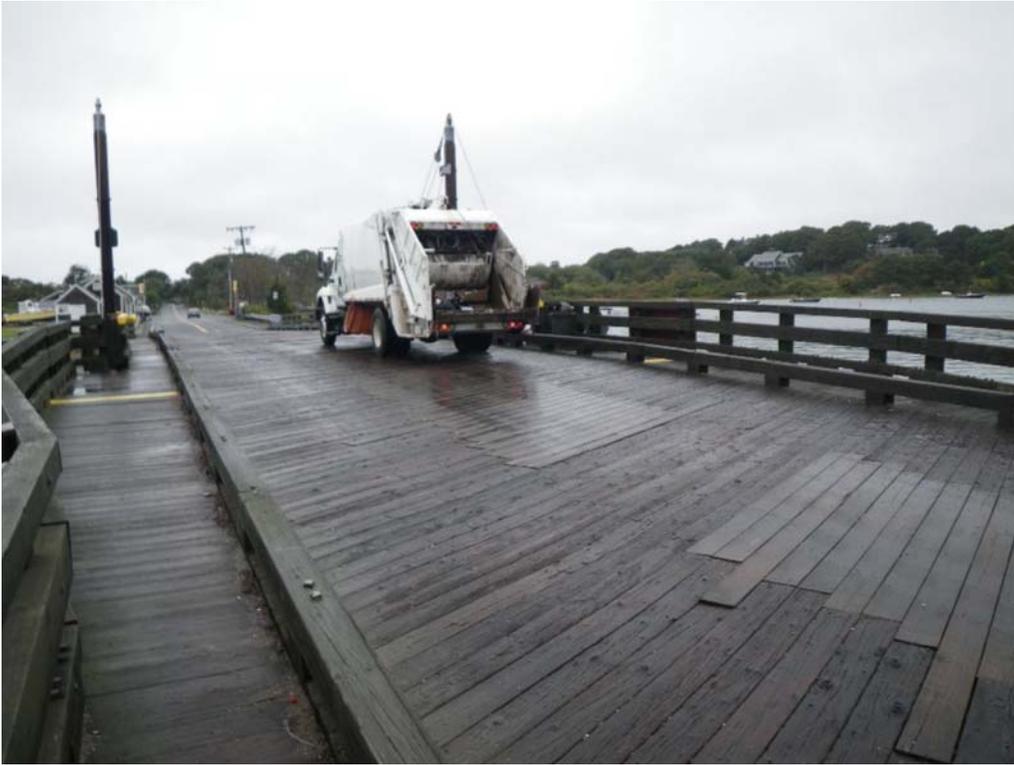
**Photo 1:** Typical worn wearing surface with protruding knots and nail heads. Also note the replacement plank not sitting flush with worn planks.

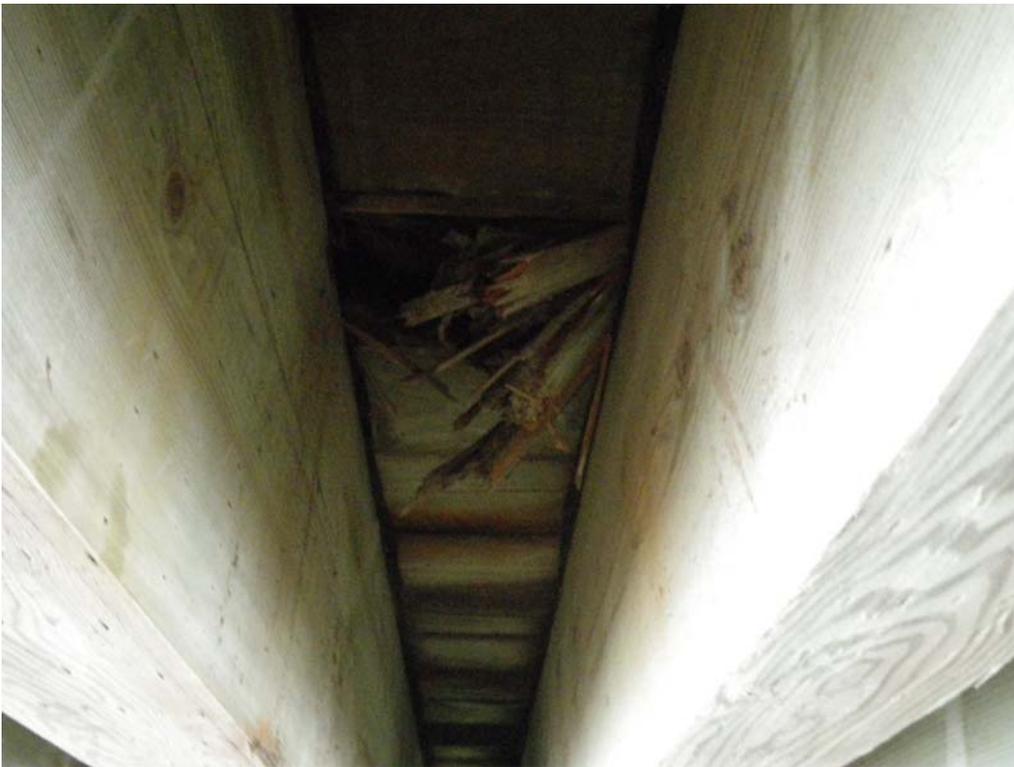
**Photo 2:** Failed deck timber between stringers 10 and 11 in span 4.

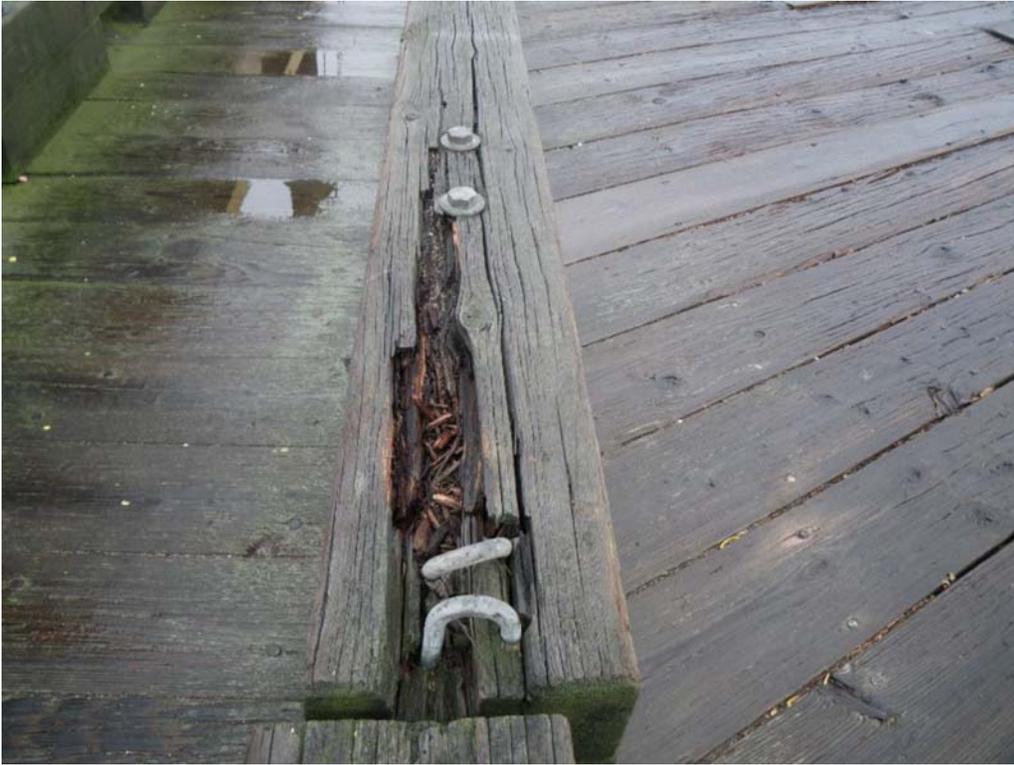
**Photo 3: Deterioration of the south curb/traffic rail at the east end of the bascule span (span 8).**

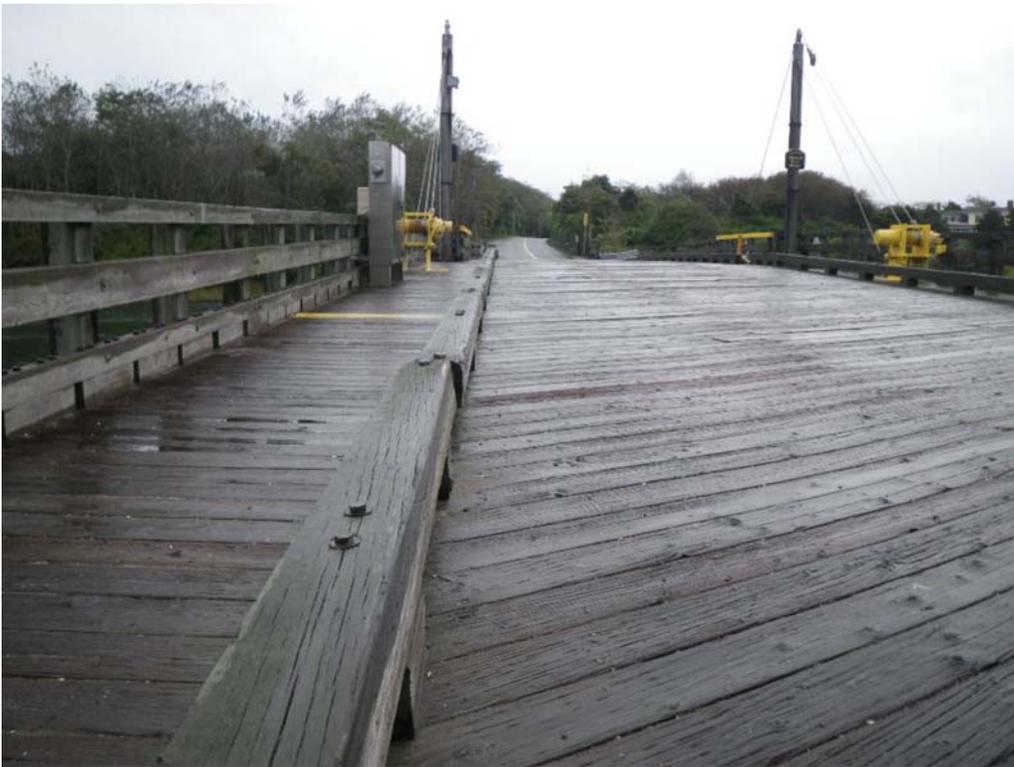
**Photo 4: Typical misalignment of up to 1 1/2" of curb/traffic rails (north curb shown).**

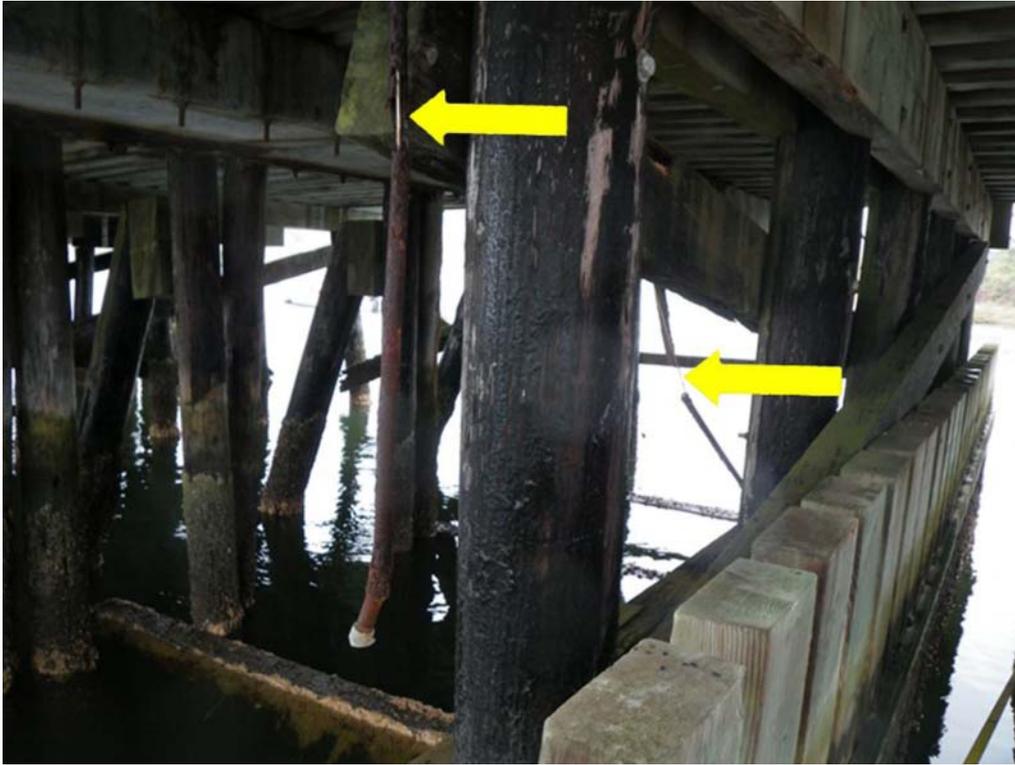
Photo 5: Deteriorated, broken and loose electrical conduits with exposed wiring along the west side of bent 7A.

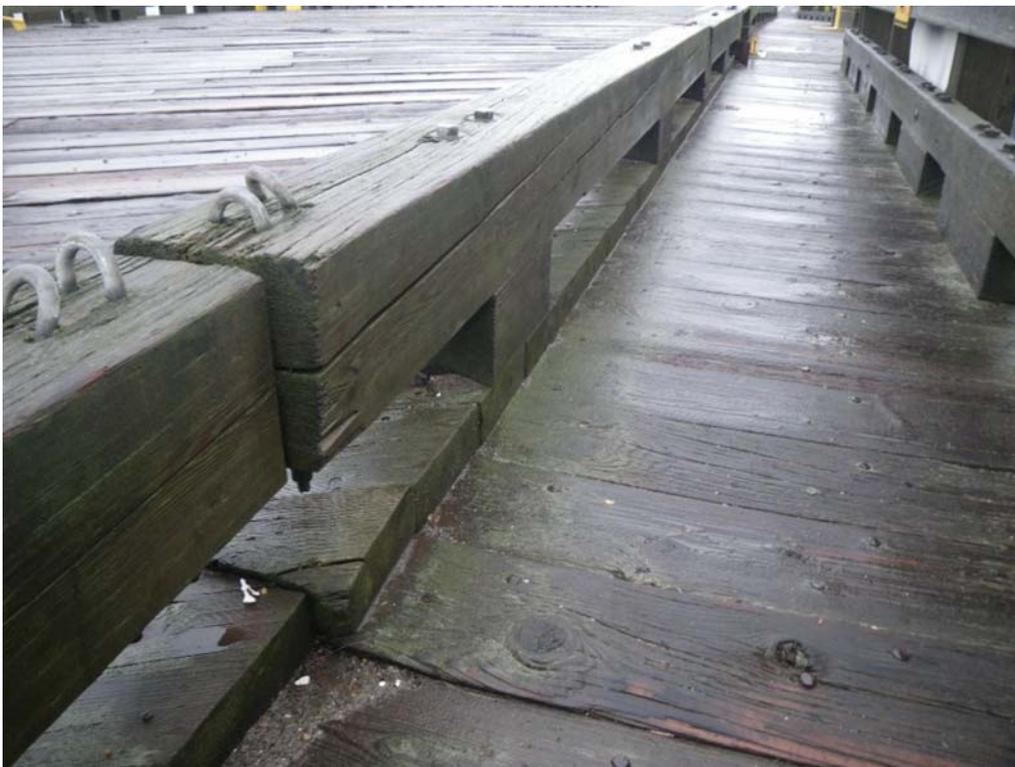
Photo 6: 1 1/2" of misalignment of bascule span toe towards the north.

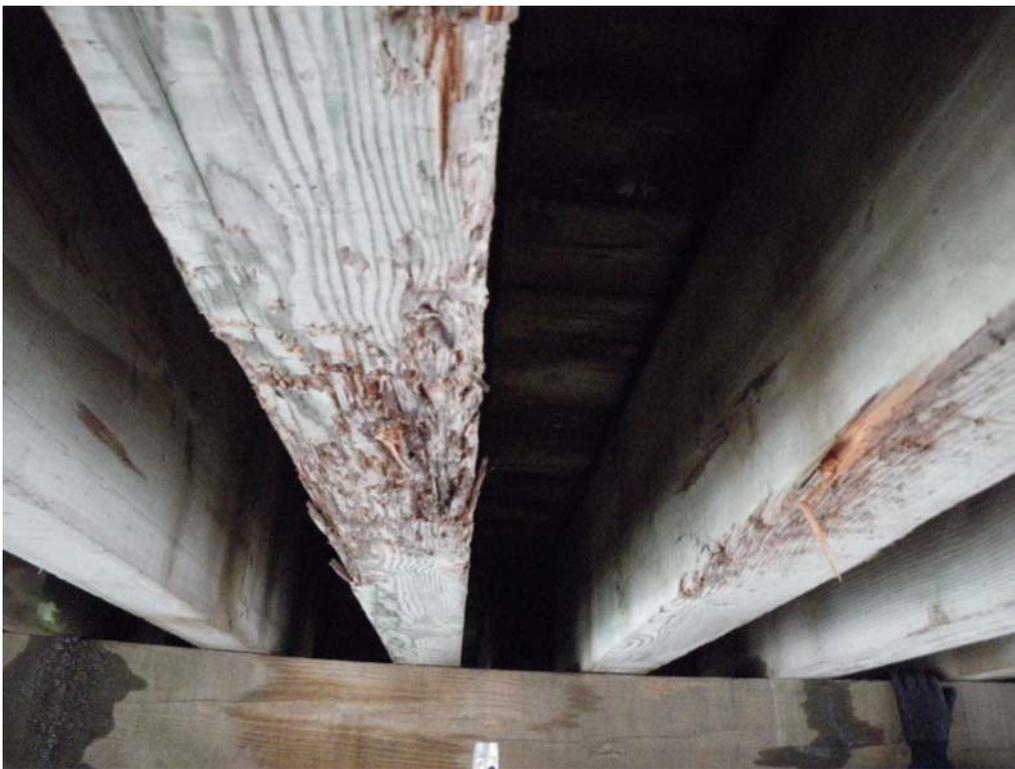
**Photo 8: Collision damage to the underside of the bascule span (span 8) stringers.**

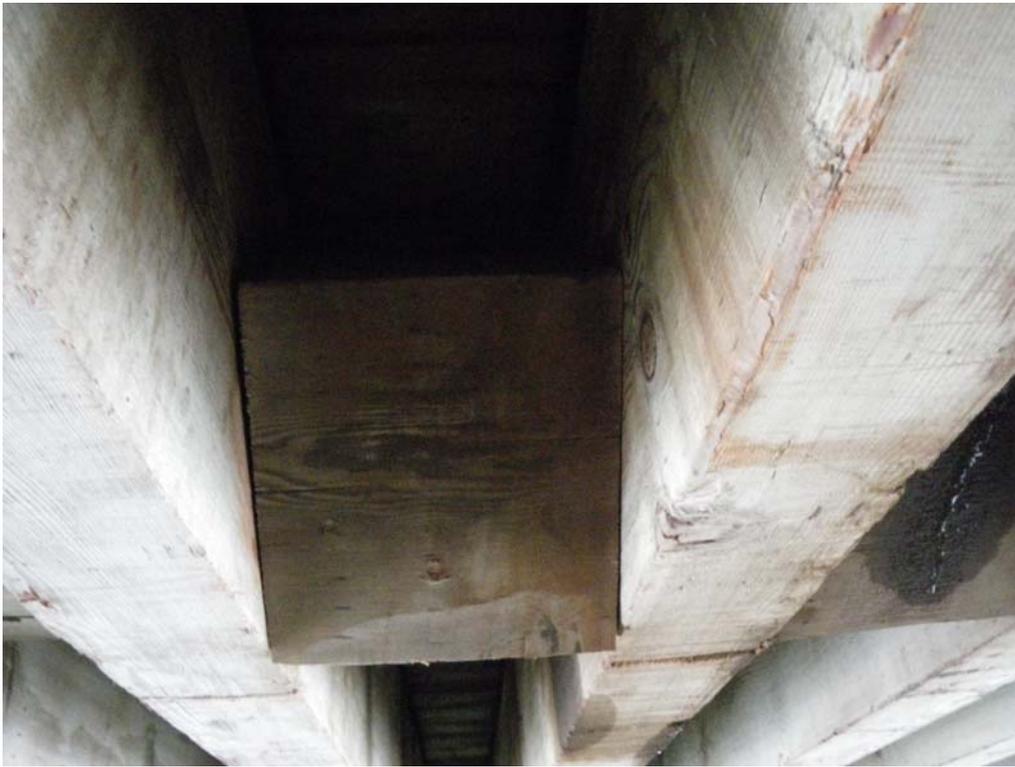
**Photo 9:** Typical loose and rotated spacer block in span 8.

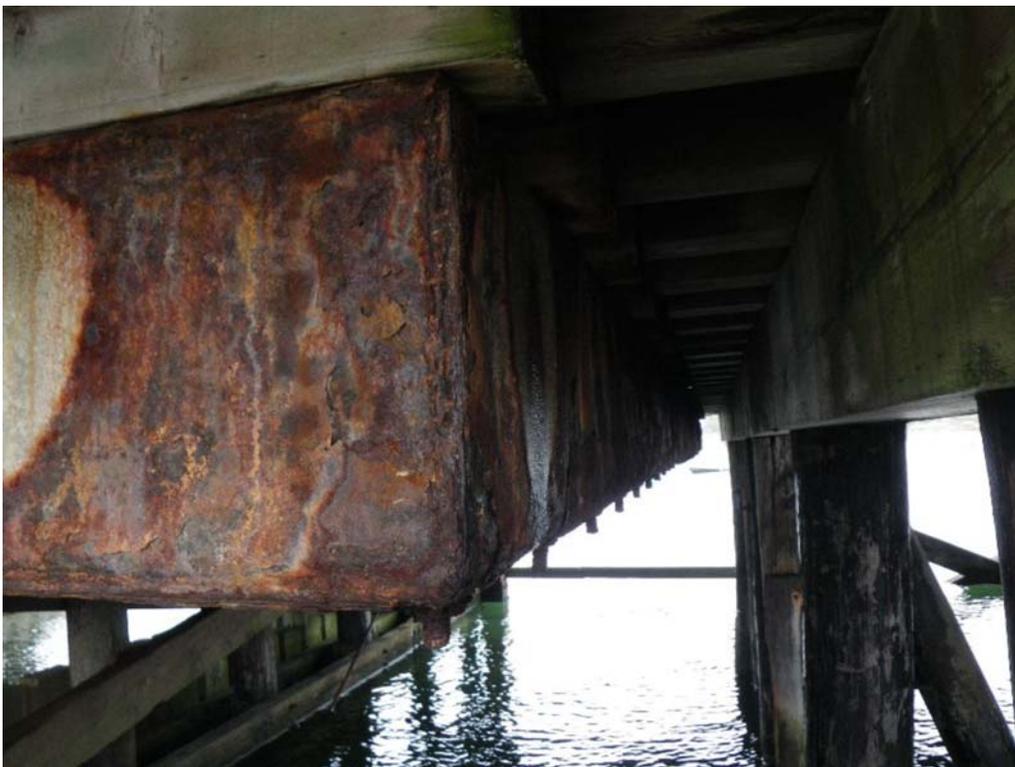
**Photo 10:** Failed galvanized coating at the east end of the counterweight steel shell.

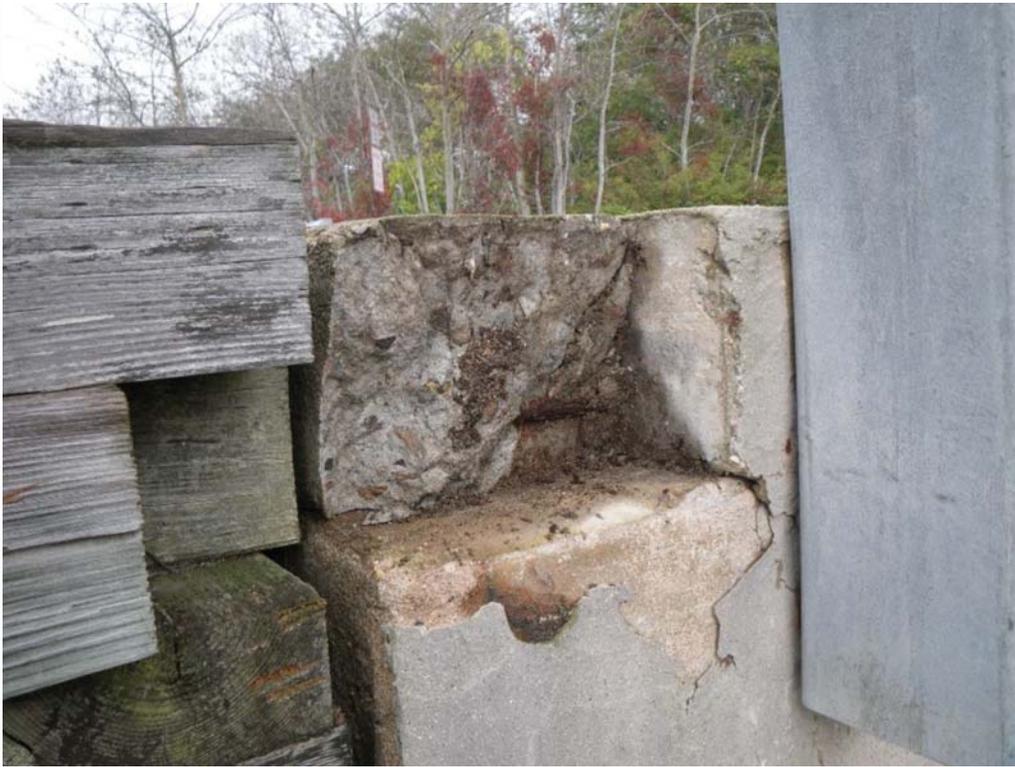
**Photo 11: 12" wide by 9" high by 6" deep spall at the south end of the east abutment backwall.**

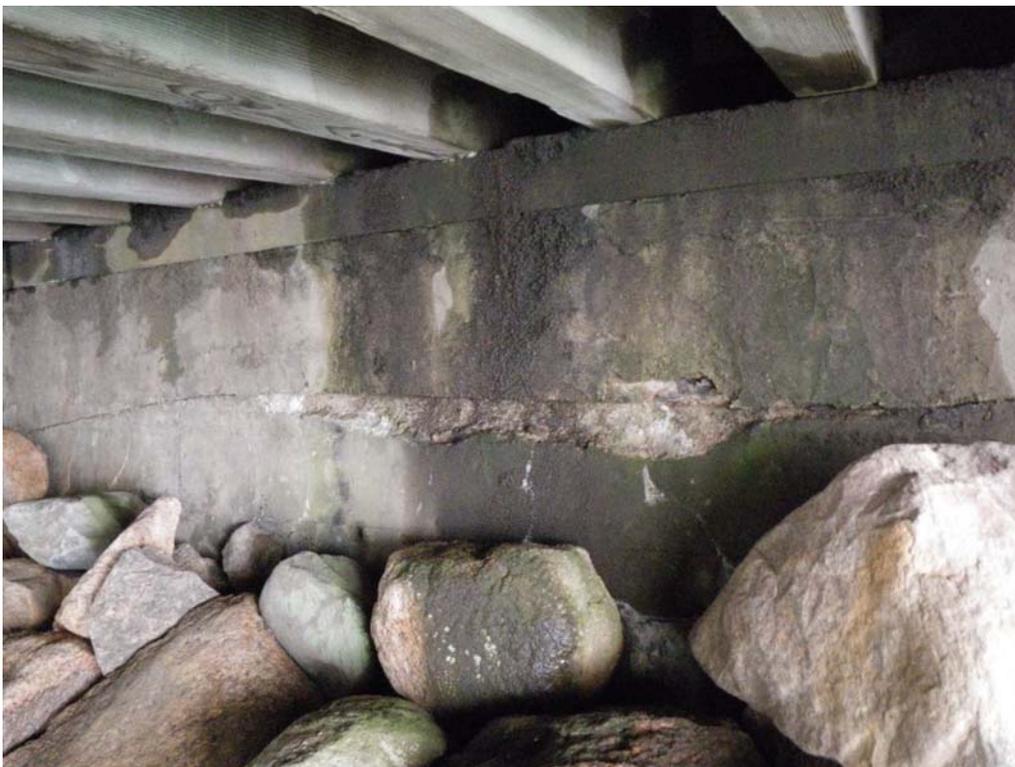
**Photo 12: 1/8" wide crack with 4'-6" wide by 5" high by 2" deep spall at east abutment breastwall.**

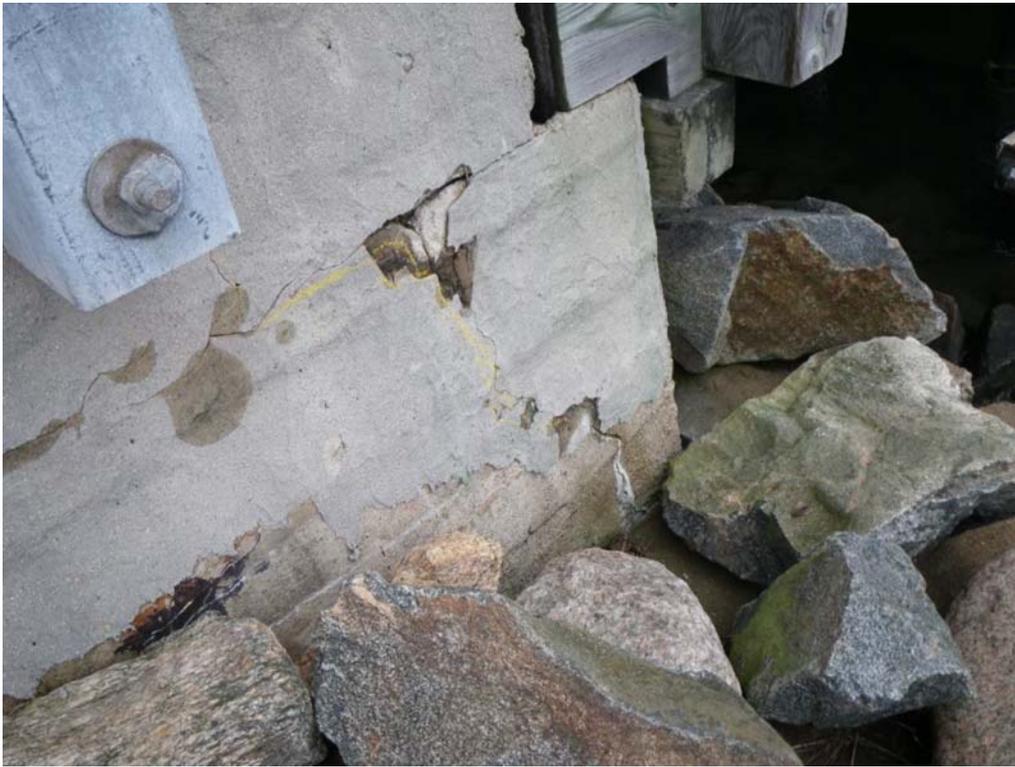
**Photo 13: Up to 1/8" wide horizontal and vertical cracks at the east end of the southwest wingwall.**

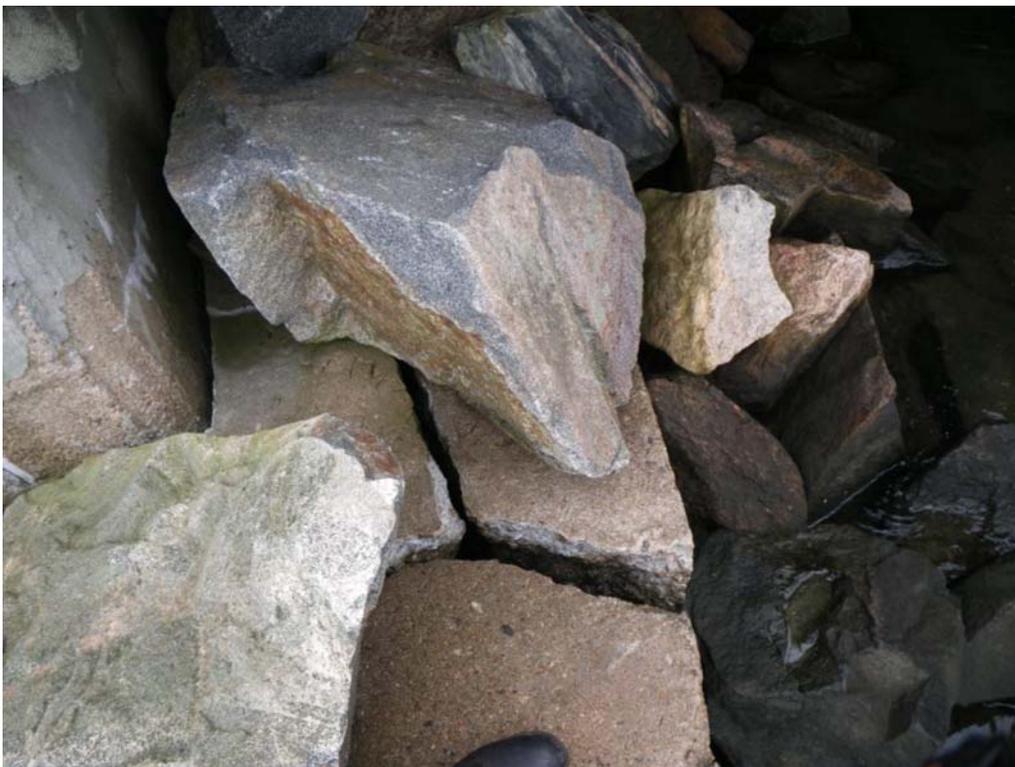
**Photo 14: Major 3" wide crack/split in concrete fender wall at south end of west abutment.**

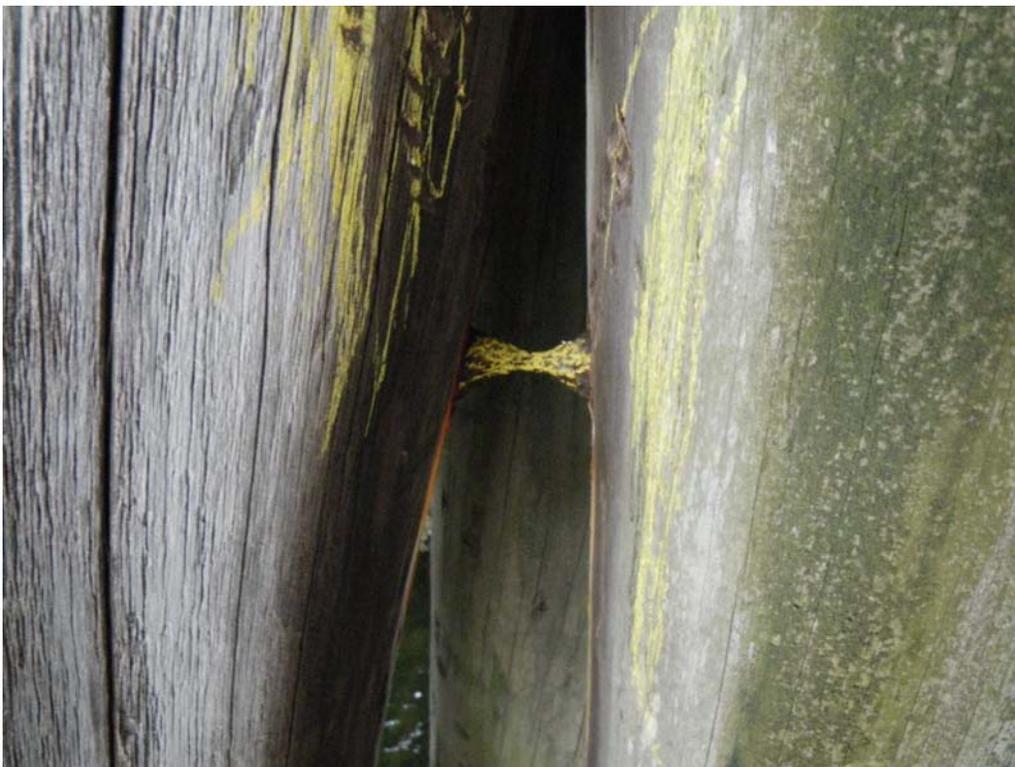
**Photo 22: Heavy rust and losses to substructure connection bolt at bent 9.**

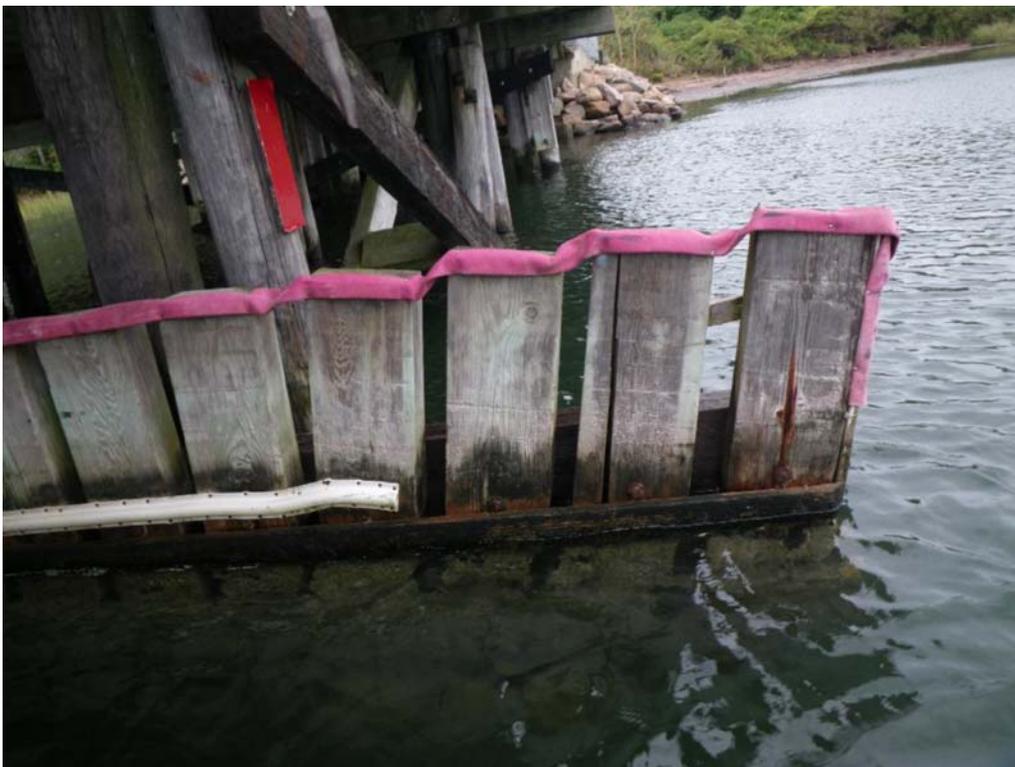
**Photo 24:** Collision damage at the south end of the bent 8 fender.

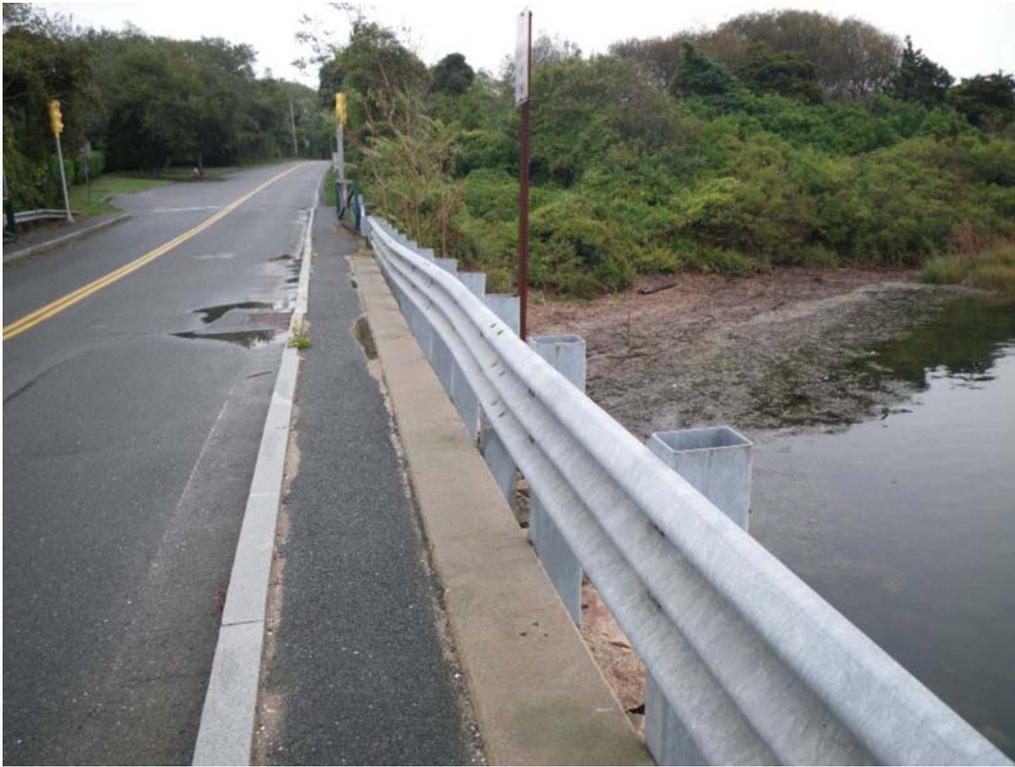
**Photo 27: Outward rotation of southeast approach guardrail posts due to loose anchor bolts.**

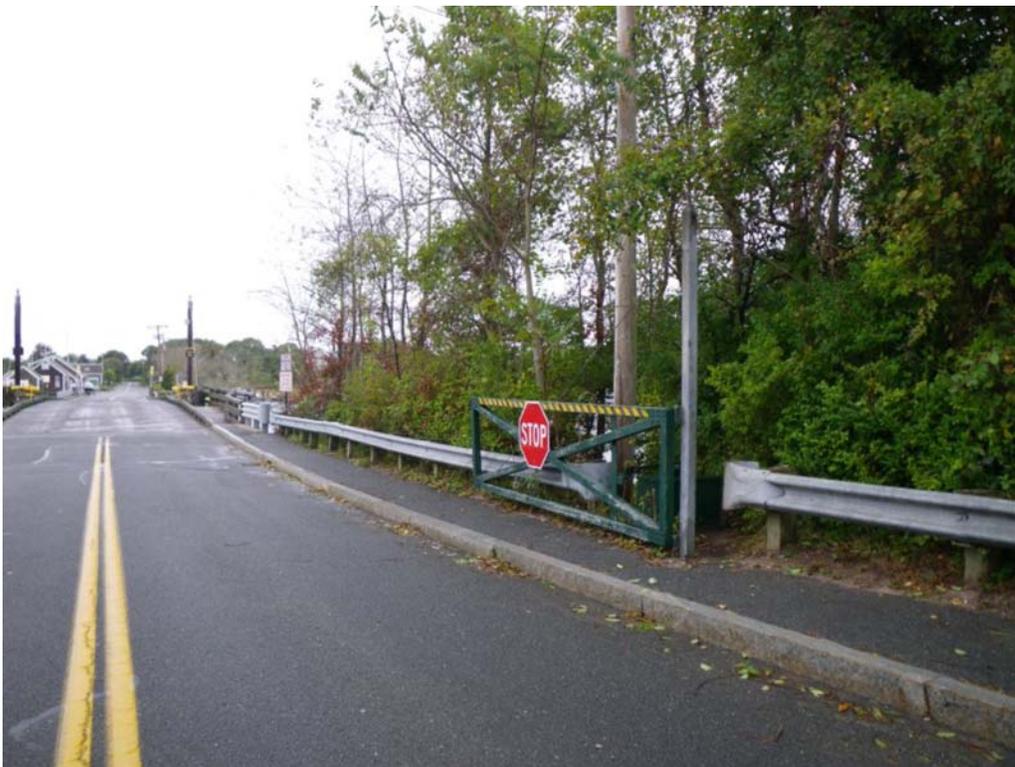
**Photo 28: Multiple non-standard guardrail types at northeast approach.**

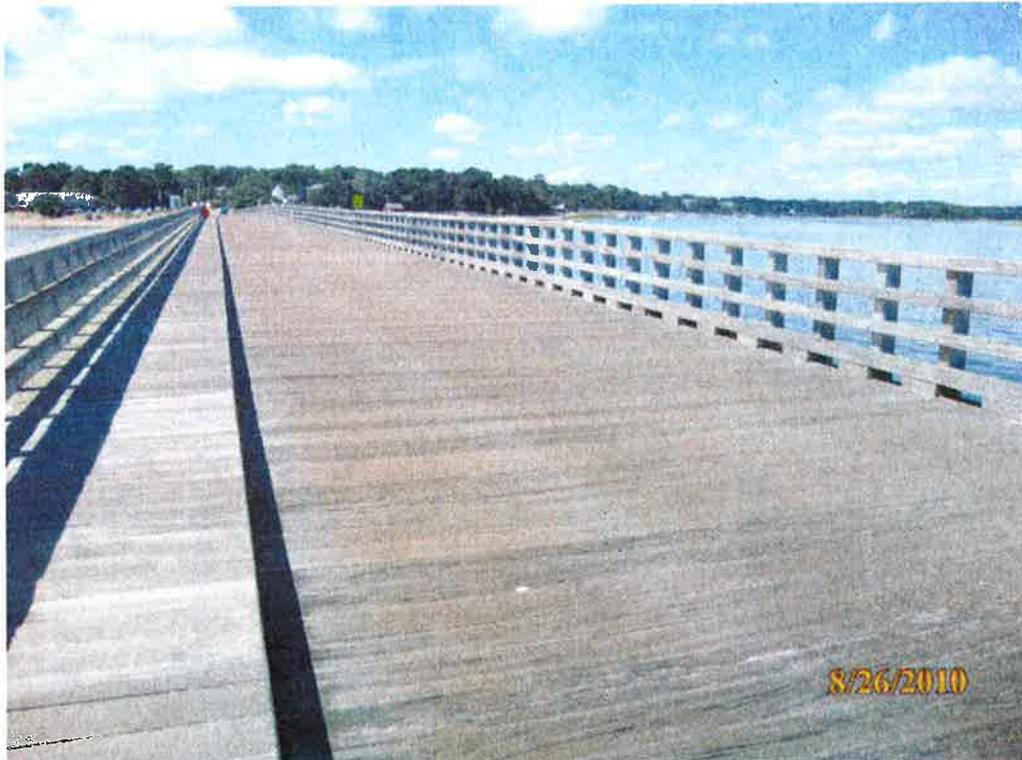
**Photo 2:** Typical condition of the top of the bridge, looking West from the center of the bridge.

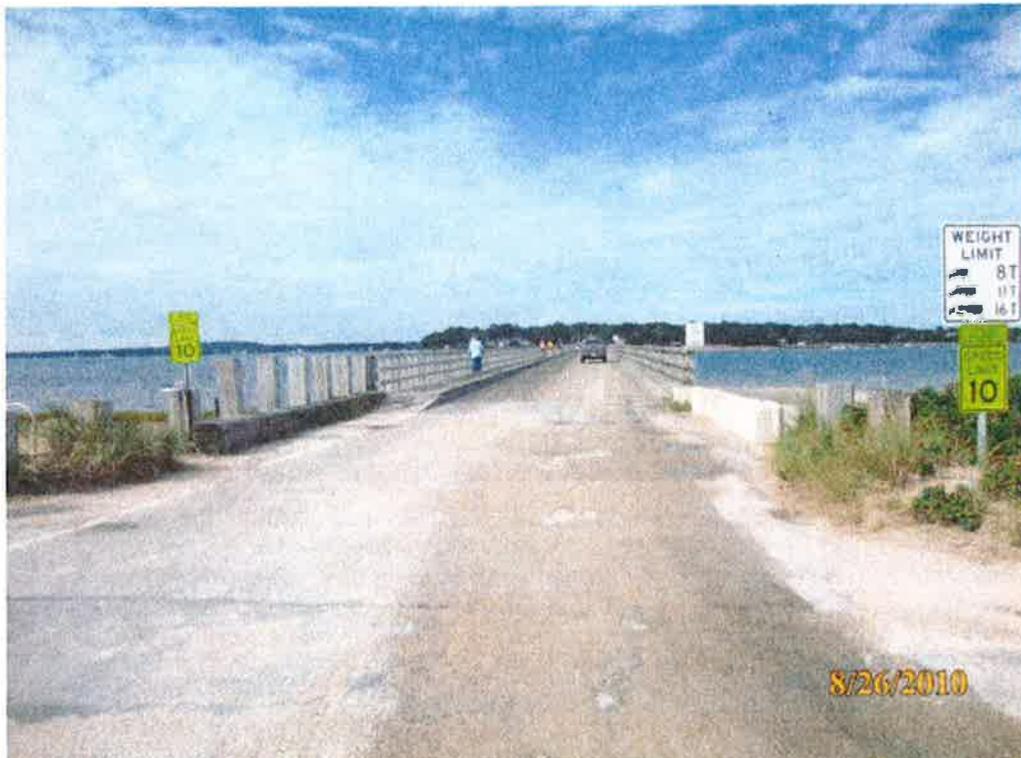
Photo 4: East approach roadway showing cracking and depressions to the pavement.

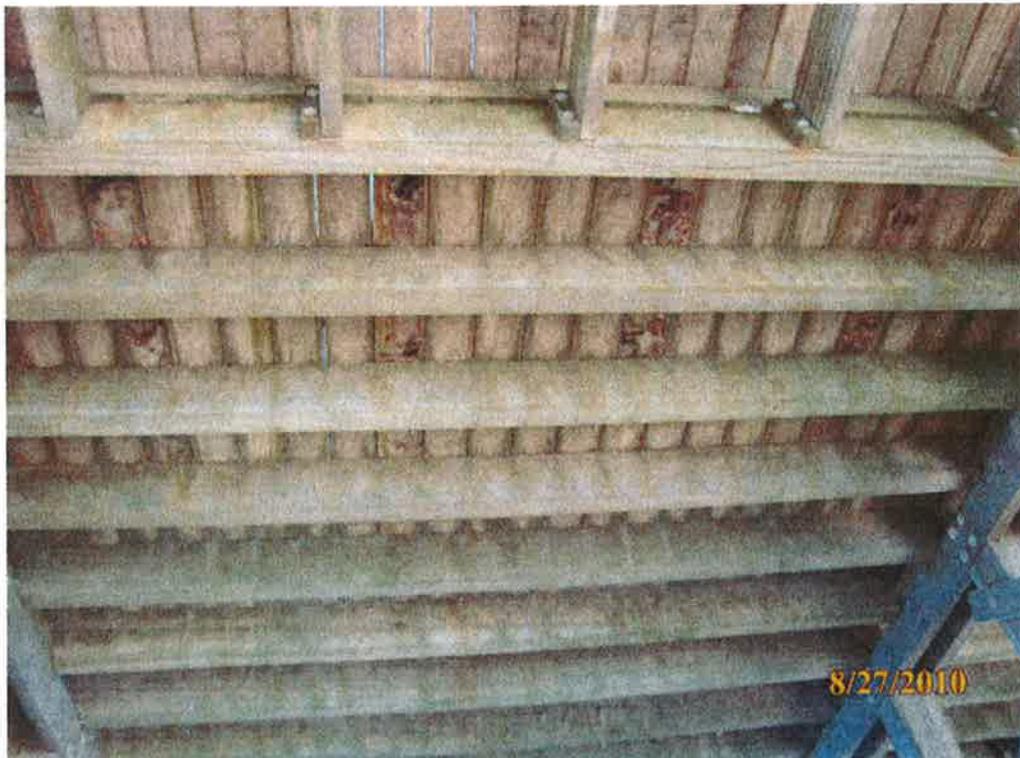
**Photo 14:** Underside of the timber deck in Span #61, showing scattered brown rot and fungi throughout.

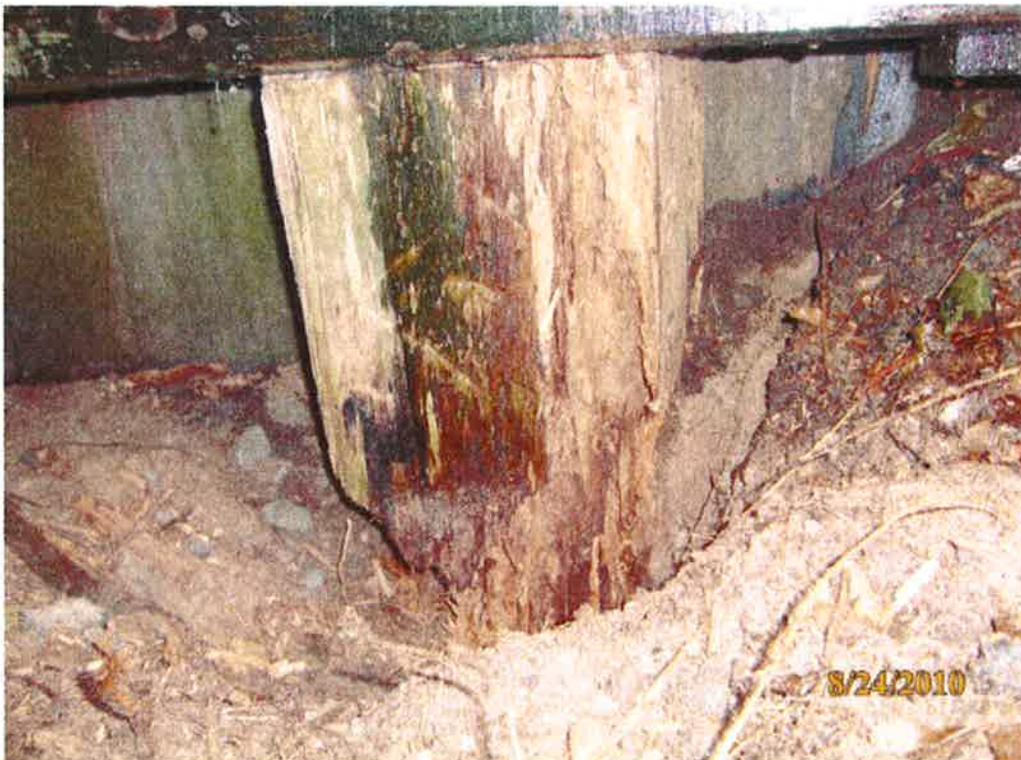
**Photo 18: Bent #1, Pile "A", showing extensive deterioration, especially at the ground line.**

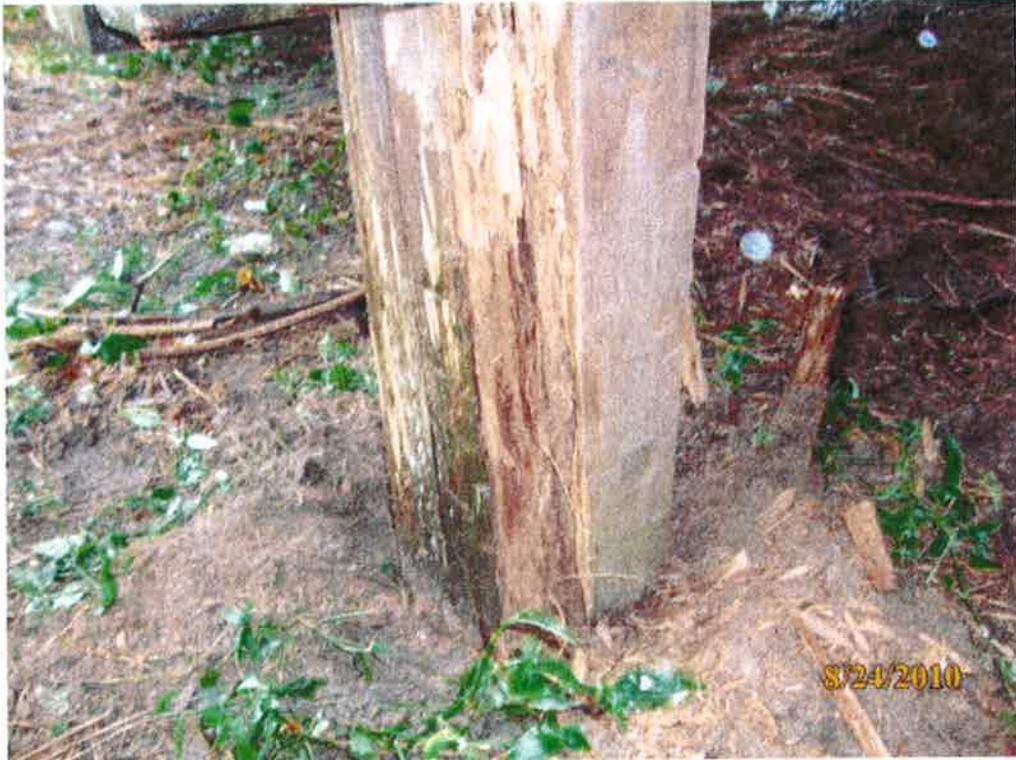
**Photo 19: Bent #2, Pile "A", showing deterioration below bent cap.**

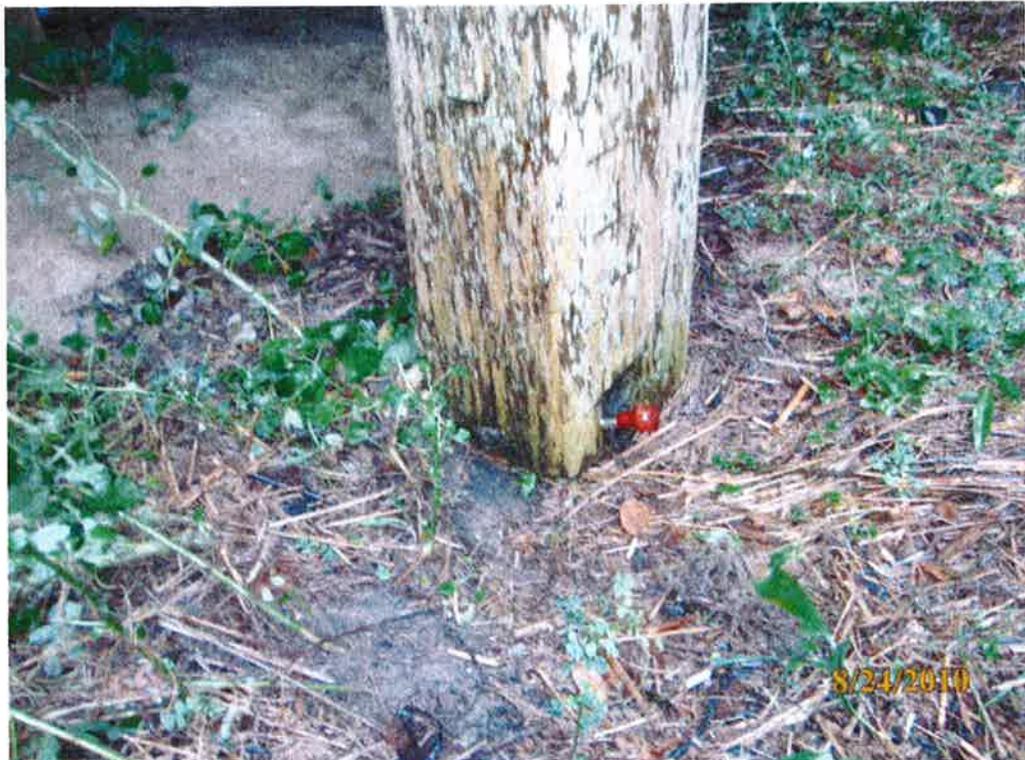
**Photo 20: Bent #3, Pile "A", showing section loss at the ground line.**

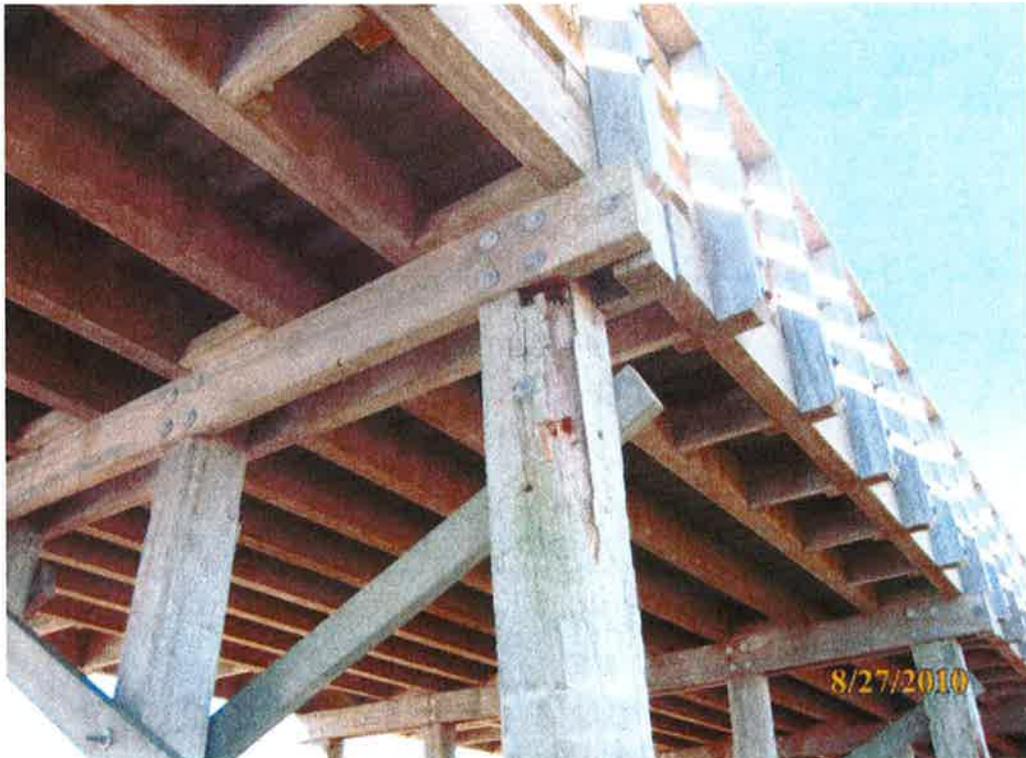
**Photo 24: Bent #12, Pile "A", showing deterioration (checking and rot) at the Northeast corner.**

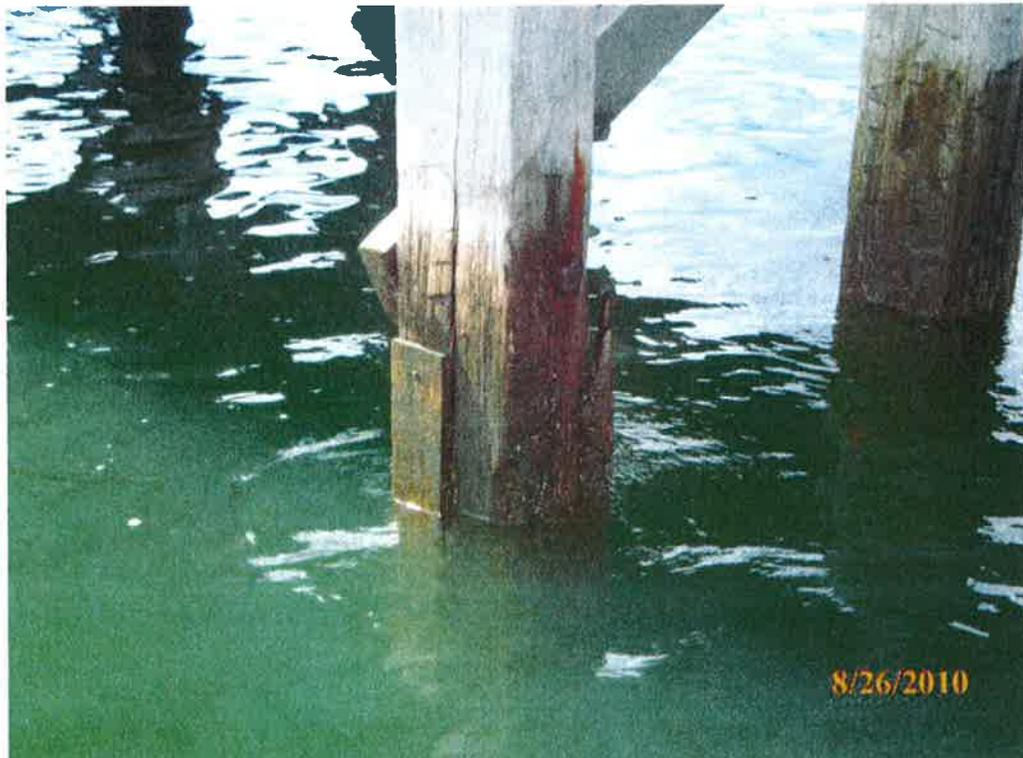
**Photo 28: Bent #15, Pile "E", showing checks and ring checks at the corners.**

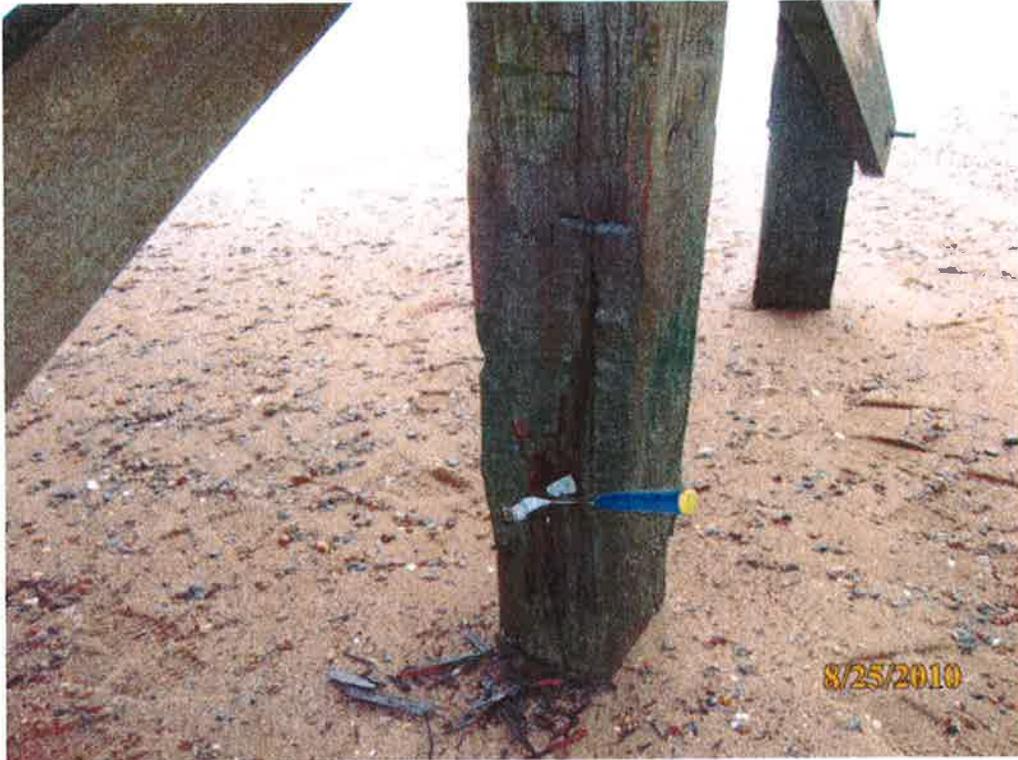
**Photo 29: Bent #16, Pile "D", showing checking and rot in the tidal zone.**

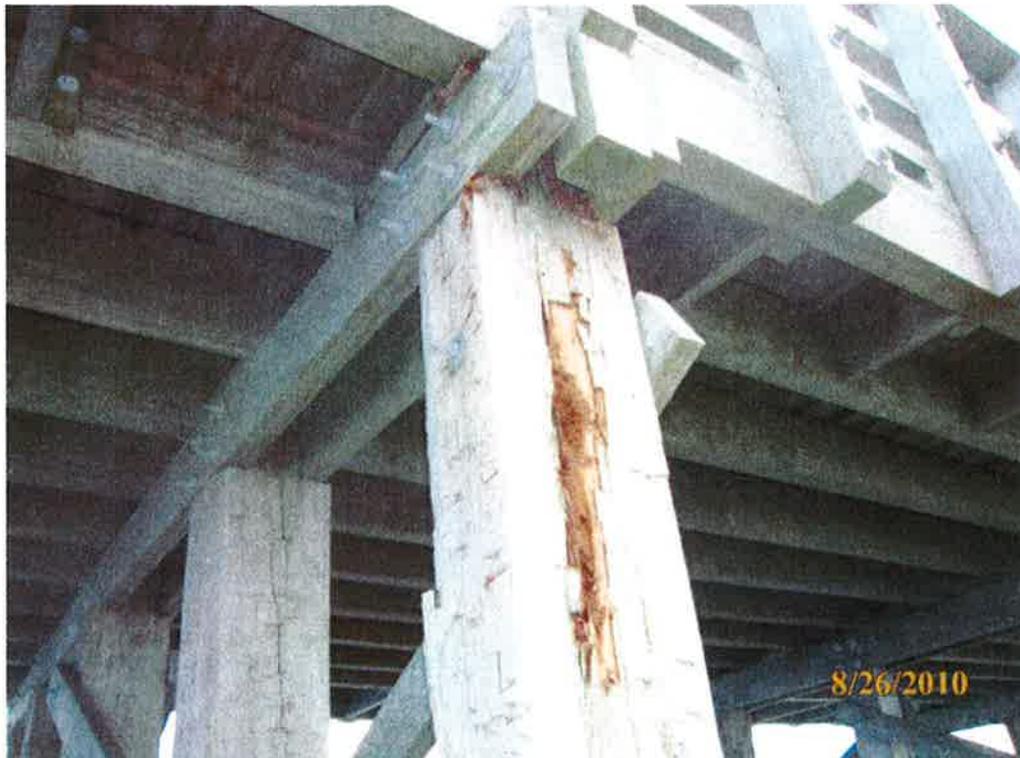
**Photo 40: Bent #44, Pile "A", showing dry rot to the North face, 3.0' high x 6" deep and brown rot at the top.**
