***Subject: Chatham, MA – Mitchell River Bridge Project  
Bridge Repair/Rehabilitation Feasibility Study***

**BRIDGE REPAIR/REHABILITATION FEASIBILITY**  
**STUDY**

**BRIDGE STREET**

**BRIDGE NO. C-07-001 (437)**

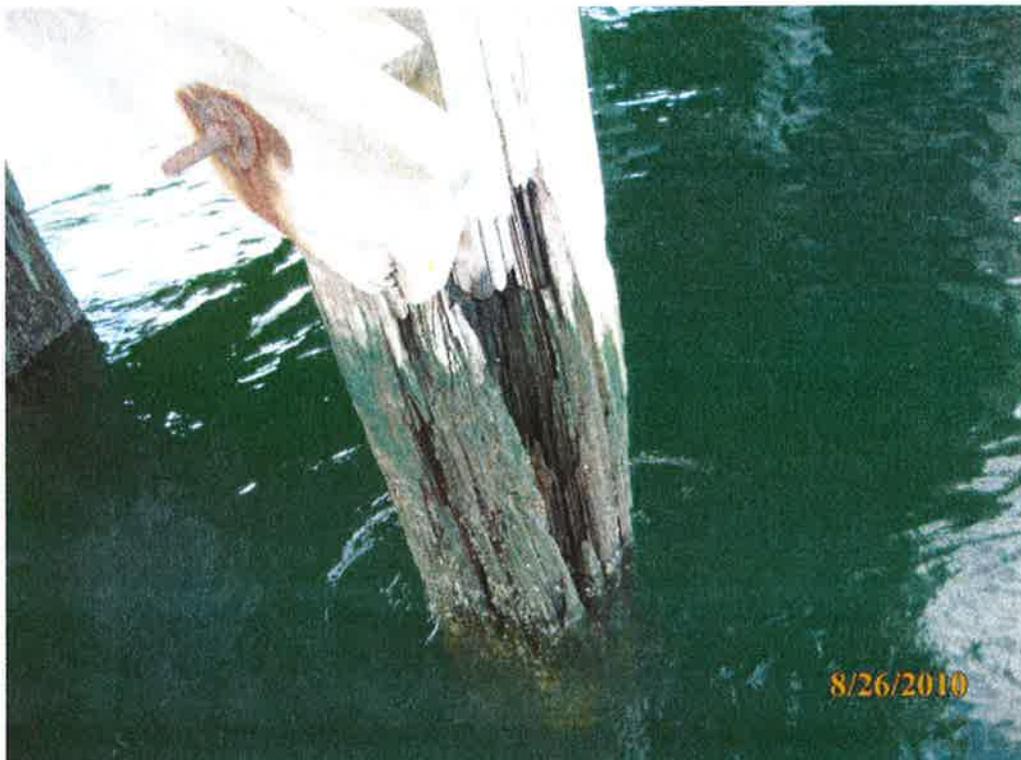
**Photo 44: Bent #49, Pile "A", showing extensive deterioration (rotted wood extending to the core).**

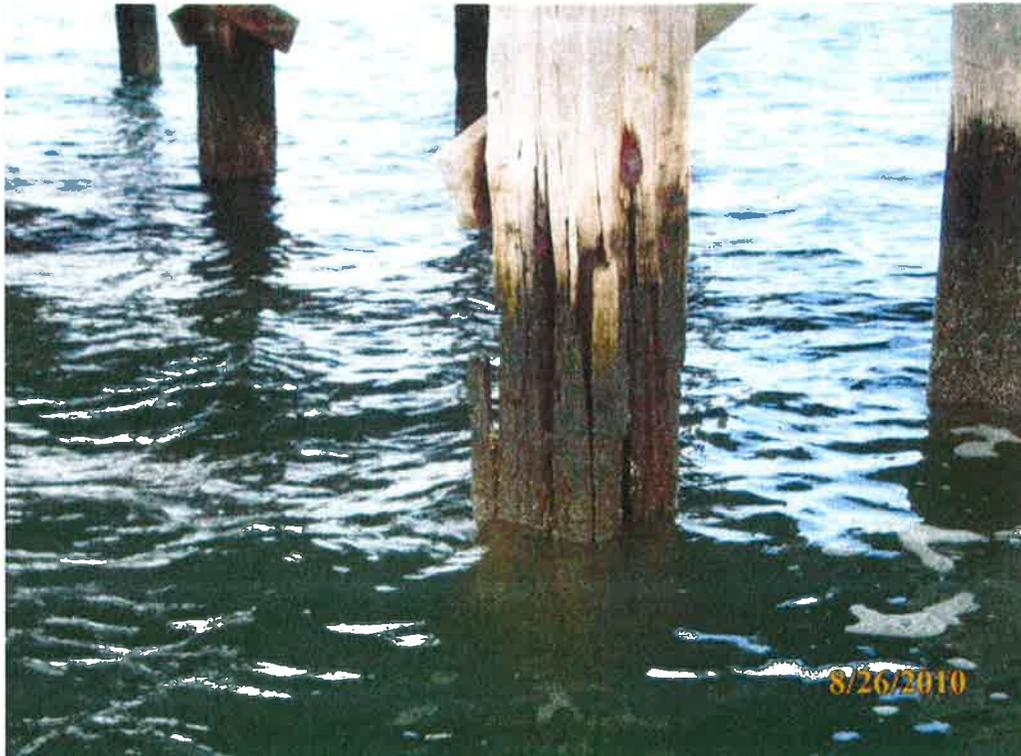
**Photo 46: Bent #54, Pile "A", showing splitting up to 11" deep, severe brooming and rot up to 2" deep.**

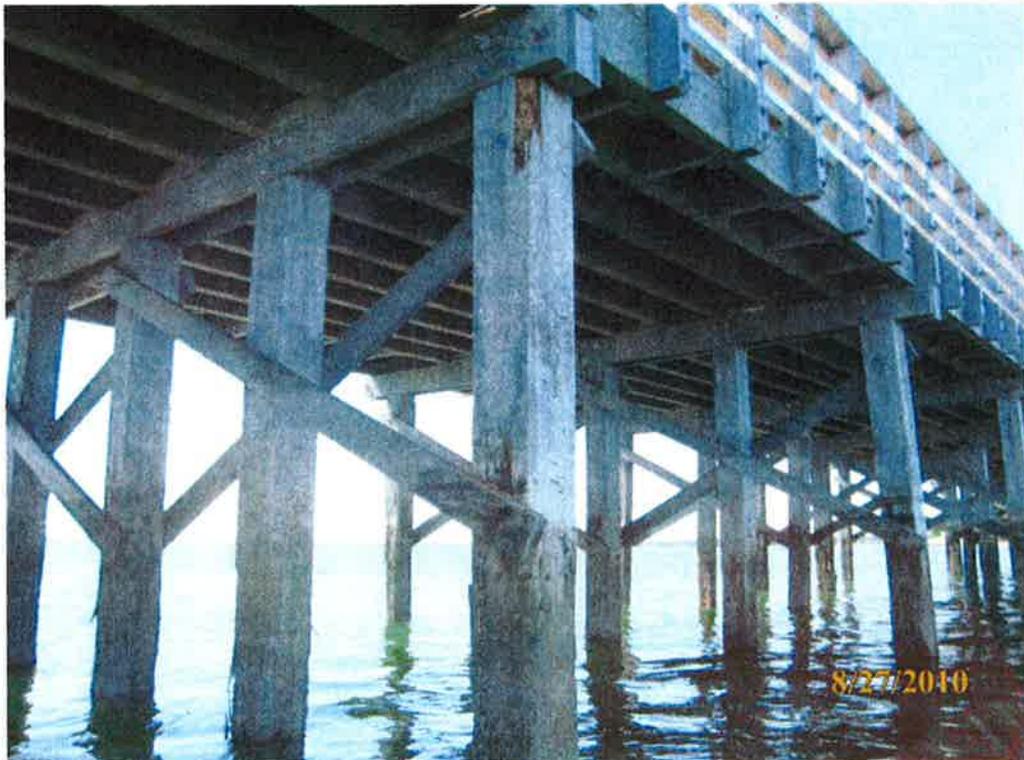
**Photo 50: Bent #67, Pile "A", showing dry rot at the top of the Northeast corner.**

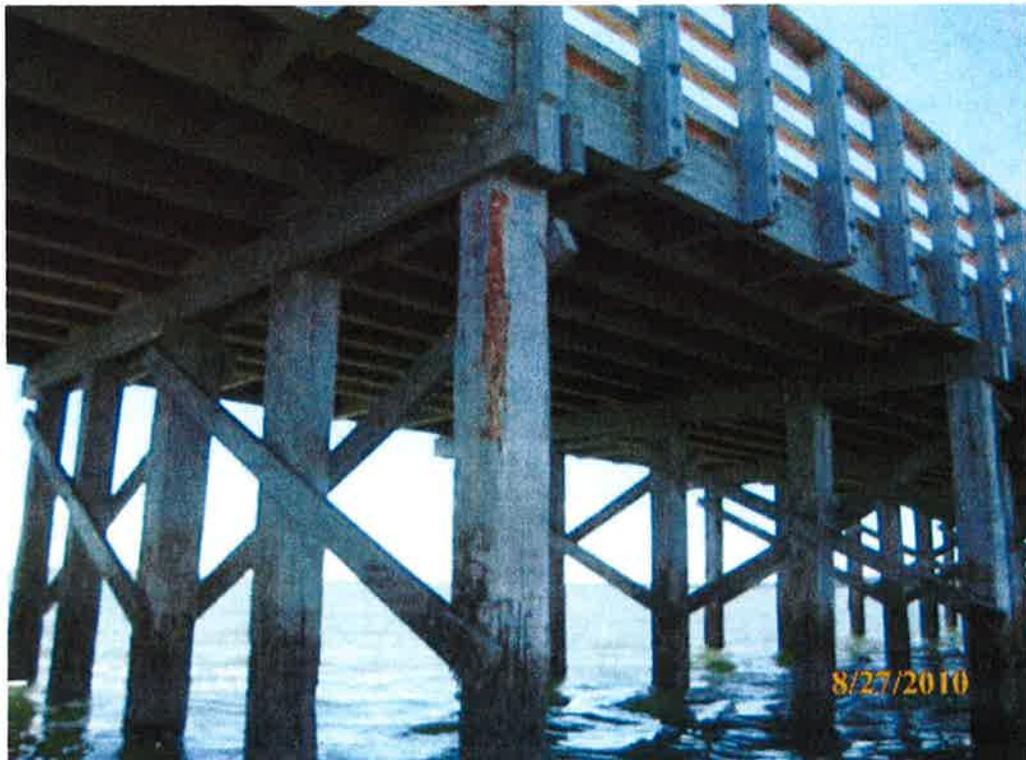
Photo 52: Bent #69, Pile "A", showing dry rot at the top of the Northeast corner up to 1.5" deep.

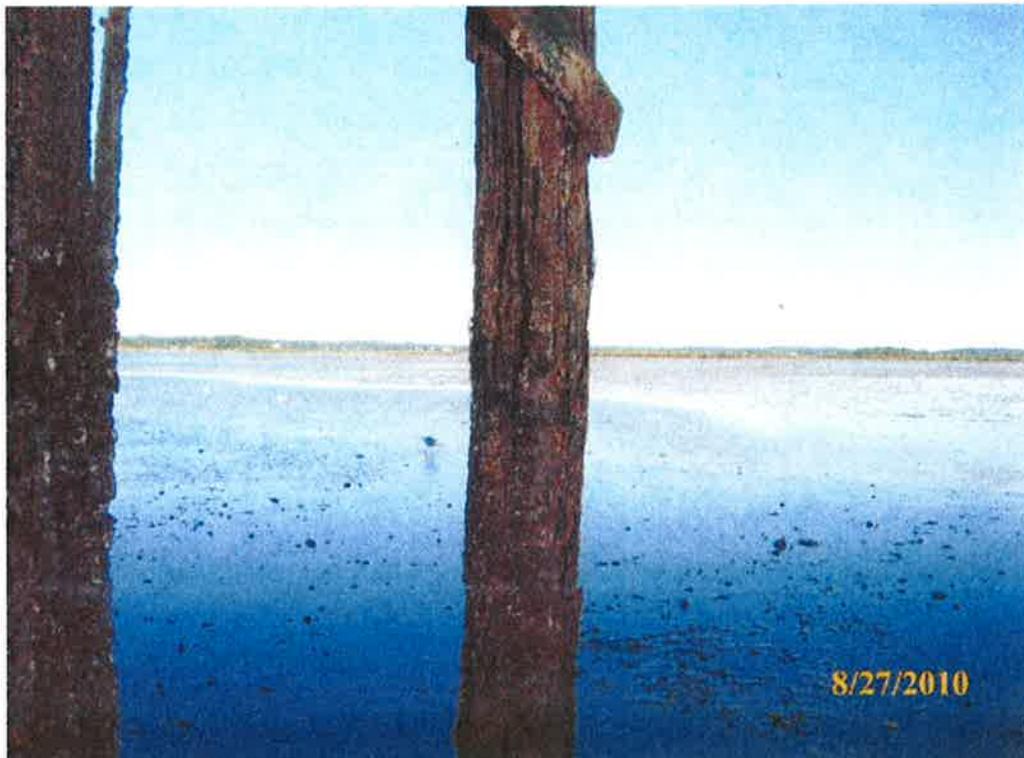
**Photo 54: Bent #81, Pile "A", showing extensive deterioration including brooming and rot up to 4" deep.**

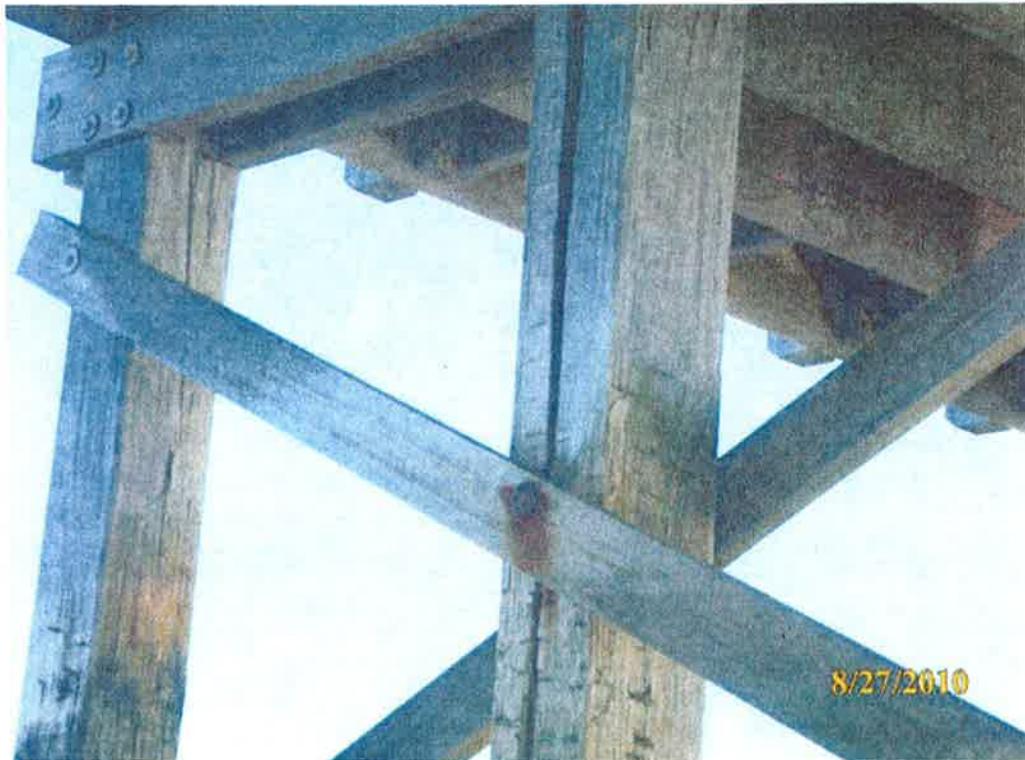
**Photo 56: Bent #87, Pile "B", showing wide split to the West face.**

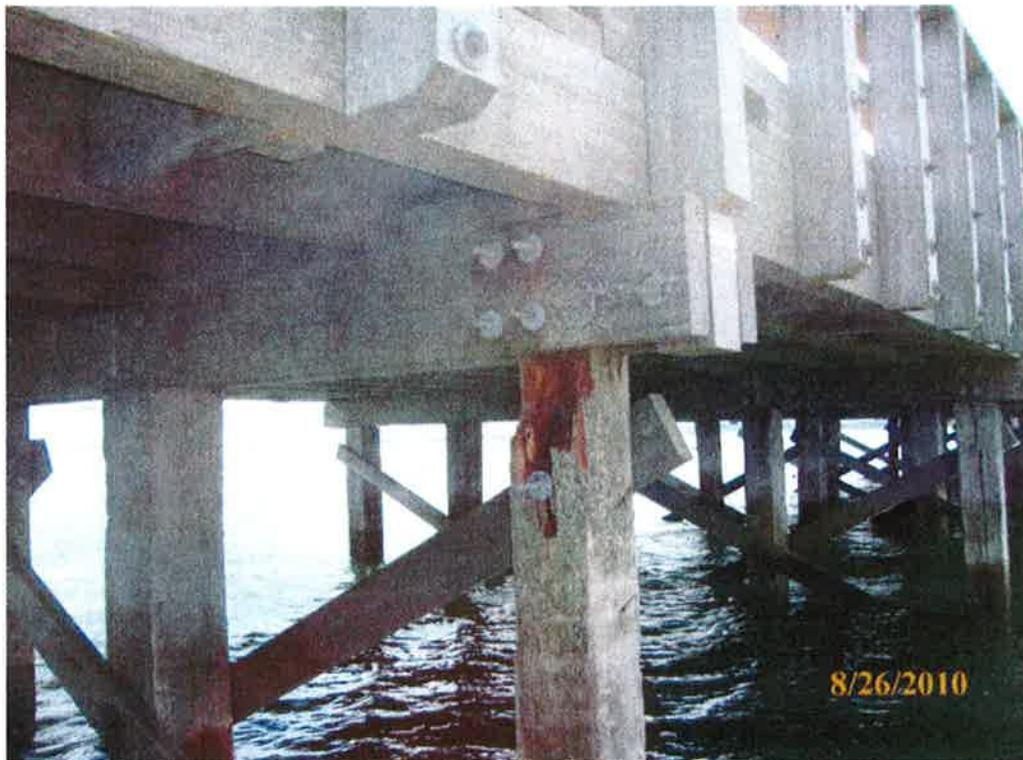
**Photo 58: Bent #98, Pile "A", showing dry rot at the top of the East face up to 2" deep.**

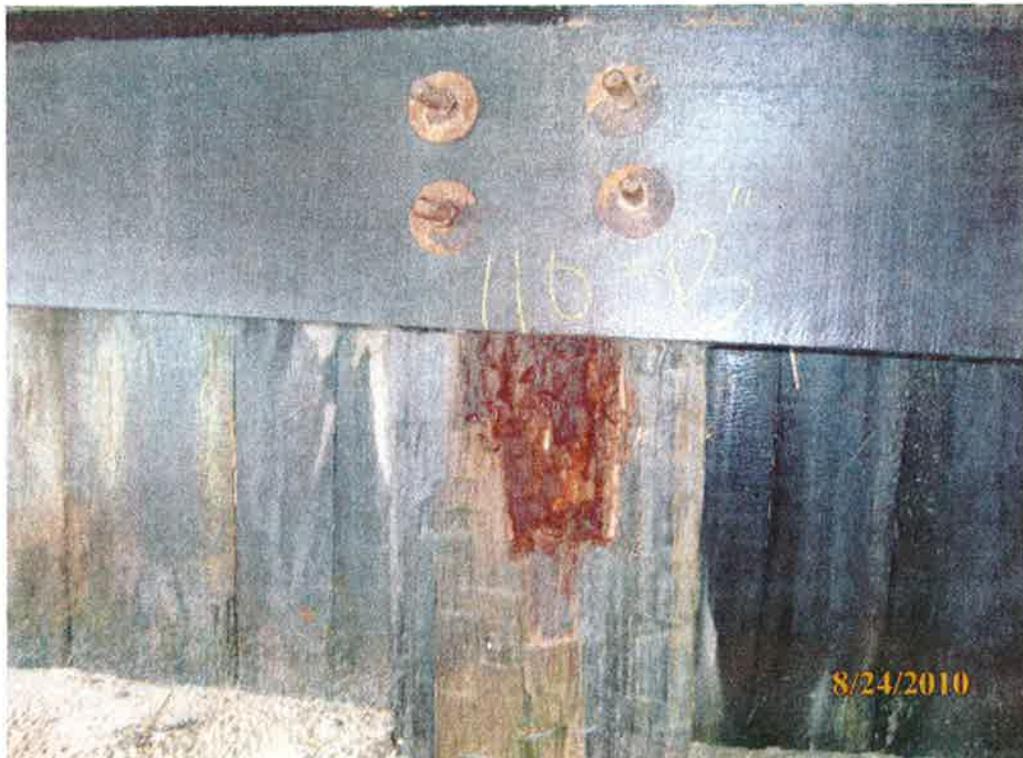
**Photo 60:** Bent #110, Pile "B", showing rot with loss at the top of the West face up to 3" deep.

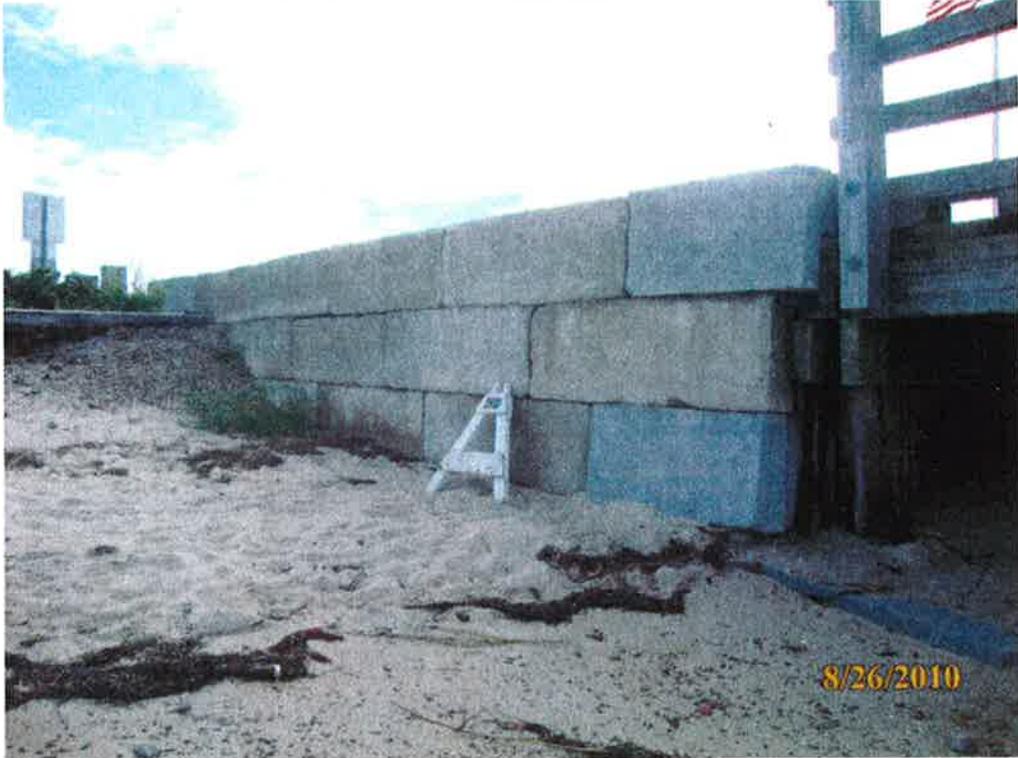
**Photo 61:** Northeast wingwall, showing minor to moderate chipping and spalling along the blocks joints.

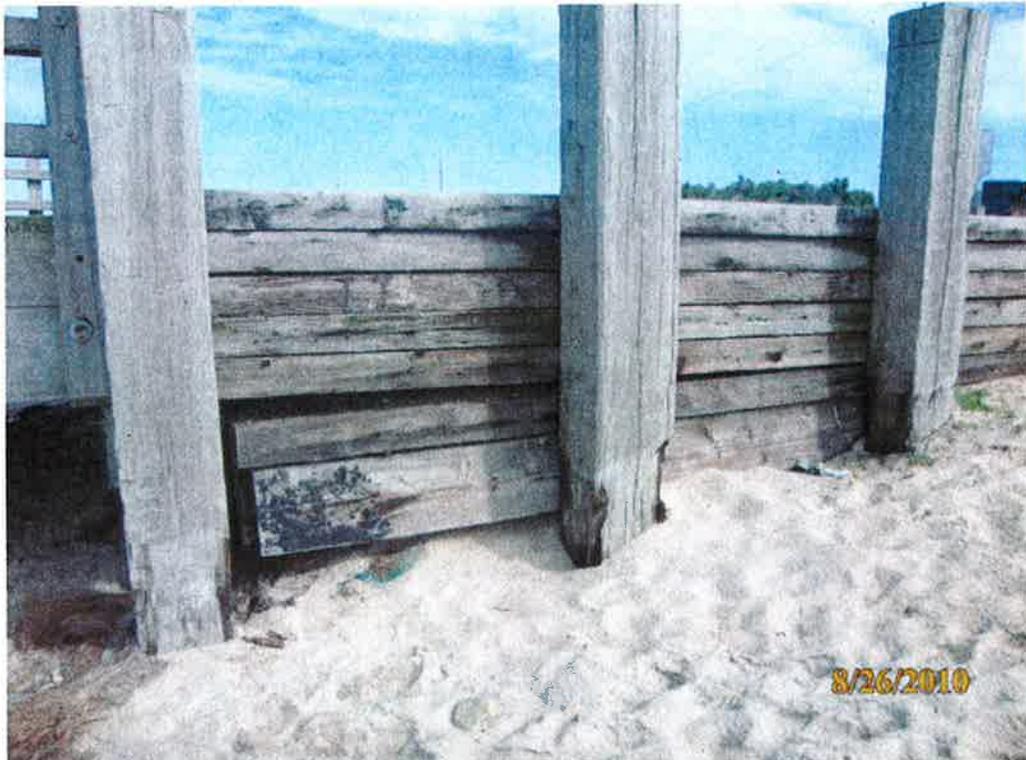
**Photo 62:** Southeast wingwall, showing splits and large voids in timber and necking down of piles at the ground.

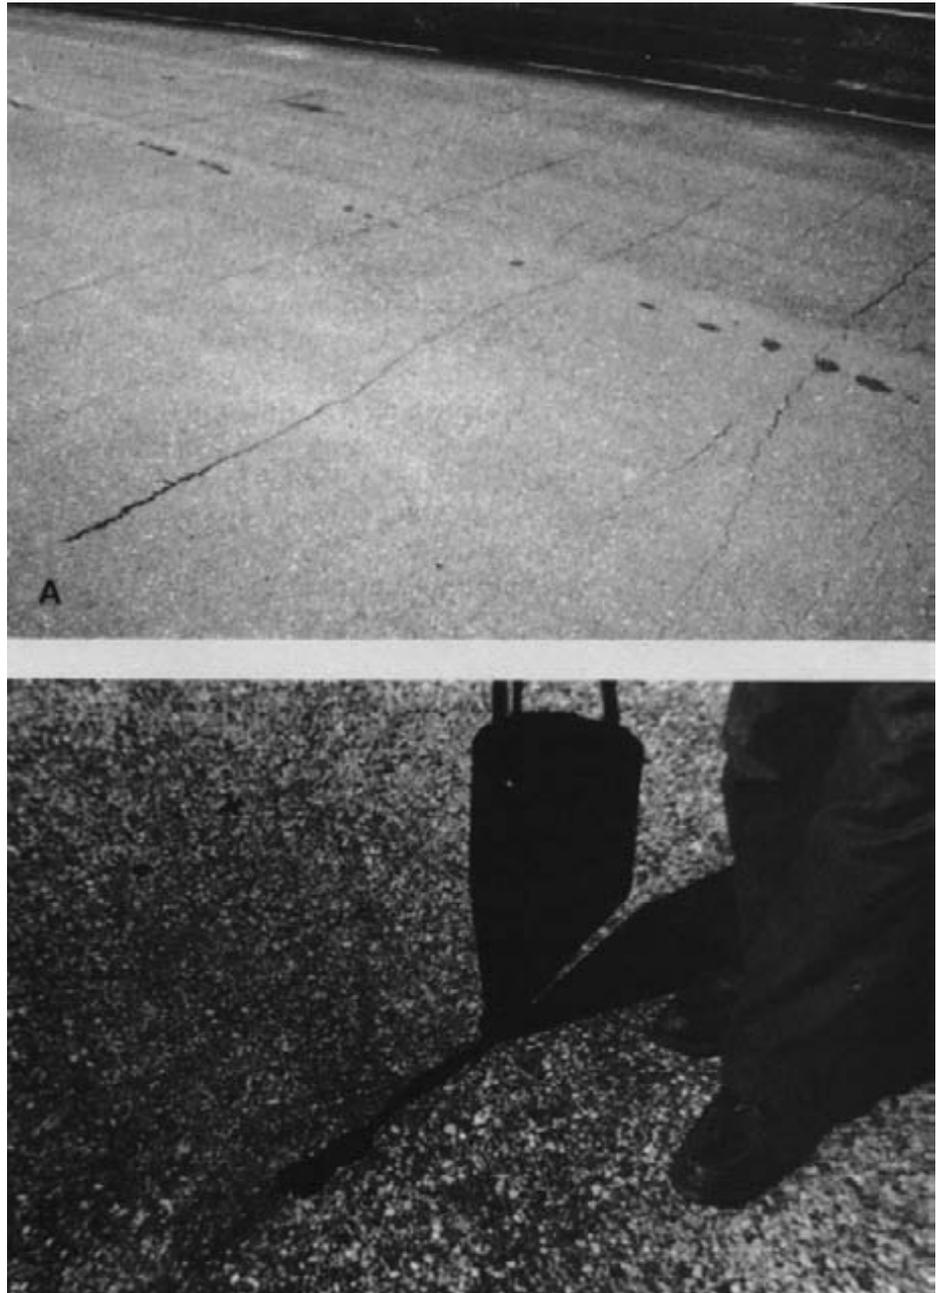
*Figure 14-4. - (A) Minor cracking in an asphalt wearing surface from differential deck deflections. (B) Sealing the cracks with an asphalt emulsion slurry.*
