SUBJECT: NATIONAL BRIDGE INSPECTION STANDARDS (NBIS)
UNDERWATER BRIDGE INSPECTION

BRIDGE ST / MITCHELL RIVER
Bridge No. C-07-001
Structure No. C07001-437-MUN-NBI

UNDERWATER OPERATIONS TEAM
ROUTINE UNDERWATER INSPECTION REPORT

BR. DEPT. NO. C-07-001

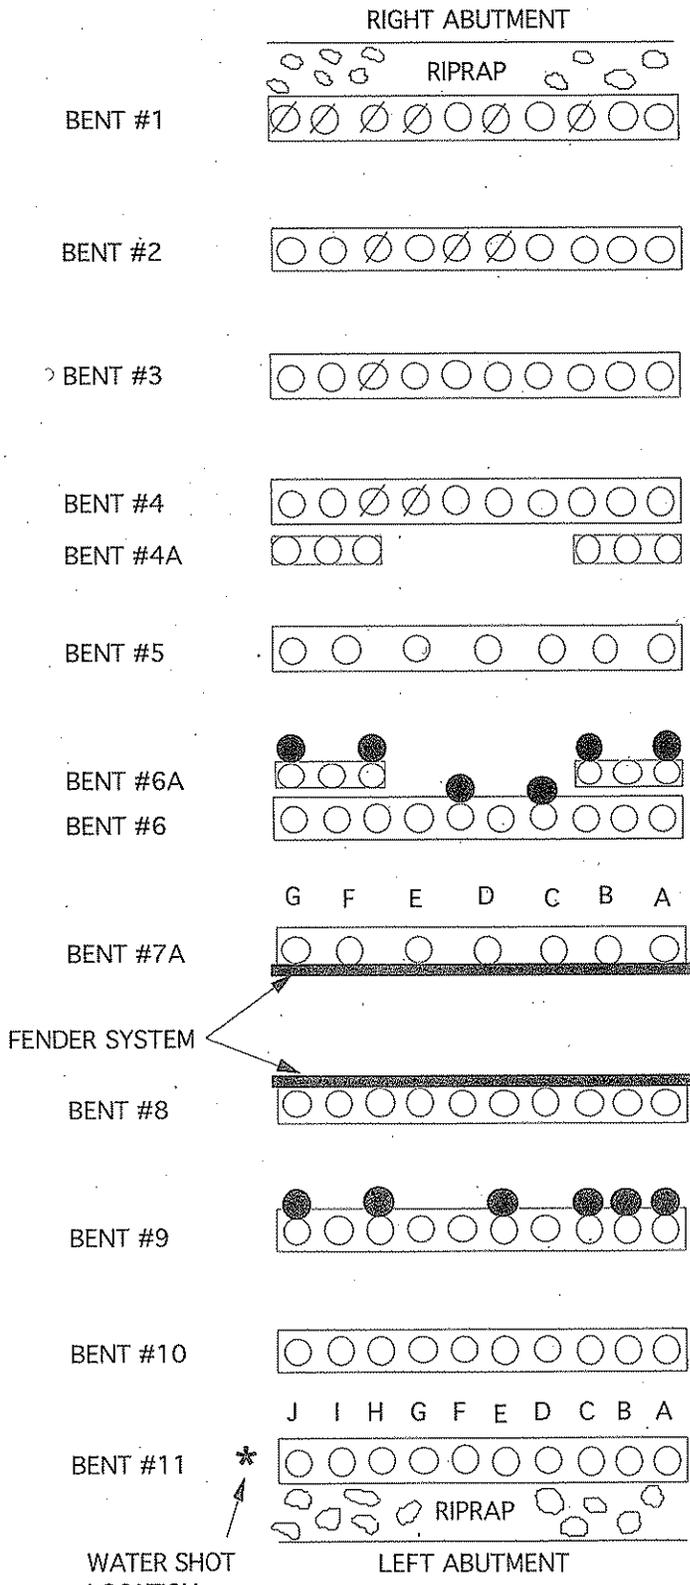
Sketch 1: PLAN VIEW (NTS)

Structure consists of eleven timber pile bents. Bents have a varied number of piles (see Plan View).

Bents are numbered from right (West) to left (East), looking downstream. Bents are numbered to be consistent with construction plans. Stub abutments are labeled left and right, looking downstream. Piles are lettered from upstream (North) to downstream (South). The draw span is between Bents #7A and #8.

A repair has previously been made to 12 piles (See sketch). This repair consists of wrapping piles with a plastic wrap held on by stainless steel bands. The wrap starts about 0.5' above the mudline and continues above the tidal zone. Most of the wrapped piles appeared to be of an older vintage.
