### Project Objective

Bridge Street Over Mitchell River

ACCELERATED BRIDGE PROGRAM  
Innovation. Efficiency. Transparency

### Project Studies

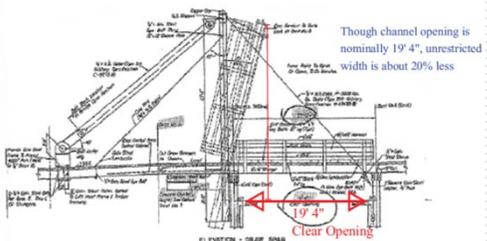
### Existing Bridge Opening

Excerpt from 1980 Plan Set

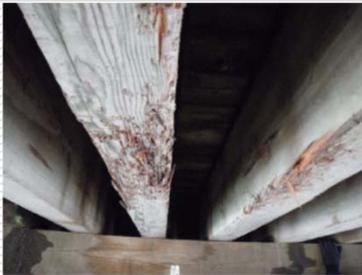
Bascule Span Collision Damage

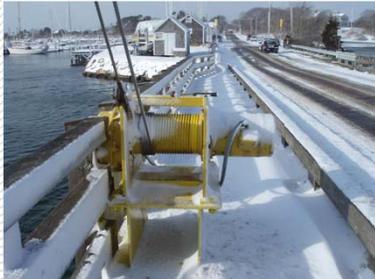
ADA and Open Machinery Issues

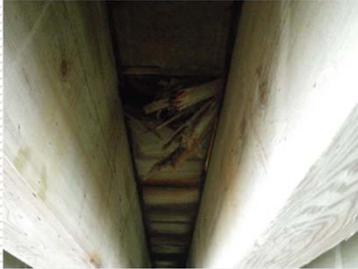
Failed Deck Area - Underside View

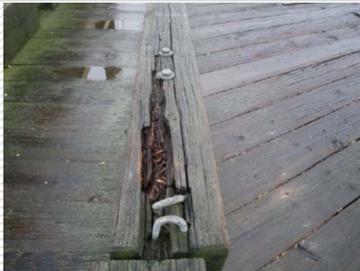
Deterioration at End of Bascule

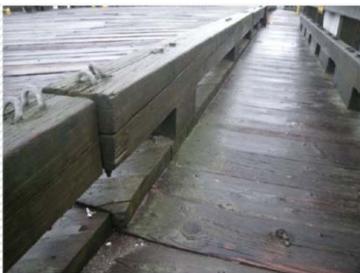
Bascule Span Toe Misalignment

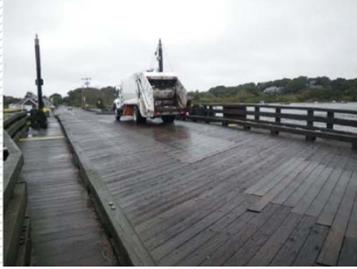
Worn Deck, Protruding Knots and Nails

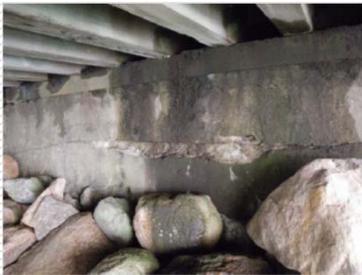
Cracking and Deep Spall at East Abutment

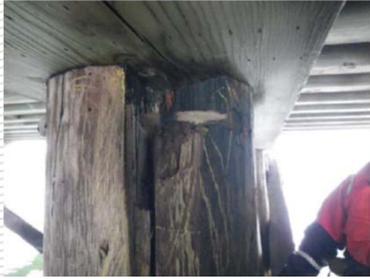
### Vertical Split in Wood Pile

**Item 60.3.b - Piles**  
 The timber piles typically have heavy marine growth with minor to moderate brooming and section loss in the tidal zone. Isolated piles exhibit heavy brooming and advanced section loss in the tidal zone, with up to 1 1/2" deep by full circumference areas of soft, punky timber (see photo 16). Above the tidal zone, the piles have vertical checks up to 1/8" wide at random locations. Random piles throughout have had a section removed from the upper portion of the pile, typically 3" deep by 2'-8" high.

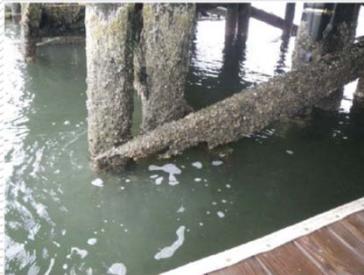
### Failed Diagonal Bracing

**Item 60.3.c - Diagonal Bracing**  
 (DEF-S/A) The diagonal timber bracing for each individual pile bent generally exhibits moderate to heavy deterioration and section loss in the tidal zone. The worst cases are at the north end of bent 5 and the south end of bent 3 where there are 5'-0" sections of the bracing which have completely deteriorated (see photo 20).

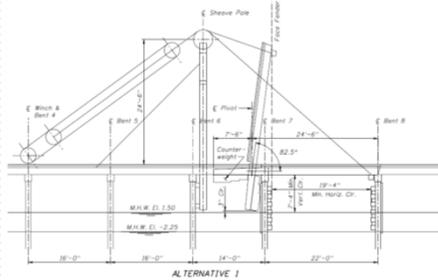
### Alternative 1 Bascule Span

- Alt 1 – All Wood Replacement/Replication 19' channel
- Alt 2 – All Wood Bridge w/Concrete & Steel Bascule Span, 25' channel
- Alt 3 – Wood Superstructure on Concrete/Steel Substructure, 25' channel
- Alt 4 – Wood Deck on Steel Beams and Concrete/Steel Substructure, 25' channel
- Alt 5 – All Concrete/Steel Replacement Structure, 25' channel with wood features

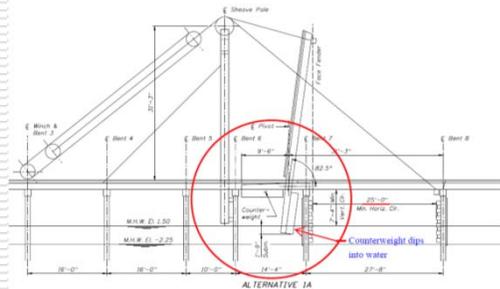
### Alternative 1A Bascule Span

- After MassDOT/FHWA comments, 2 additional alternatives were developed for “apples to apples” comparison
  - Alternative 1A – All Wood Bridge with 25’ span
  - Alternative 1B – All Wood Bridge with 25’ span and protective pier

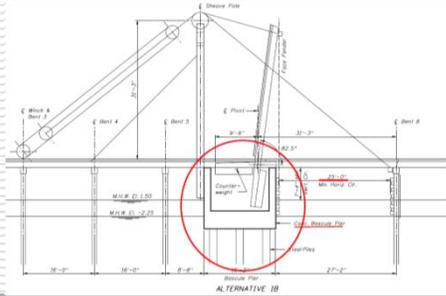
### Alternative 1B Bascule Span

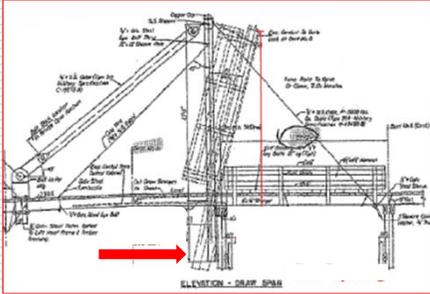
### Counterweight Position

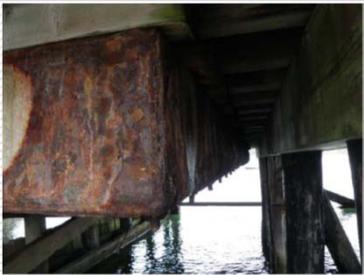
### Corroded Counterweight

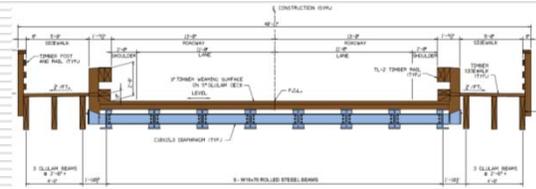
### Alternative 4 Superstructure

Wood Deck with Steel Beams

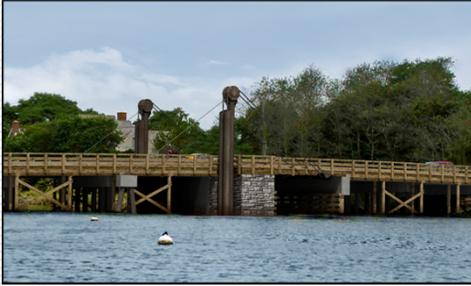
### Sheave Poles Outboard of Bridge

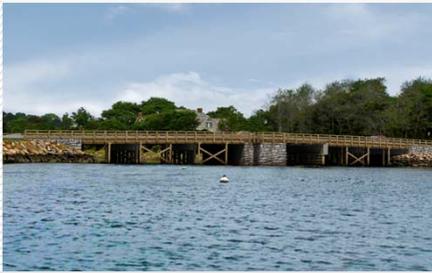
### Alt's 3-5 Profile Simulation
