**ANALYSIS OF COASTAL PROCESSES
FOR THE CHATHAM SOUTH COAST BETWEEN
MILL CREEK AND BUCKS CREEK**

**Town of Chatham
Ted Keon, Director
Department of Coastal Resources
549 Main Street
Chatham, MA 02633**

**Applied Coastal Research and Engineering, Inc.
766 Falmouth Road, Suite A-1
Mashpee, MA 02649
www.appliedcoastal.com**

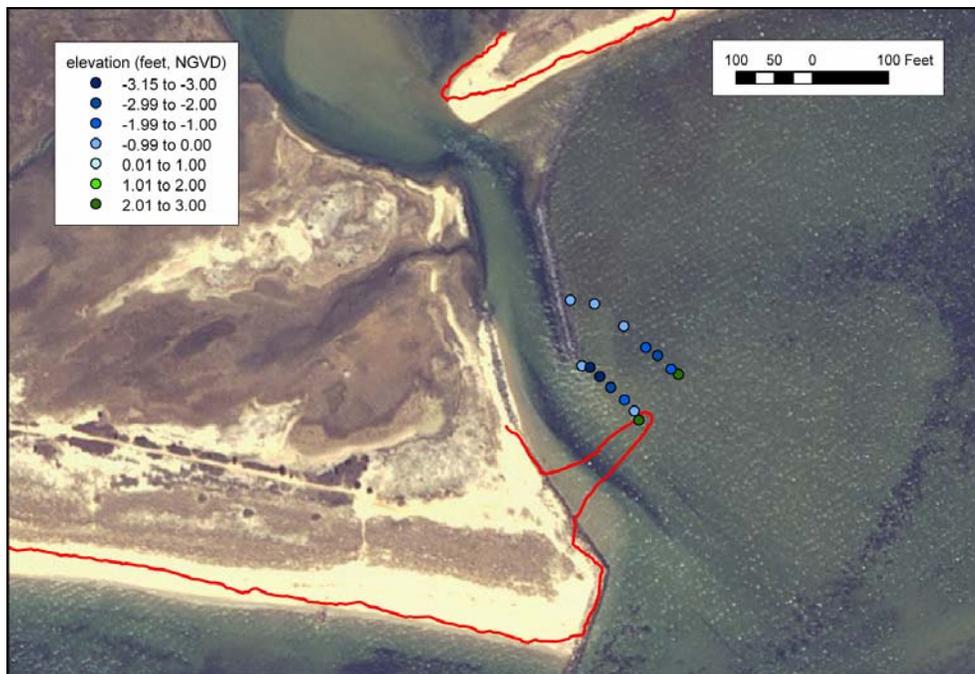
Figure 2. Plot of channel cross sections surveyed May 31, 2007 at the inlet to Mill Creek and Taylors Pond. Survey Points and the measured GPS shoreline (solid red line) from the same day are plotted over an April 2005 Mass GIS aerial orthophoto.

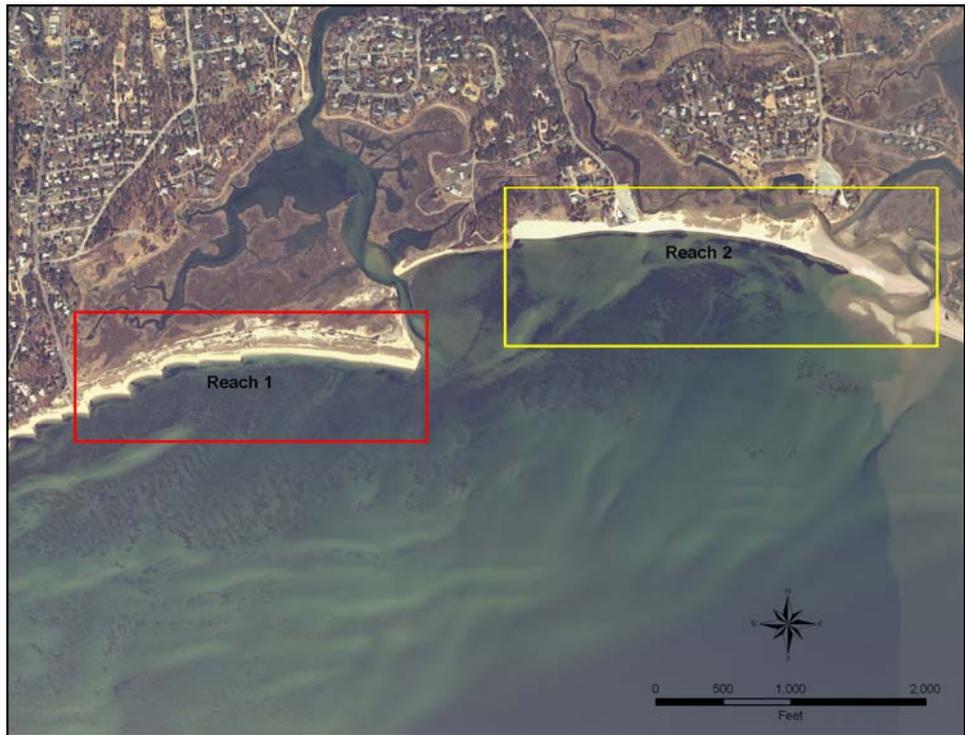
Figure 5. Overall study area showing the two areas (Reach 1 and 2) where shoreline change analyses were performed.

Shoreline change rates for two areas along Chatham's south coast were performed for this analysis, as shown in Figures 5 and 6. Shoreline positions from 1978, 1994, 1999, 2005 and 2007 were determined using different sources. The 1978 shoreline position was compiled from aerial surveys by the Massachusetts Office of Coastal Zone Management. The 1994 and 2005 shoreline positions were visually interpreted from color orthophotographs available from MassGIS. The 1999 and 2007 high-water shorelines were collected using a differential Global Positioning System (GPS). The location of the GPS shoreline was determined visually from morphologic features present on the beach and/or from a debris line when available.

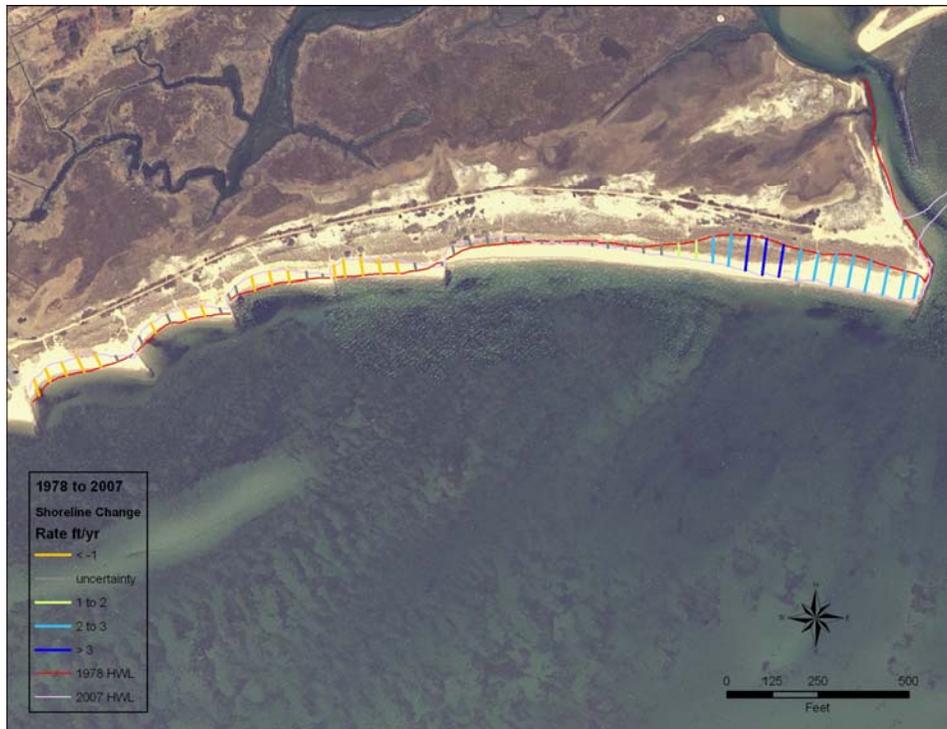
Figure 6. Historical shoreline change for Reach 1 (Forrest Beach parking lot to the Mill Creek west jetty) from 1978 to 2007. Shorelines are shown overlaid on the 2005 MassGIS aerial orthophoto of the area.

Rates of change in high-water shoreline position between 1978 and 2007 and 1994 and 2007 were evaluated 2500 feet to the west of the Mill Creek jetty (Reach 1). These two periods highlight shoreline changes as the two easternmost groin compartments of Forest Beach (adjacent to Mill Creek Inlet) filled with sand. The longer time period shows the infilling of the second-to-last compartment, while the shorter period between 1994 and 2007 shows the complete infilling of the eastern-most compartment.

During the 1978 to 2007 time interval, change rates ranged from 3.4 to -1.6 ft/year along the shoreline west of the Mill Creek jetty. Along the same stretch of shoreline the rates ranged from 5.8 to -2.1 ft/year during the 1994 to 2007 interval. The shoreline advanced during both time intervals up to 700 feet west of the jetty. The rest of the beach experienced mainly shoreline retreat during both time intervals. The magnitudes and rates of this retreat varied along the beach depending on proximity to one of the five groins. Figures 6 and 7 illustrate the shoreline change along Reach 1 for the time periods 1978 to 2007 and 1994 to 2007, respectively.

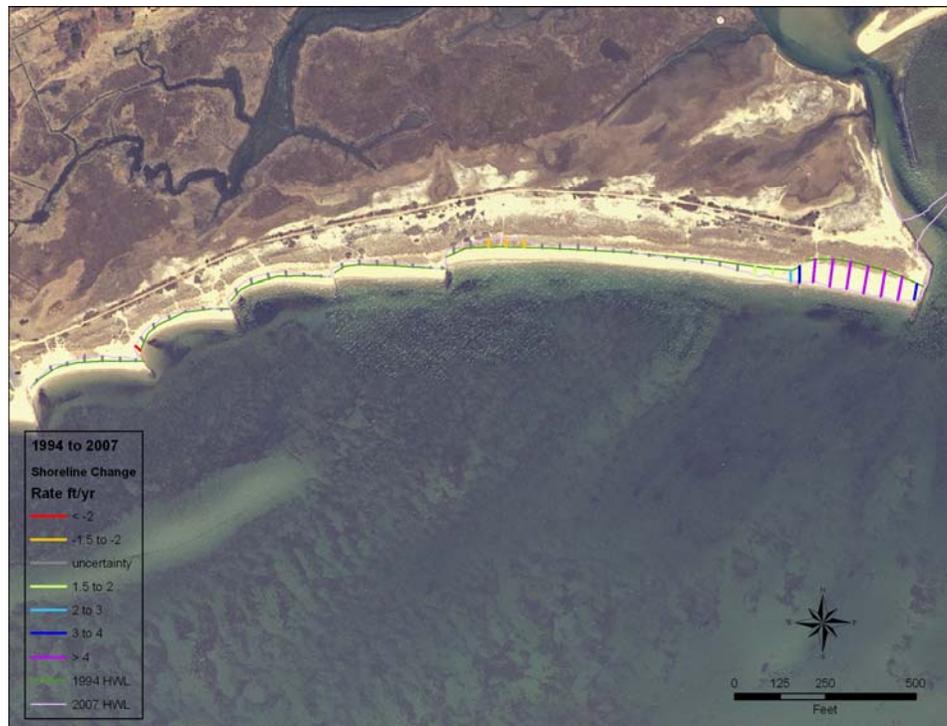
Figure 7. Historical shoreline change for Reach 1 (Forrest Beach parking lot to the Mill Creek west jetty) from 1994 to 2007. Shorelines are shown overlaid on a 2005 MassGIS aerial orthophoto of the area.

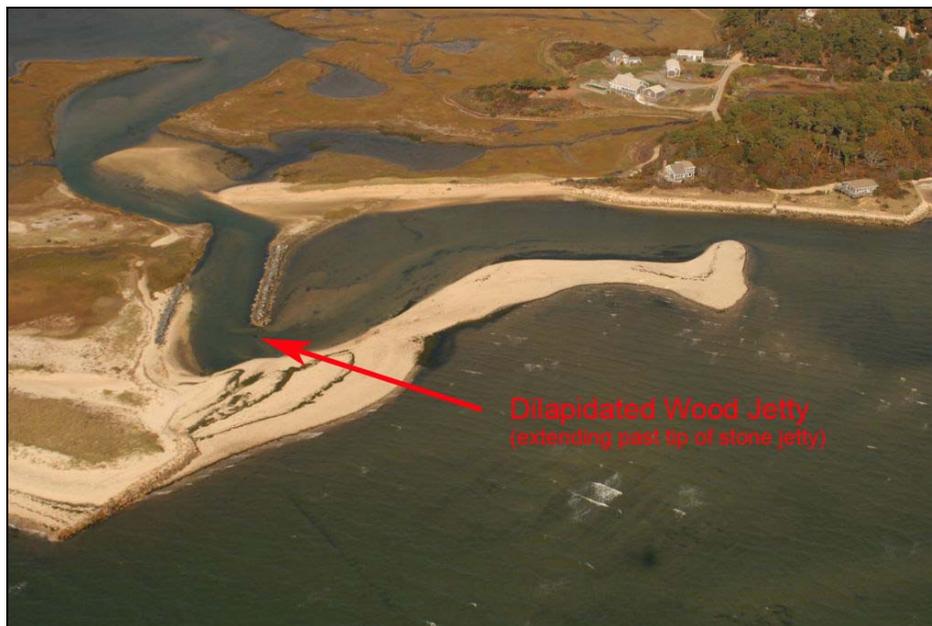
Figure 8. Oblique aerial photograph of the Mill Creek entrance in October 2007. This photograph was taken near low tide to illustrate the extent and migration patterns associated with the sand spit and shoal system.

As part of any future effort to maintain the inlet of Mill Creek, it would be possible to remove the dilapidated wood sections of either jetty (Figure 8). Their removal likely would not cause any detrimental effects to system flushing, and would benefit navigation.
