# TREATED WATER RECHARGE SITE EVALUATIONS

## Final Report COMPREHENSIVE WASTEWATER MANAGEMENT PLANNING PROJECT Town of Chatham, Massachusetts

**COMPREHENSIVE WASTEWATER MANAGEMENT PLANNING PROJECT**  
**TREATED WATER RECHARGE SITE EVALUATIONS**  
**FINAL REPORT**

Project No. 70098.52

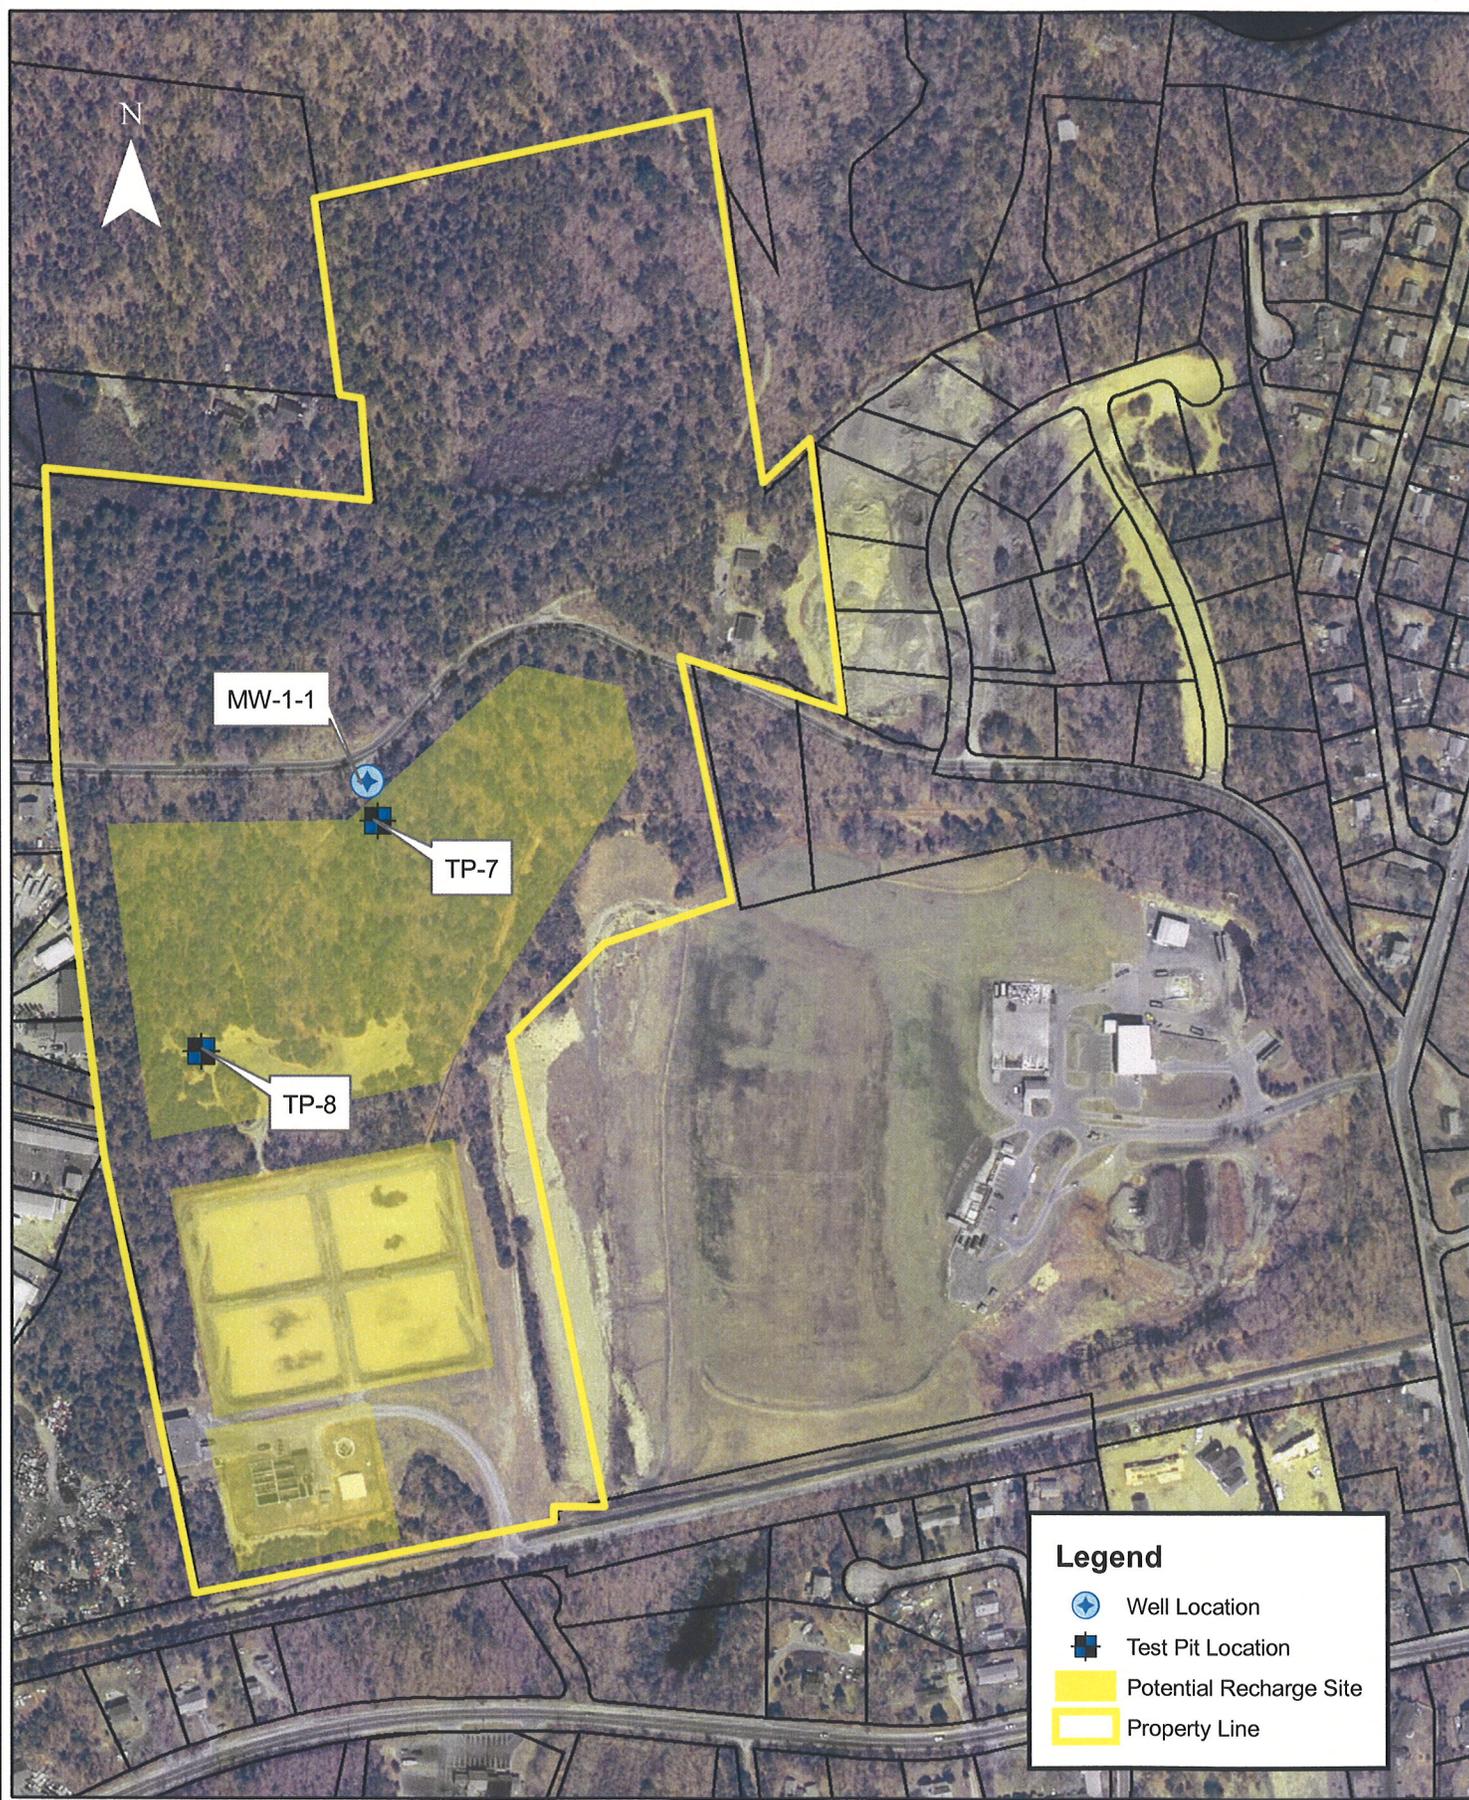
Town of Chatham, Massachusetts  
 Treated Water Recharge Site Evaluations  
**FIGURE 2 - TREATMENT PLANT NORTH SITE**

- Well Location
- Test Pit Location
- Potential Recharge Site
- Property Line

1. Site Location. Treatment Plant North (Site 1) is located south of Middle Road and is adjacent to the north side of the existing treatment plant. The entire parcel is approximately 82 acres, of which approximately 10 acres would be considered for new treated water recharge facilities. The treatment plant lies in the southeast corner of the parcel while the evaluated location is on the north side of the parcel at the entry to an existing dirt access road. The location is approximately 900 feet from the treatment facility. This site is illustrated on Figure 2.
