***Subject: Chatham, MA – Mitchell River Bridge Project  
Bridge Repair/Rehabilitation Feasibility Study***

**BRIDGE REPAIR/REHABILITATION FEASIBILITY**  
**STUDY**

**BRIDGE STREET**

**BRIDGE NO. C-07-001 (437)**

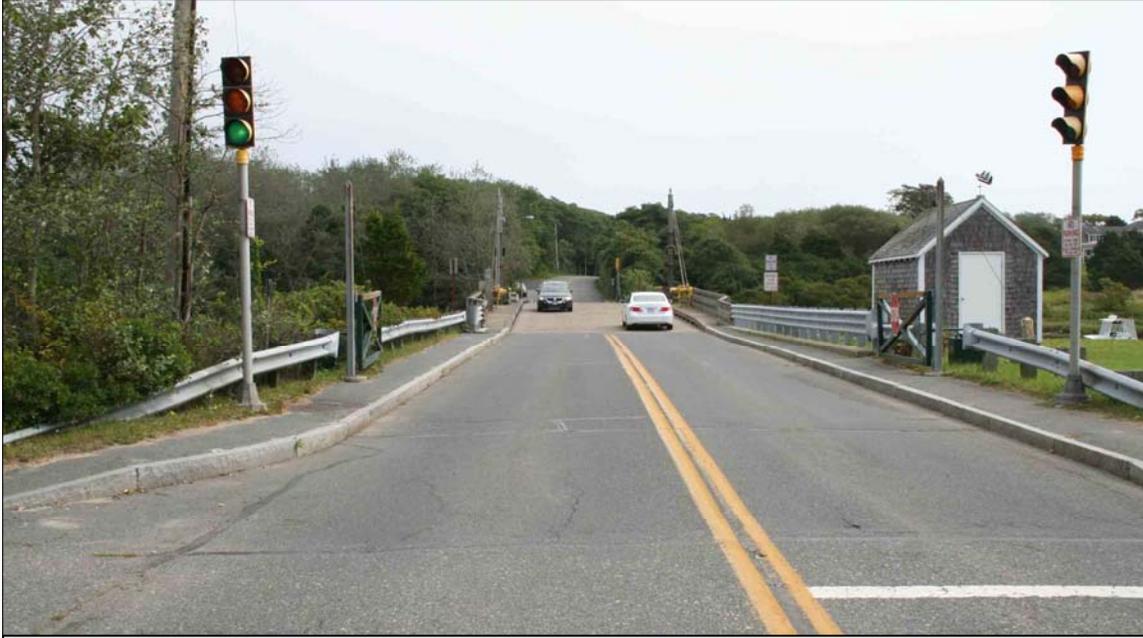
Photo 2 - Present Mitchell River Bridge - Roadway Section Looking East

The bridge currently has a clear roadway width of 24'-0" and carries one lane of traffic in each direction with sidewalks located each side of the roadway behind timber curbs and with timber bridge railings at the back of sidewalk. In Spans 2 thru 7 and Spans 9 thru 11 the sidewalks are 5'-9" wide with an overall bridge width of 37'-6". In Spans 1, 8 and 12, the sidewalks are 2'-9" wide with an overall bridge width of 31'-6". There is a tapered transition in sidewalk width in Spans 2 and 11 (see Appendix A.)

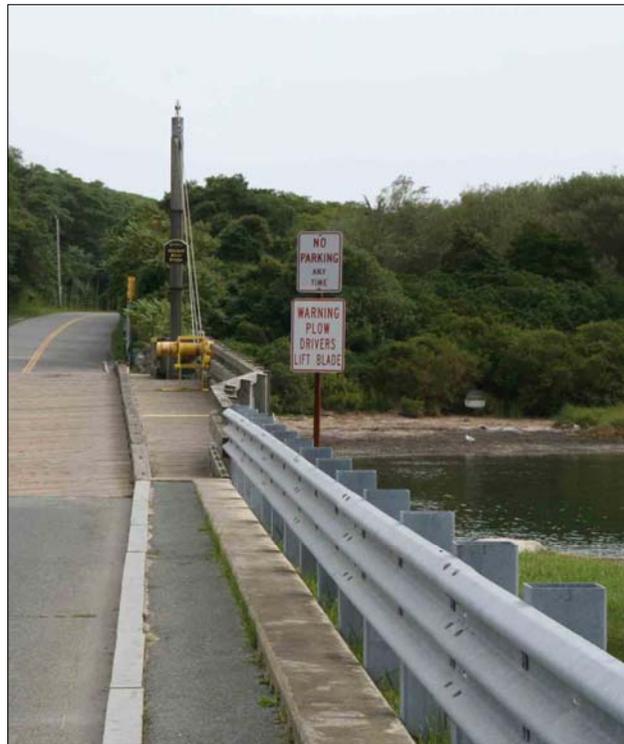
Photo 3 - Approach Sidewalk and Guardrails

The existing bridge does not contain traffic railings that are crash tested in accordance with NCHRP 350 as required by current design standards. Low-level curbs, such as the existing 1'-1" high timber curbs, have a history of causing errant vehicles that strike the curb to lose control and rollover. The traffic railings are required to meet Test Level 2 (TL-2) crash testing criteria as a minimum, which are appropriate for use on local collector roads, with favorable site

conditions, a small number of heavier trucks and reduced speeds. Based on the relatively high volumes of pedestrians that use the bridge for activities such as fishing, it is recommended that a crash tested traffic railing separate the sidewalk from the roadway to better protect pedestrians from vehicular traffic.

The bridge railing contains openings between horizontal rail elements of 8" where as the NFPA Life Safety Code specifies that the openings in guards protecting drop-off hazards should not permit a 4 inch diameter sphere to pass.

The steel guardrails along the abutment wing walls also do not meet standards of safety for protecting drop-off hazards. The guardrail is less than the required minimum height of 42" and includes openings greater than 4".

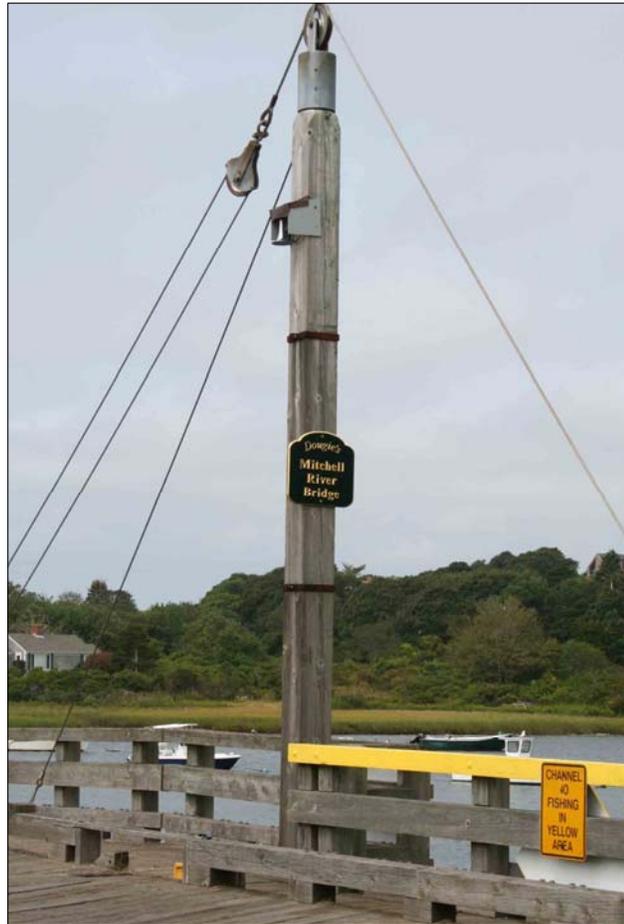
Photo 6 - Sheave Pole (Mast)

Similar to the stringers, there are options for in-place preservative treatment of the masts including both internal and surface treatments (see 4.3.1 above). However, many of the same risks and concerns for in-place preservative treatments exist for the masts with exception that the drilled holes for internal treatment are not likely to significantly reduce the capacity and there are no access concerns. Due to the location of the timber masts along the sidewalks, there are significant concerns with human contact with the toxic chemicals and concerns with environmental contamination from spills or run-off of chemicals that leech from the masts. As such, in-place preservative treatments are not recommended for the masts.

*Rehabilitation Scope:* It may be necessary to increase the size of masts in order to resist larger operating forces meeting current design standards and to accommodate the details of conjunction of the new operating equipment including new larger deflector sheaves (see 4.3.6 below).

Alternatively, the masts can be strengthened with the addition of fiber reinforced polymer (FRP) sheets to the exterior faces of the members. However, as FRP is expensive relative the cost of the timber and a relatively new technology without a long track record of use in extremely aggressive saltwater environments, it may be more economical and prudent to replace the substandard timber members than to strengthen them with FRP.

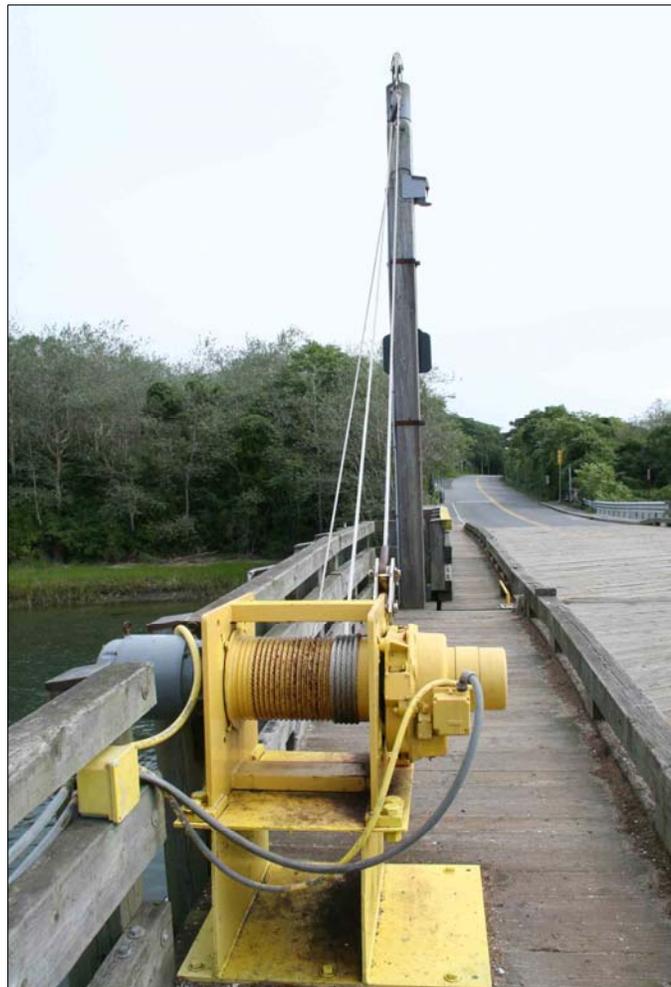
Photo 7 - Operating Equipment

*Condition Description:* The condition of the bridge operating equipment is not described in the Structures Inspection Field Reports. However, there are numerous reported concerns with the frequent required maintenance and unreliable operation of the bridge.

Boaters requesting that the bridge be raised to the maximum extent possible to maximize the horizontal clearance have reportedly been told by the bridge operator that the bridge cannot be fully raised due to safety concerns. The bridge operating equipment reportedly struggles to raise the bridge and shudders, creaks, and vibrates significantly as the bridge operates. The tight fit between the bascule span and approach spans has reportedly resulted in the bascule leaves to periodically become stuck in the lowered position.

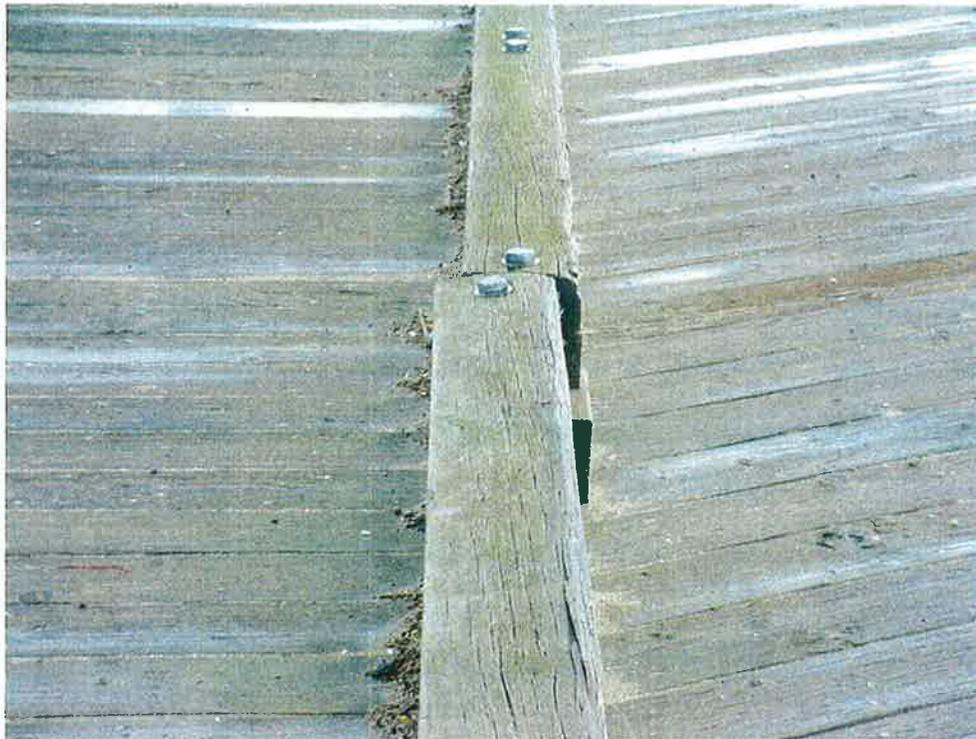
Photo 1: Misalignment of north timber curb at the east end of span 2.

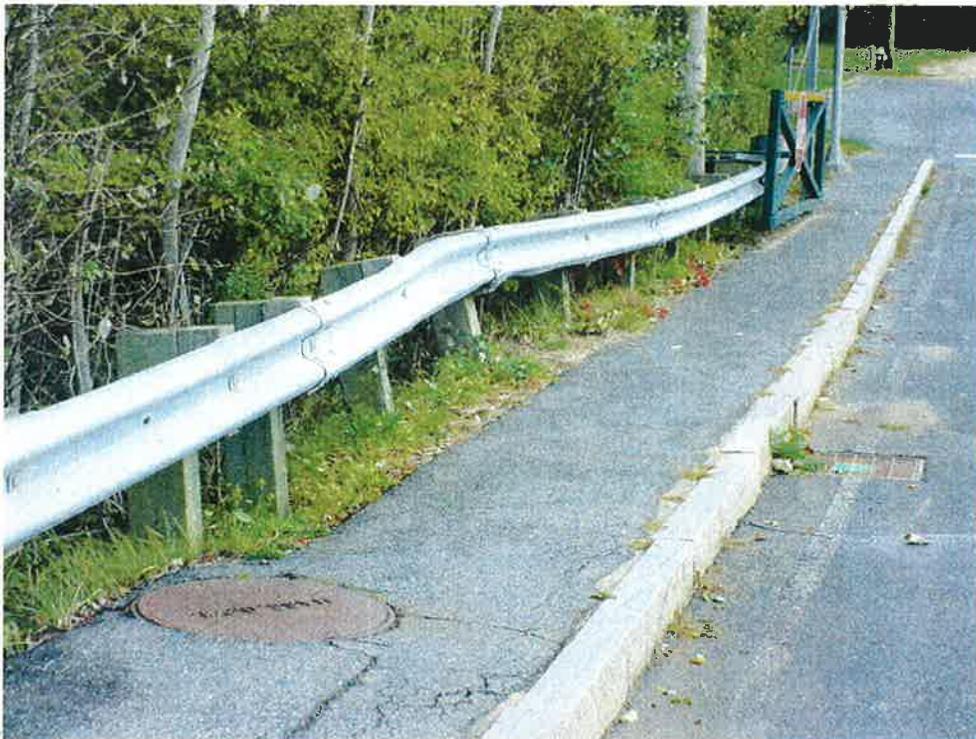
**36.3 Approach Guardrail (Satisfactory):** The approach guardrail is typically in satisfactory condition with an area of minor impact damage to the northeast (see photo 2) and northwest approach guardrail. The approach guardrail does not appear to conform to current standards. There are four posts for the southeast approach guardrail which are not tight against the wingwall (see photo 3). The maximum gap between the wingwall and the post is 1¼".

Photo 2: Impact damage to northeast approach guardrail.

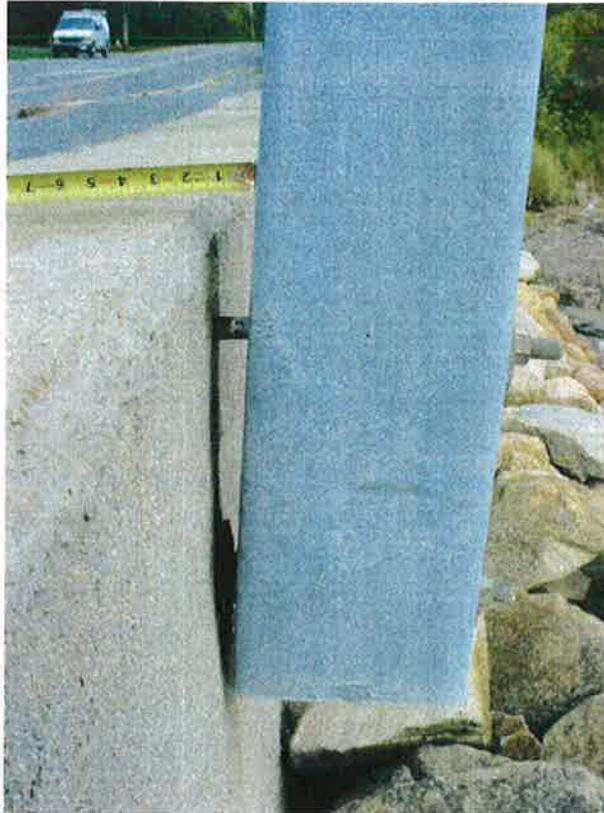
**Photo 3:** 1/4" gap between southeast approach guardrail and wingwall.

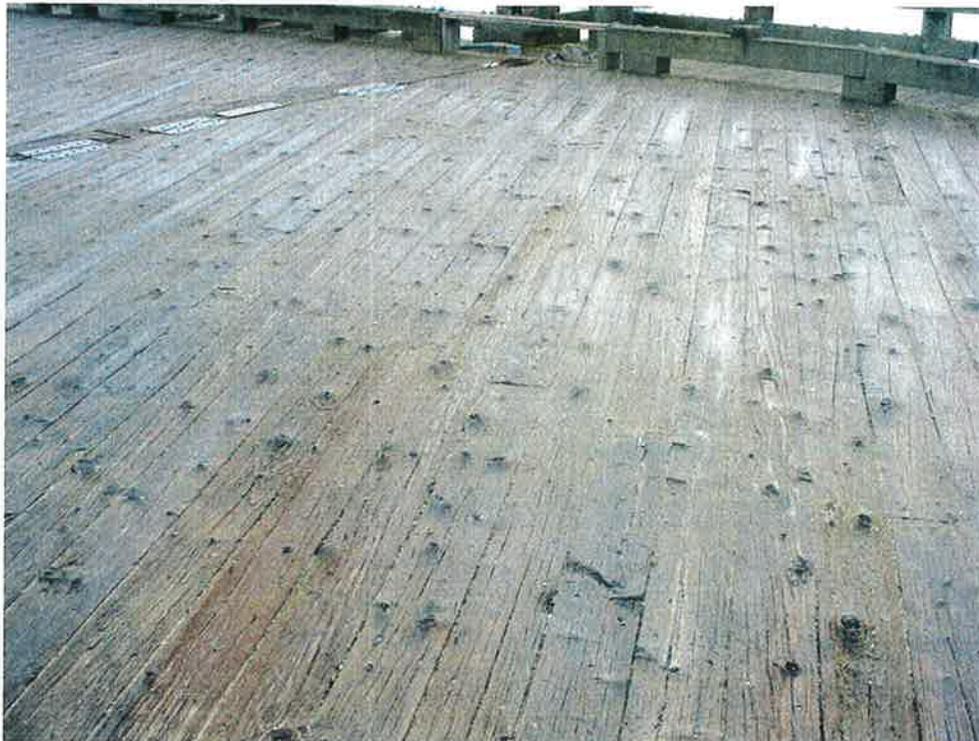
**58.1 Wearing Surface (Fair):** The timber wearing surface typically exhibits light to moderate wear typically in the wheel lines and minor checks and splits throughout. Span 6 exhibits the heaviest wear on the timber planks (see photo 4). Random timber planks have been replaced throughout.

**Photo 4:** Typical condition of timber wearing surface in span 6.

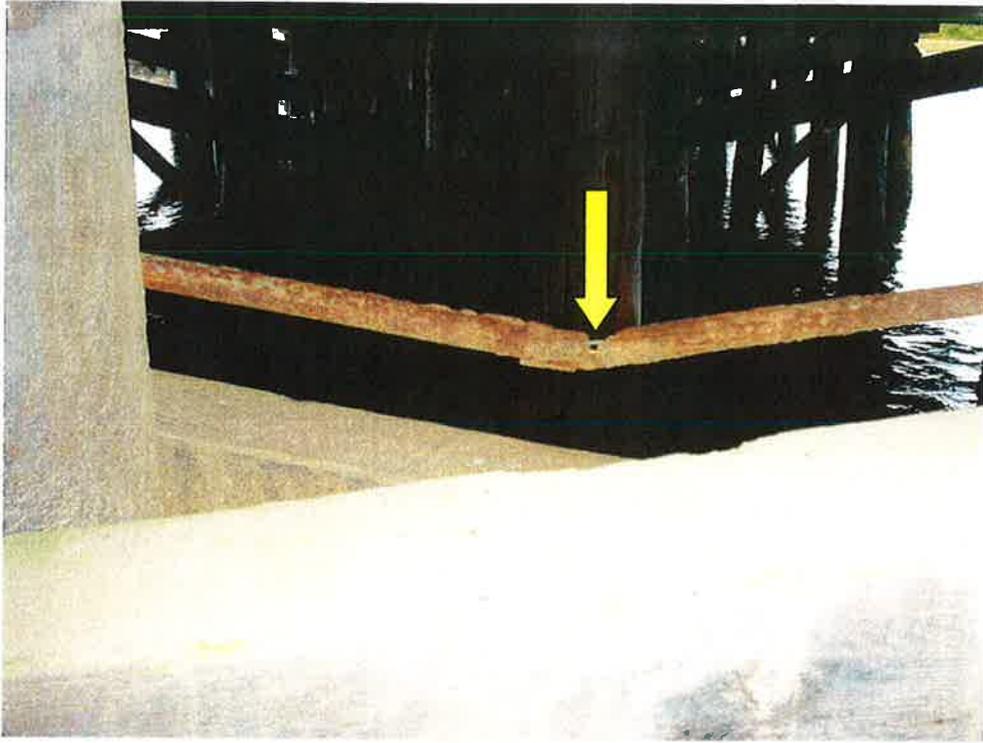
**58.12 Utilities (Satisfactory):** There are isolated broken or loose brackets for the electrical conduit on the north side of the bridge. There is a 1½" diameter transverse conduit on the west elevation of bent 7A which exhibits heavy corrosion with isolated holes along its length exposing the wire inside (see photo 5).

**Photo 5:** Utility conduit with corrosion hole on west elevation of bent 7A.

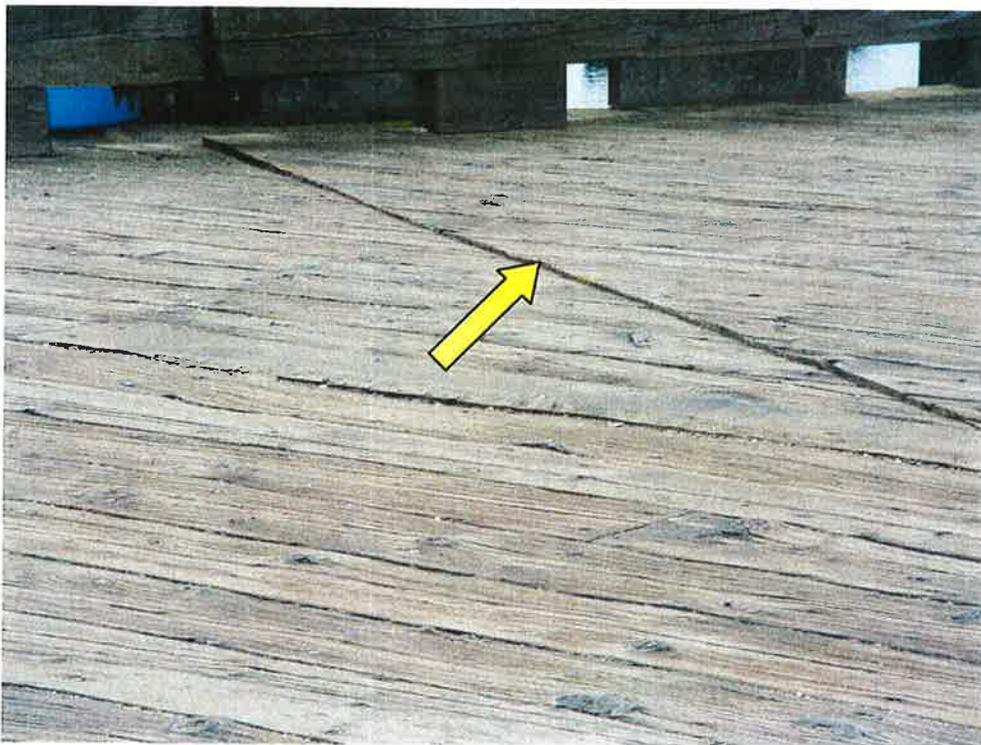
**Photo 6:** Bascule span deck is approximately a 1/2" higher than the adjacent span deck after opening.

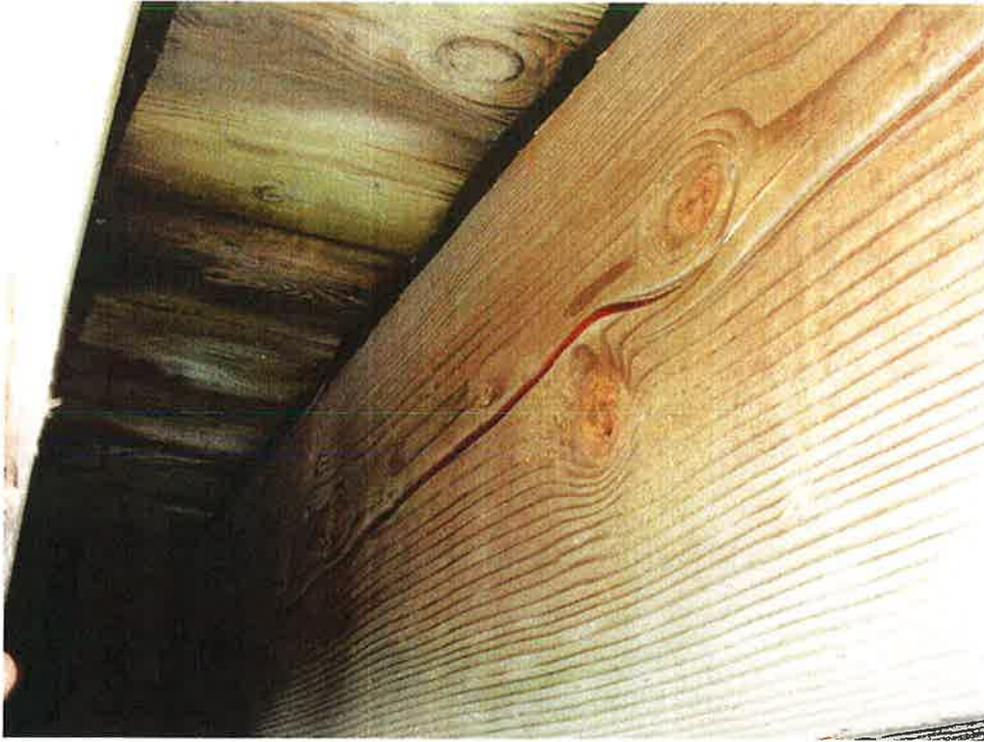
**59.1 Stringers (Satisfactory):** The timber stringers are typically in satisfactory condition with isolated areas of punky wood, minor splits and minor scrapes on the underside of the bascule span. Isolated stringers exhibit checks up to  $\frac{5}{16}$ " wide by up to 5'-0"± long with a maximum depth of 1 $\frac{7}{8}$ " (see photo 7).

**Photo 7:**  $\frac{5}{16}$ " wide by 5'-0"± long check on the north face of the ninth stringer from the south in span 8.

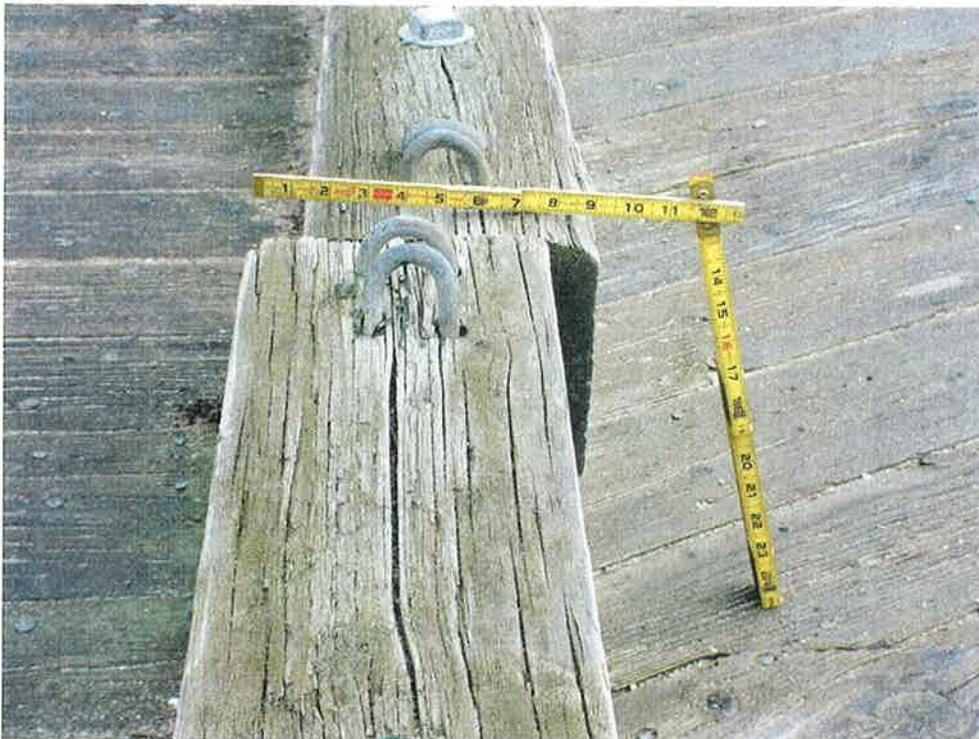
**Photo 8:** Misalignment of the toe of the basculer span at the north curb.

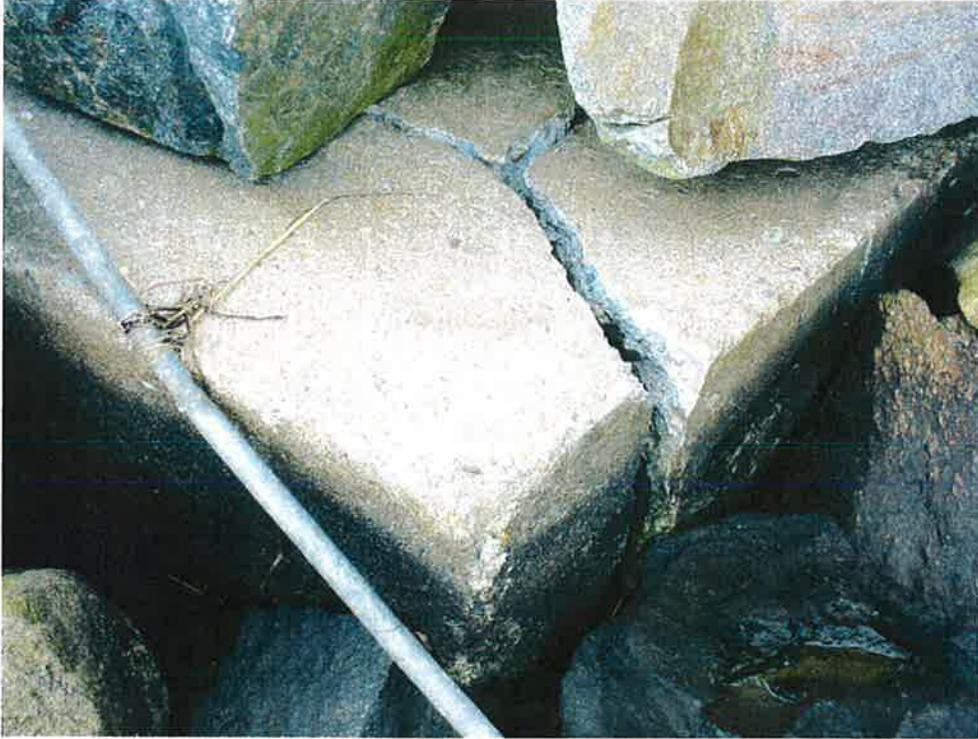
**60.1h Footings (Fair):** There is a 2" wide crack through the south corner of the west abutment footing (see photo 9). The east and west abutment footings are partially exposed through the rip-rap.

**Photo 9:** Crack in the south corner of the west abutment footing.

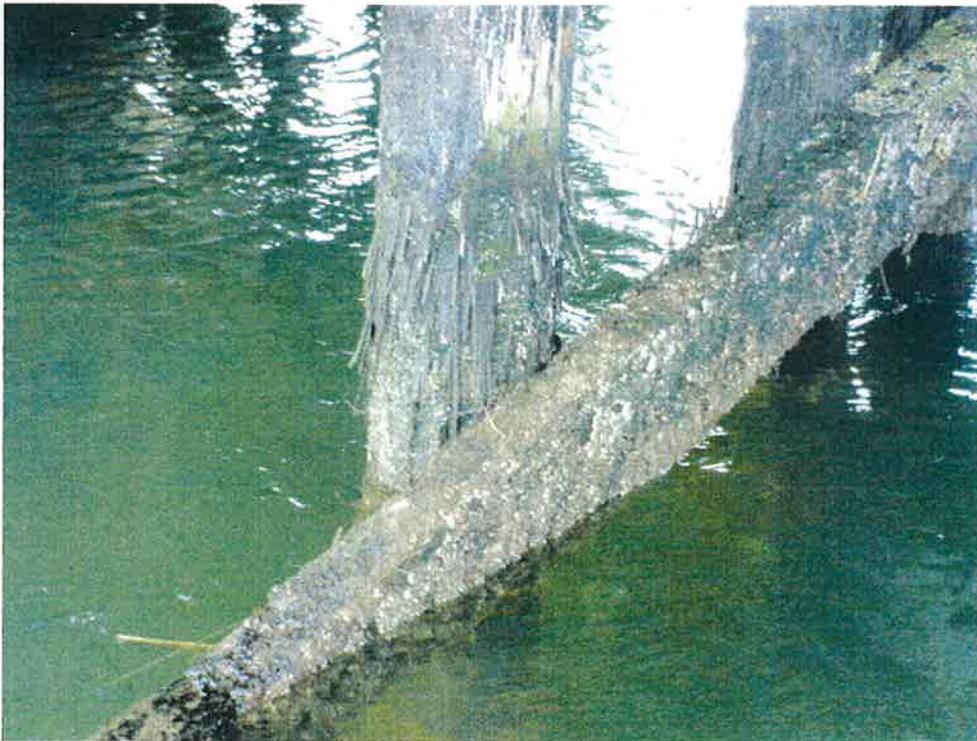
**60.3c Diagonal Bracing (Poor):** The diagonal bracing typically exhibits heavy marine growth and moderate section loss in the tidal zones (see photo 10). The fasteners typically exhibit heavy rust with minor section loss in the tidal zones. See Routine Underwater Inspection Report for more information.

**Photo 10:** Typical deterioration of the timber pile and diagonal bracing in the tidal zone.

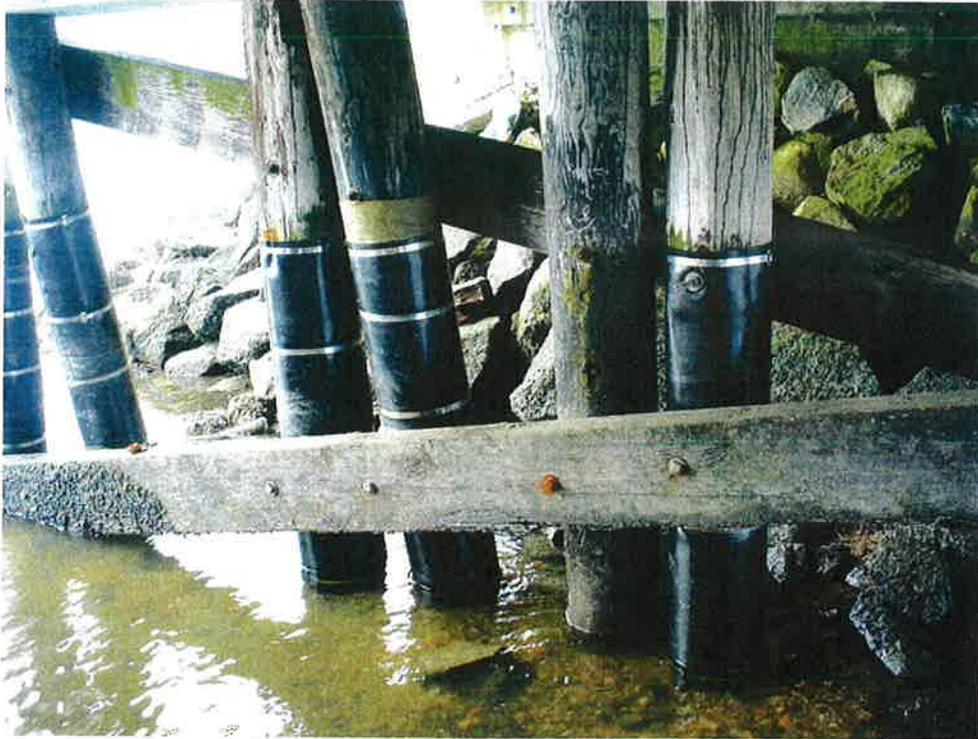
**Photo 11:** Protective sleeves placed around deteriorated piles in bent 1.

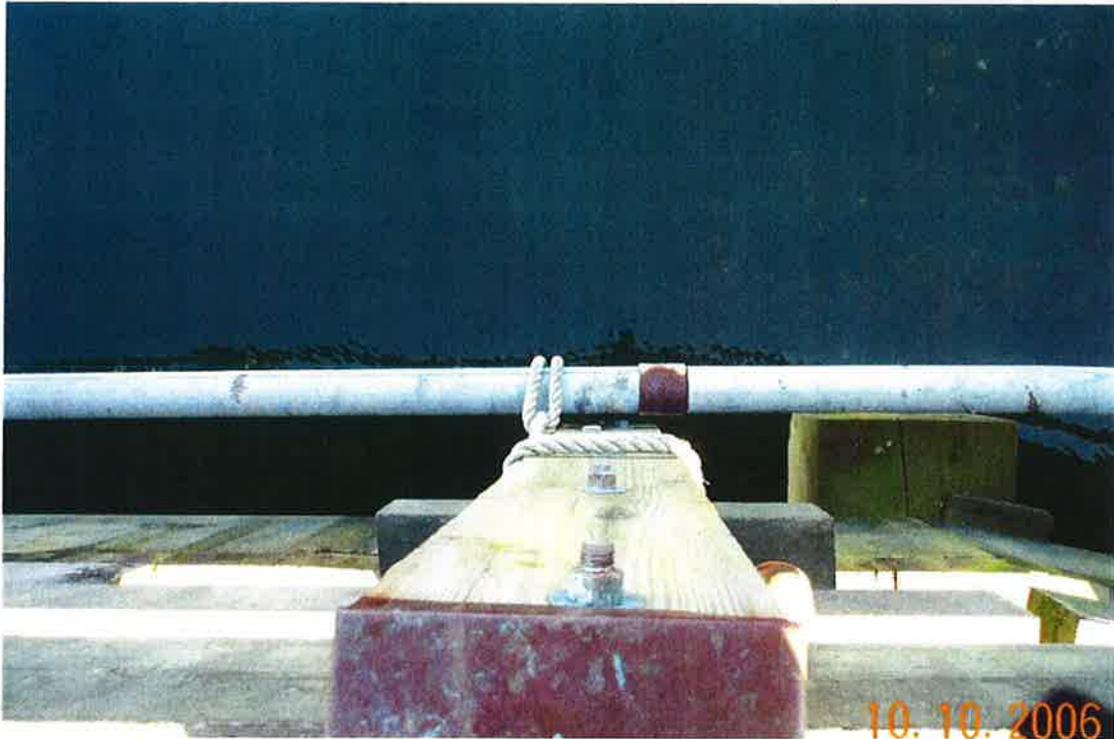
**Photo 7:** Temporary nylon rope support for the electrical conduit on the north side of the bridge at Bent 10, looking down.

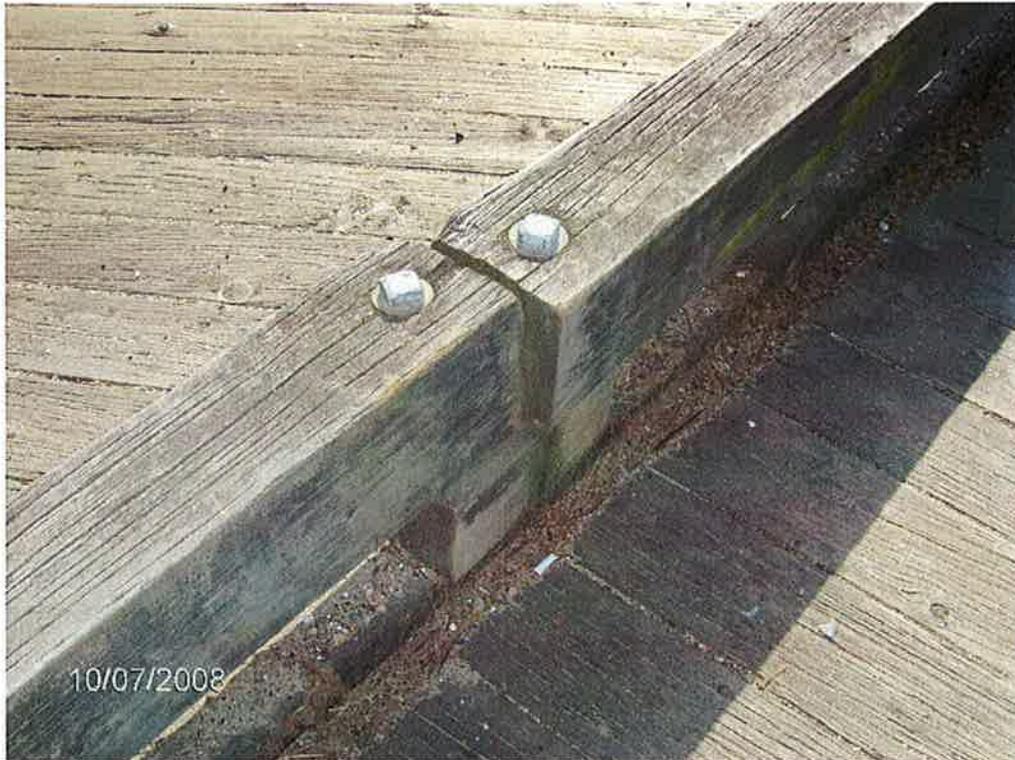
**Photo 3: 1 1/2" of misalignment of the north curb/traffic rail between spans 2 and 3.**

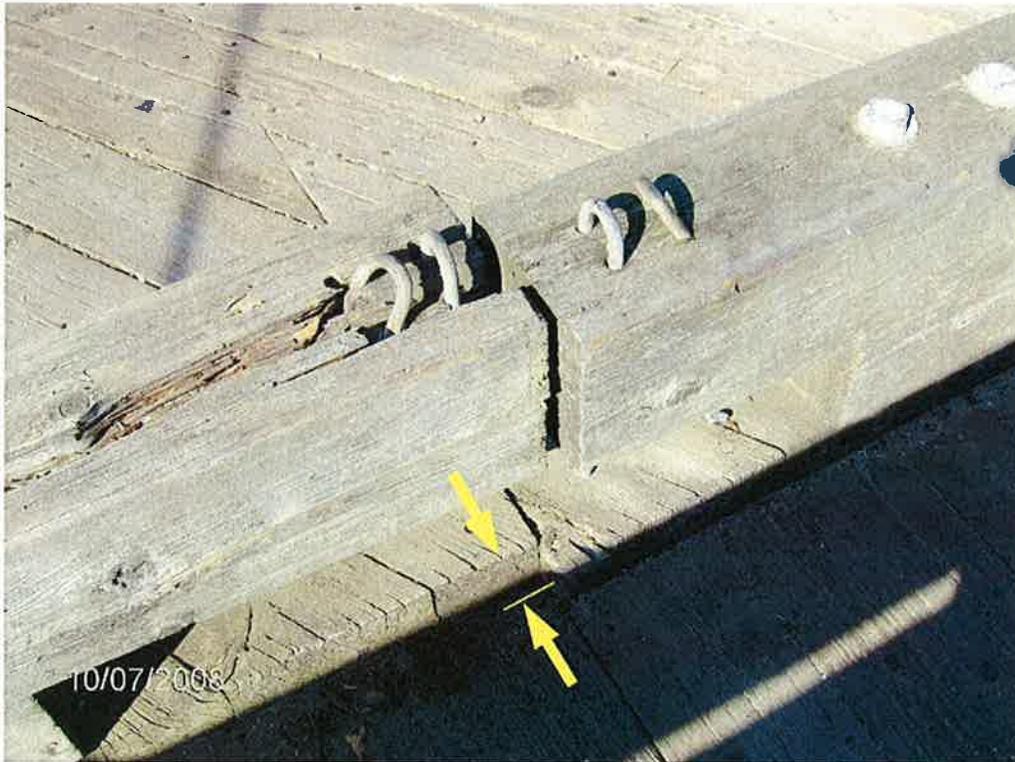
**Photo 5: 1 1/2" of misalignment of the bascule span toe towards the north.**

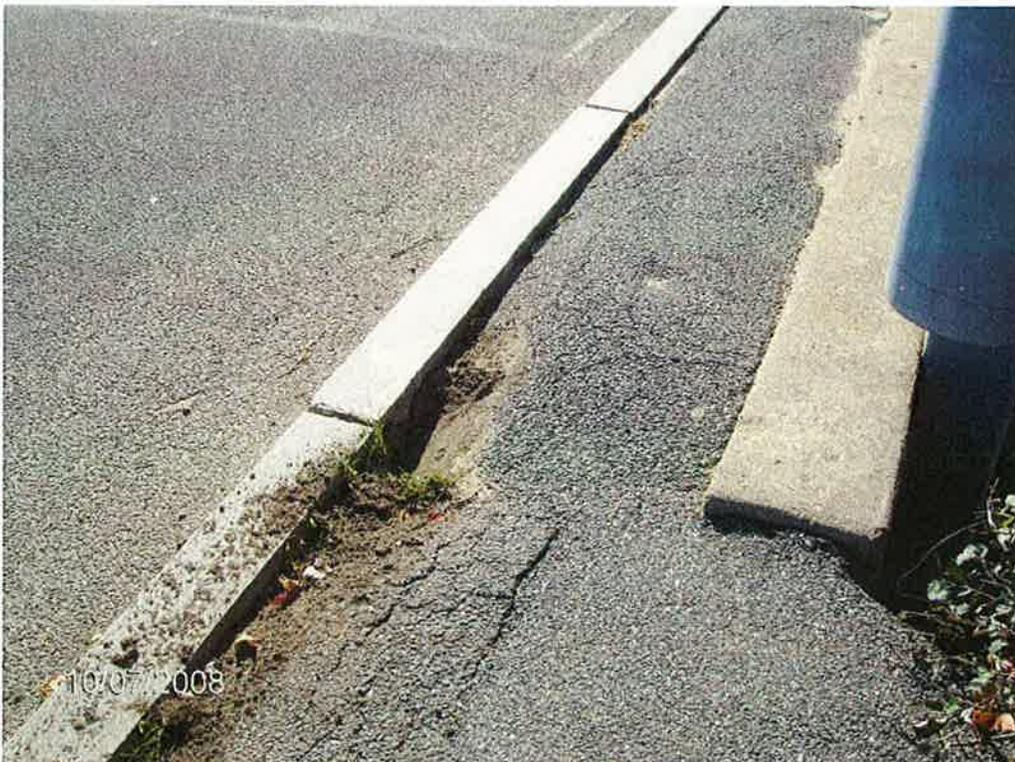
**Photo 6: 4" deep settlement of the northeast approach sidewalk.**

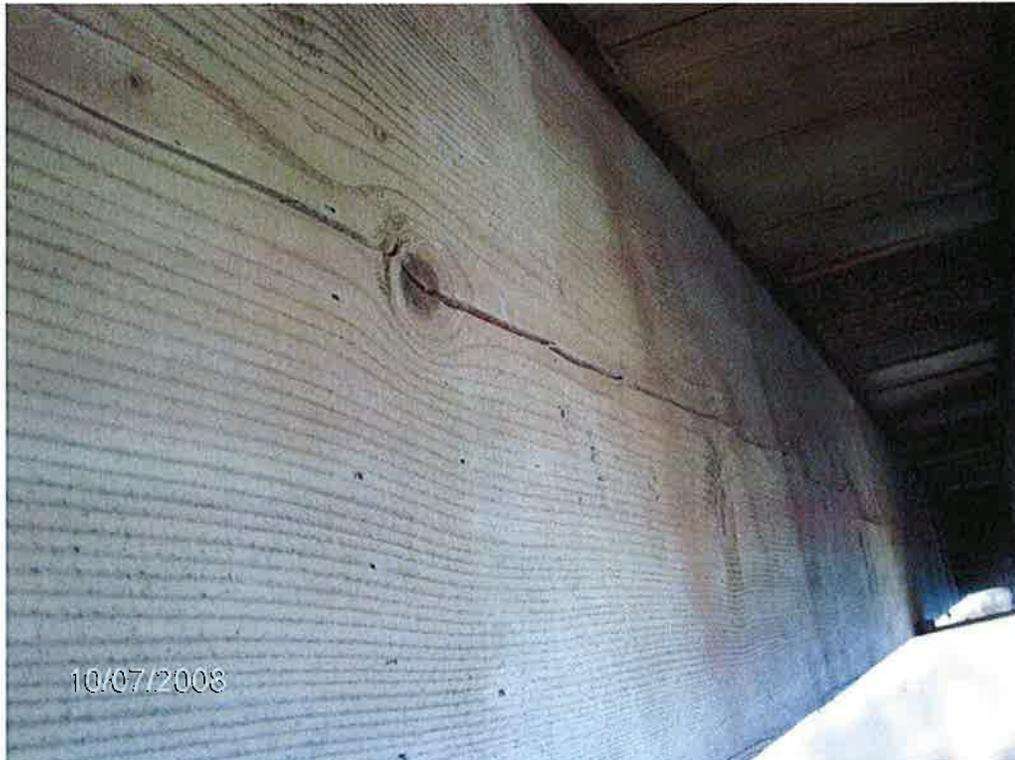
Photo 7: 1/8" wide check in timber stringer S2 of span 10.

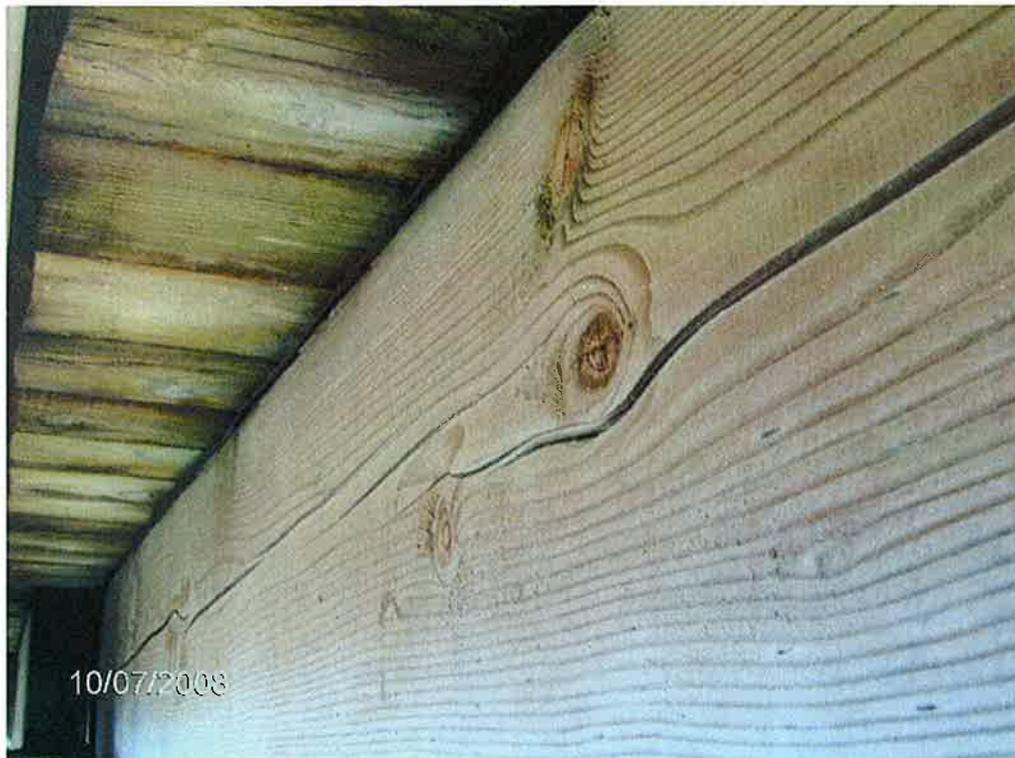
Photo 8: Up to 5/16" checks in timber stringer S9 of span 8.

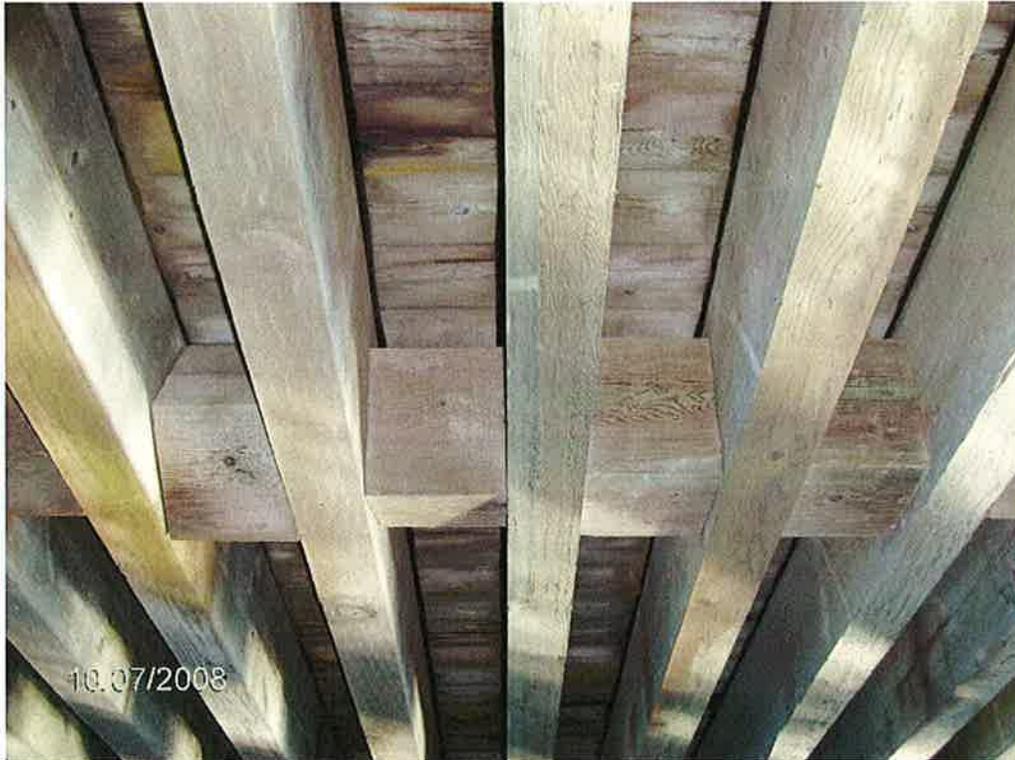
**Photo 11: Loose and rotated spacer blocks in span 3.**

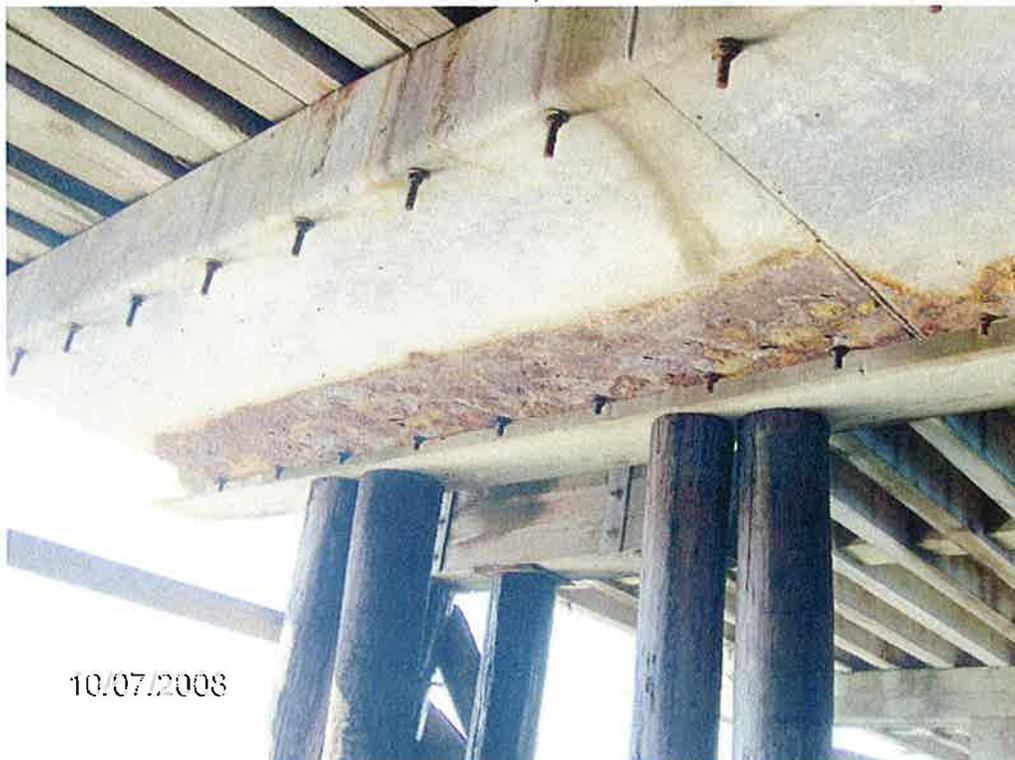
**Photo 12: Failed galvanized coating on the underside of the counterweight steel shell.**

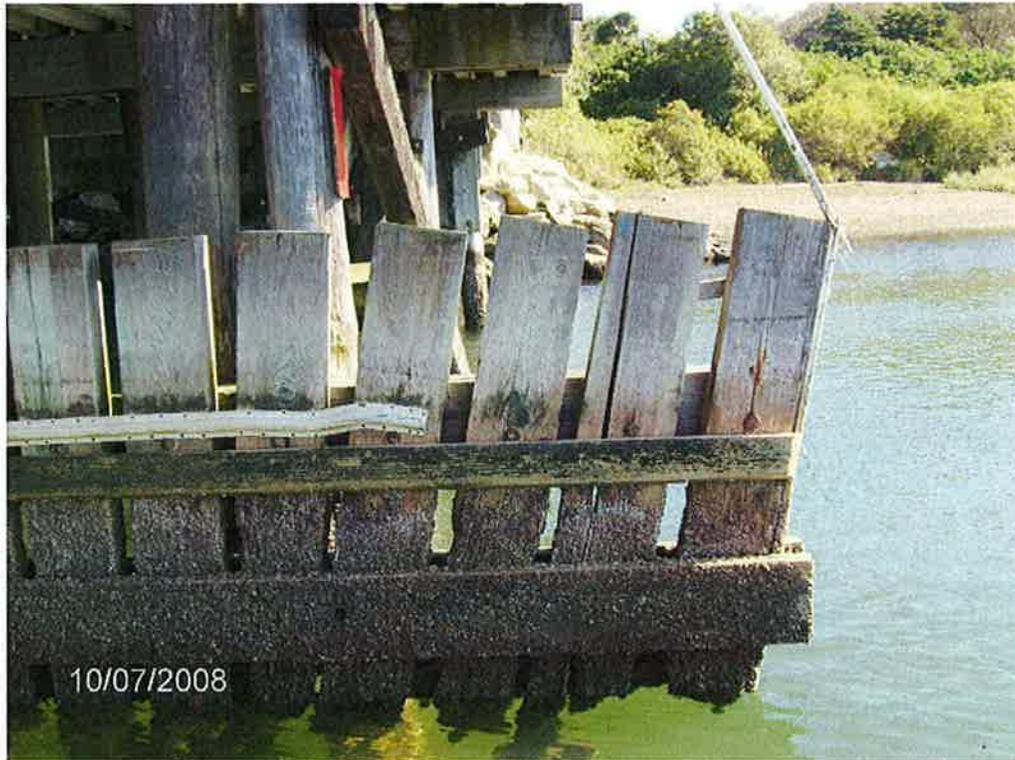
**Photo 17: Collision damage and heavy deterioration to south end of the bent 8 fender.**

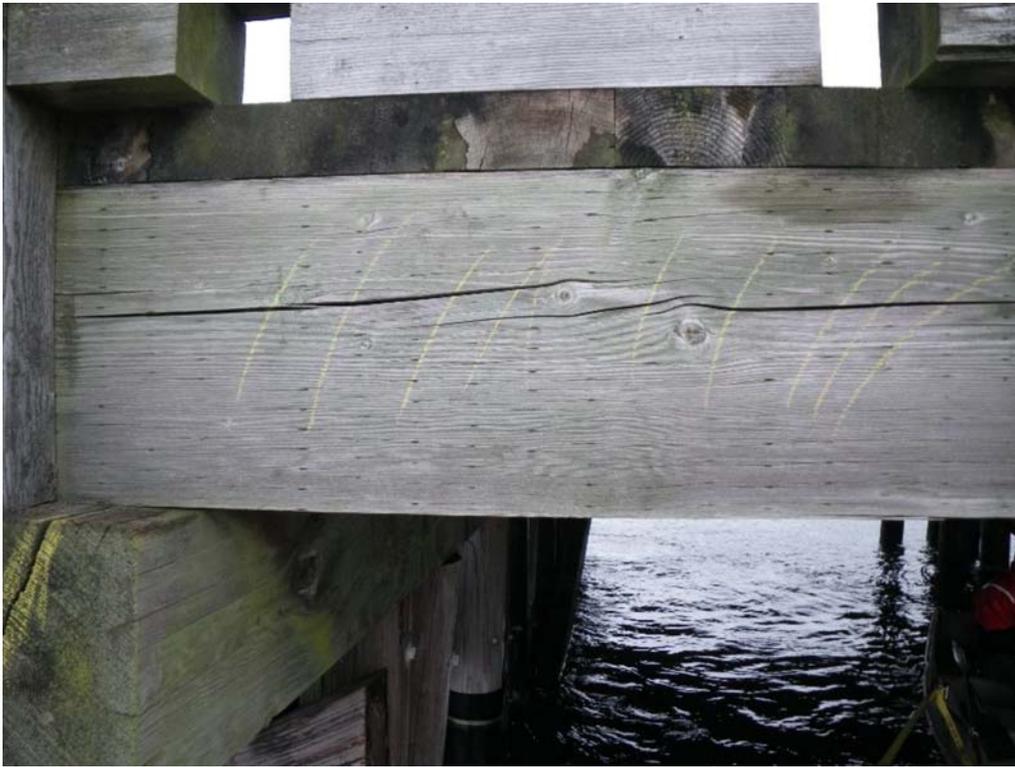
**Photo 7: Up to 5/16" checks in timber south fascia stringer in span 4.**

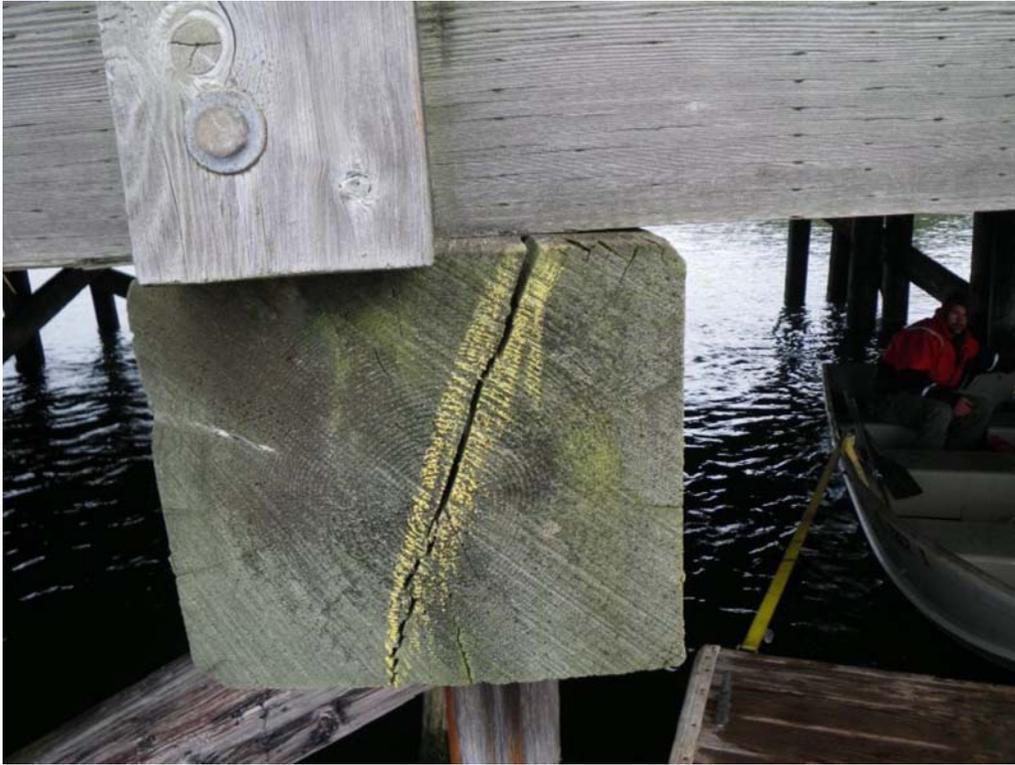
**Photo 15: Full height diagonal split at south end of bent 3 pile cap.**

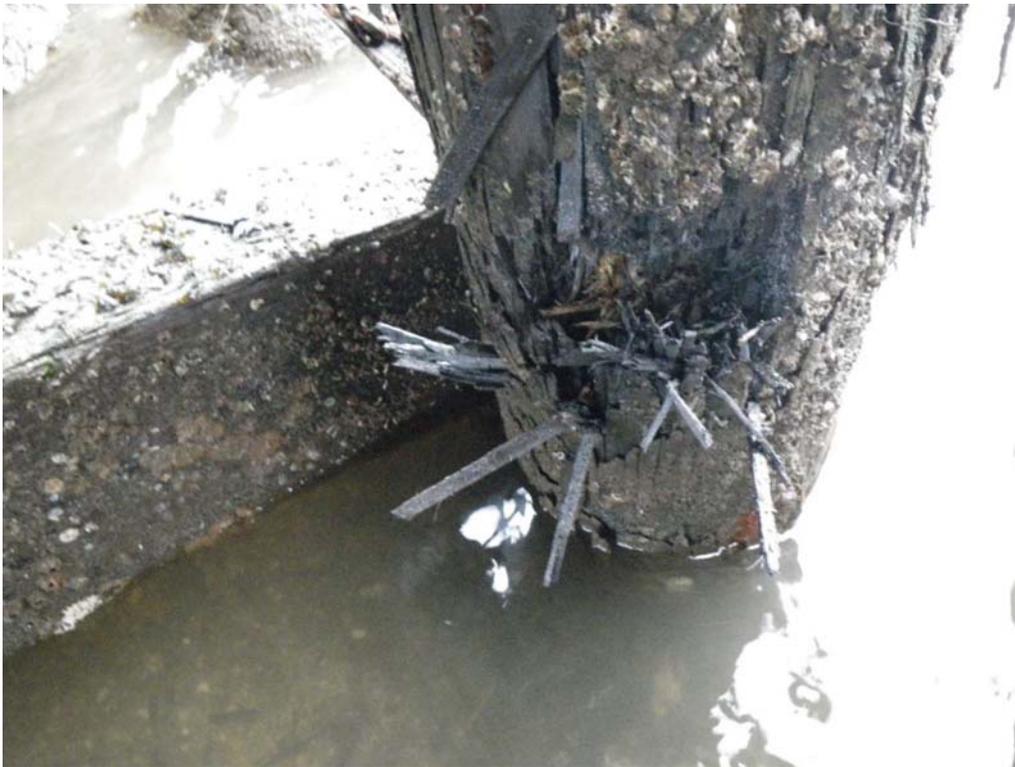
**Photo 16: Heavy brooming and advanced section loss to the northernmost pile at bent 1.**

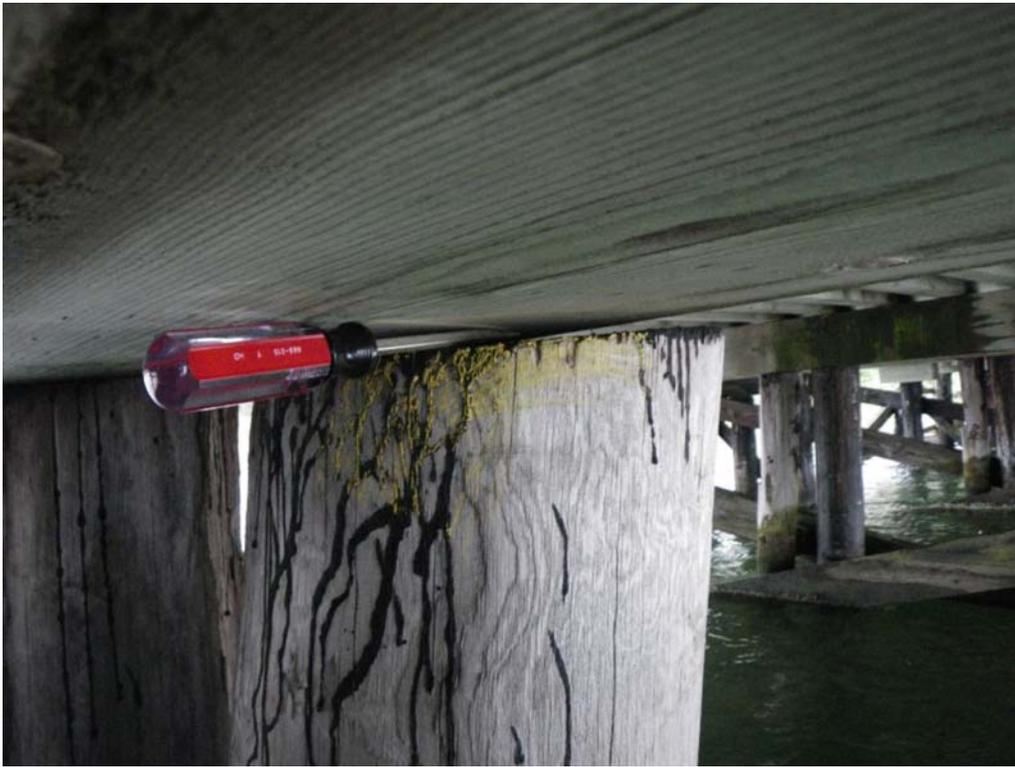
**Photo 17: 3/4" gap between top of 5th pile from south and pile cap at bent 2.**
