***Subject: Chatham, MA – Mitchell River Bridge Project  
Bridge Repair/Rehabilitation Feasibility Study***

**BRIDGE REPAIR/REHABILITATION FEASIBILITY**  
**STUDY**

**BRIDGE STREET**

**BRIDGE NO. C-07-001 (437)**

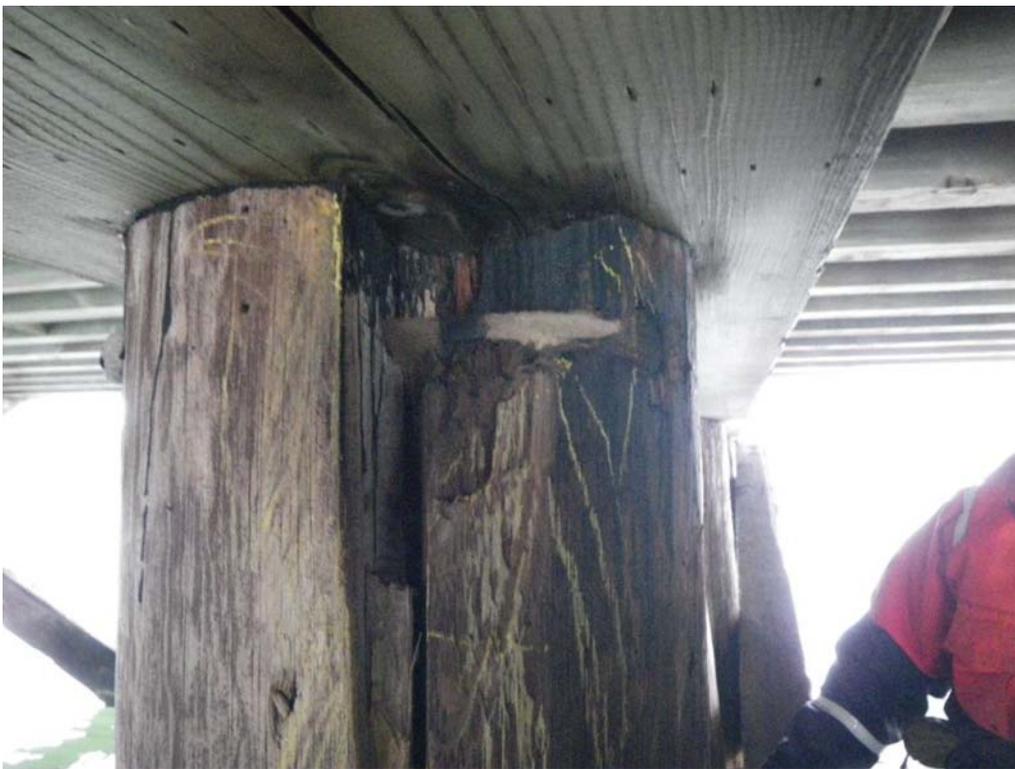
**Photo 18: Section loss and full depth vertical split at 6th pile from south end of bent 2.**

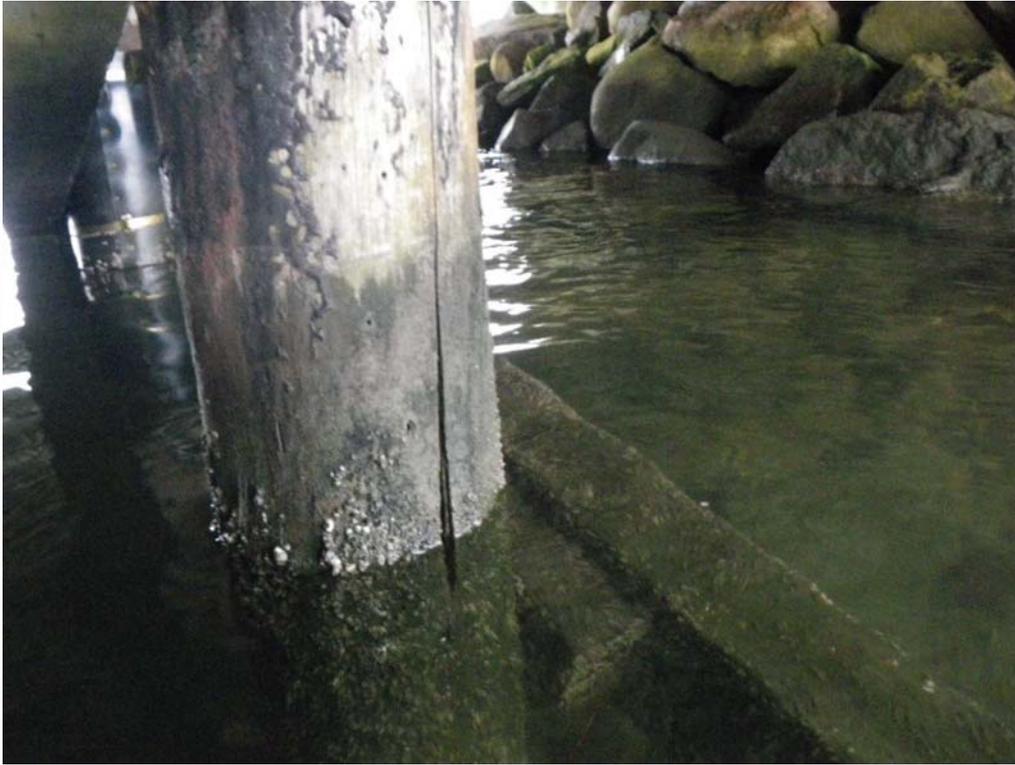
**Photo 19: Full depth by full height split on third pile from south end of bent 1.**

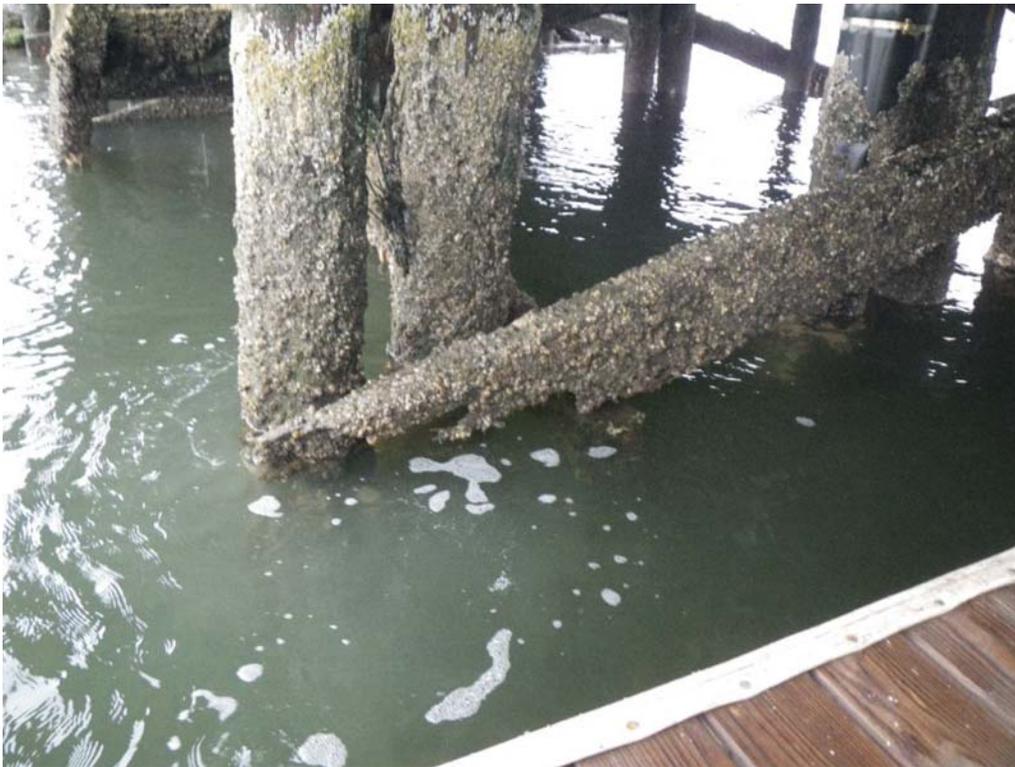
**Photo 20: 100% loss to diagonal bracing at south end of bent 3.**

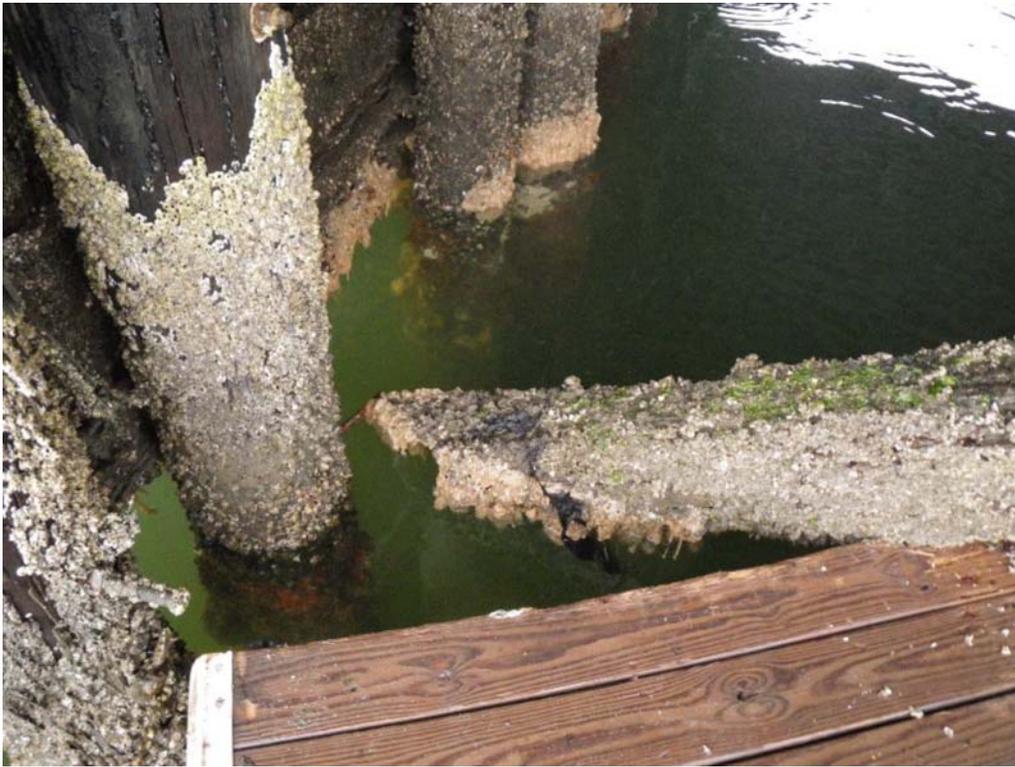
**Photo 21: 100% loss to horizontal bracing between bents 8 and 9 at the south end of bent 8.**

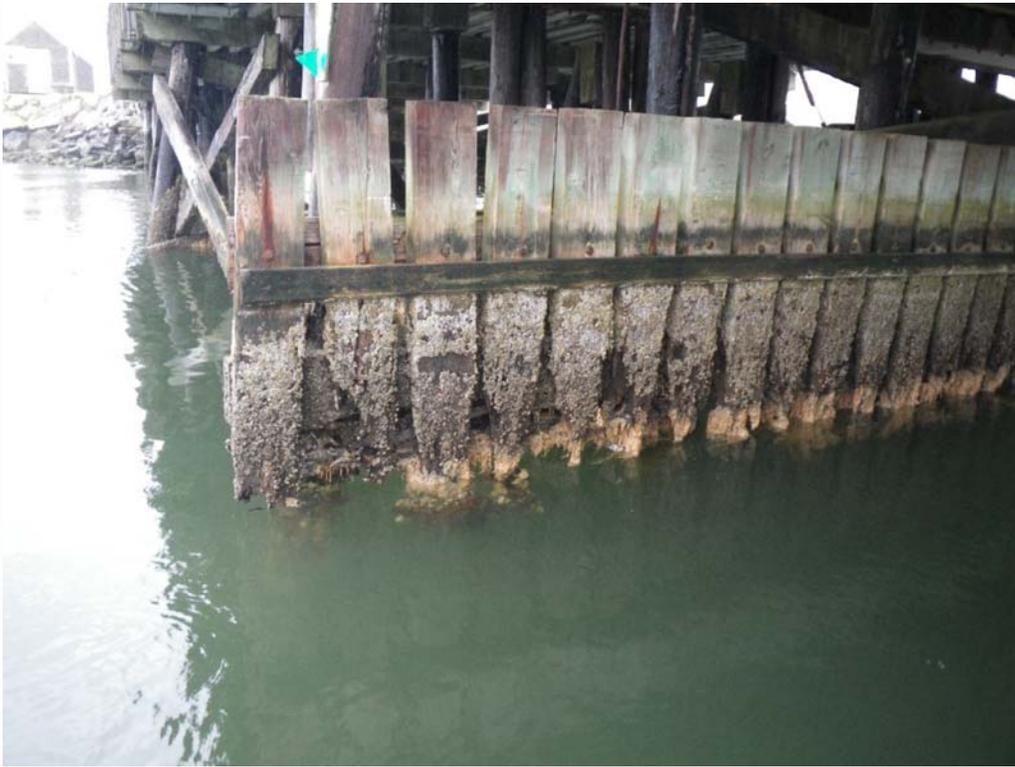
**Photo 23:** Heavy marine growth with up to 100% section loss to vertical bracing members at bent 7a fender.

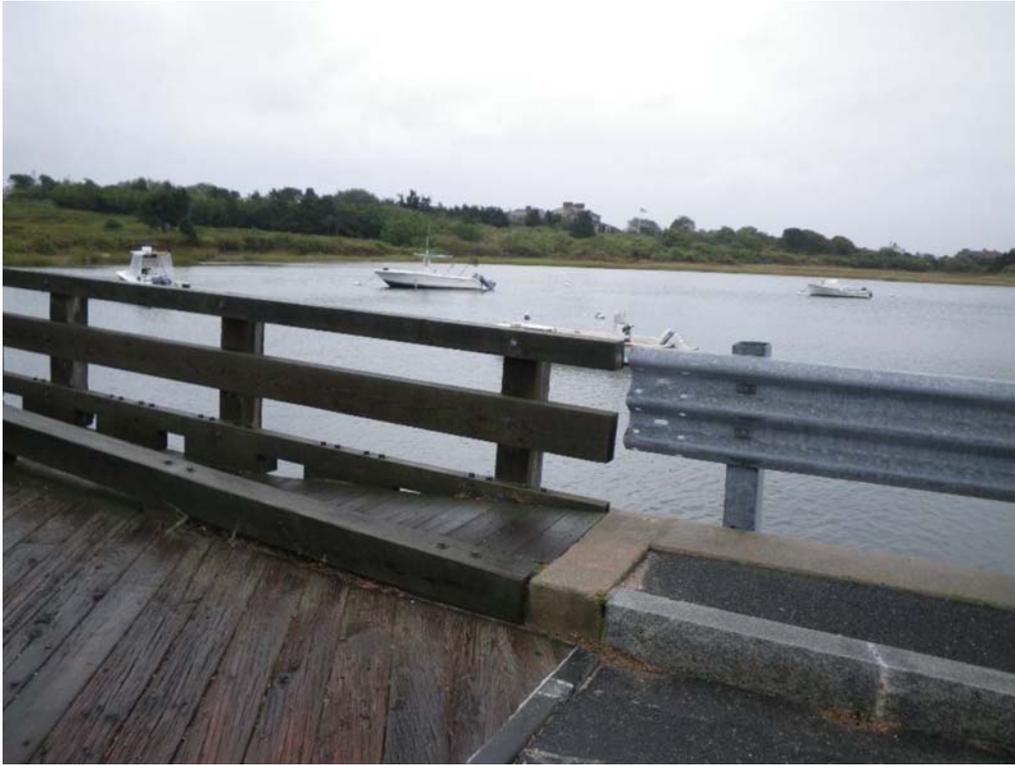
**Photo 25: Lack of transition between bridge rail and approach rail at southwest corner of bridge.**

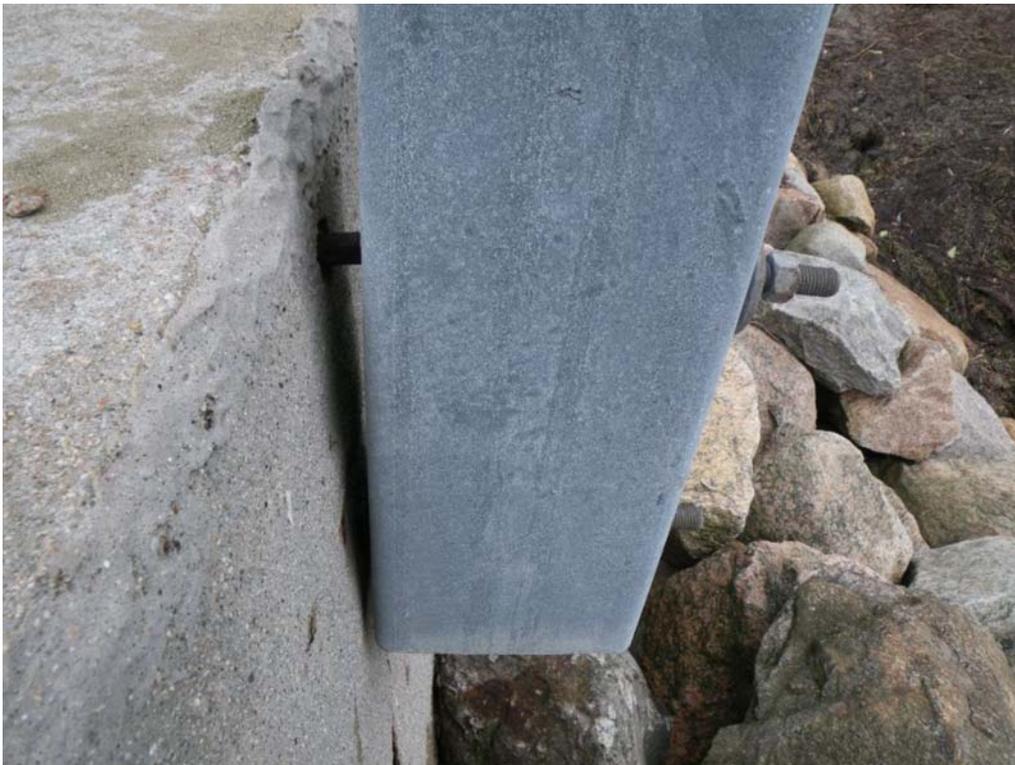
**Photo 26: 1 1/2" gap between the southeast approach guardrail posts and the face of the wingwall.**

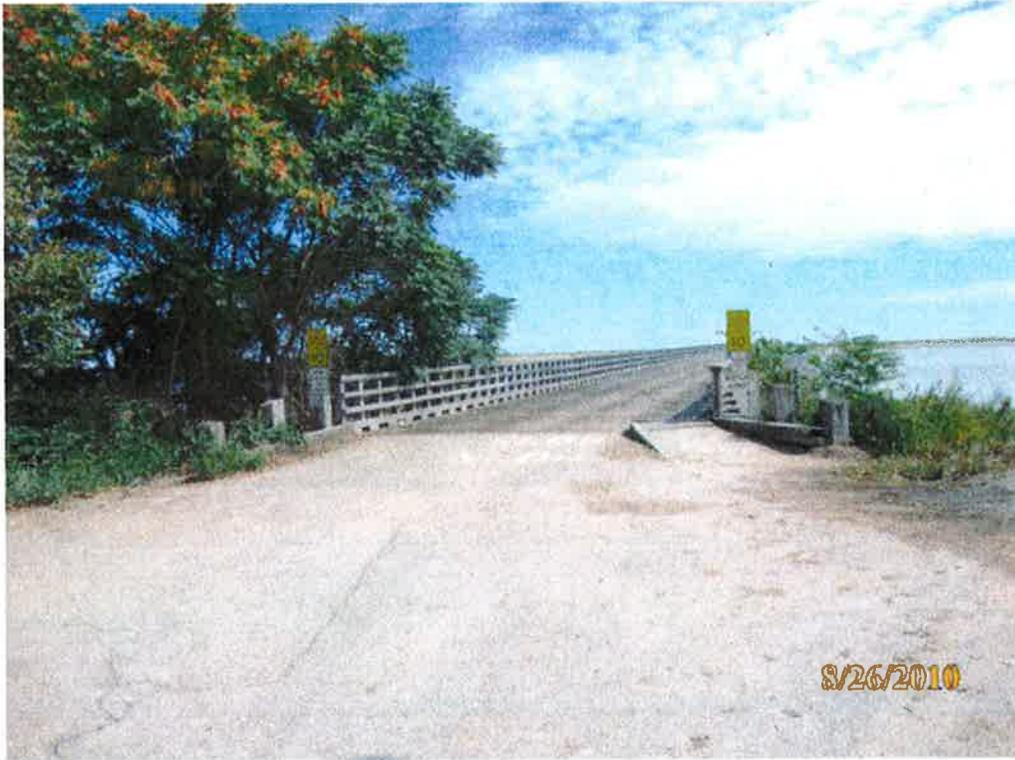
**Photo 1:** West approach roadway showing cracking and depressions to the pavement and low visibility load posting sign.

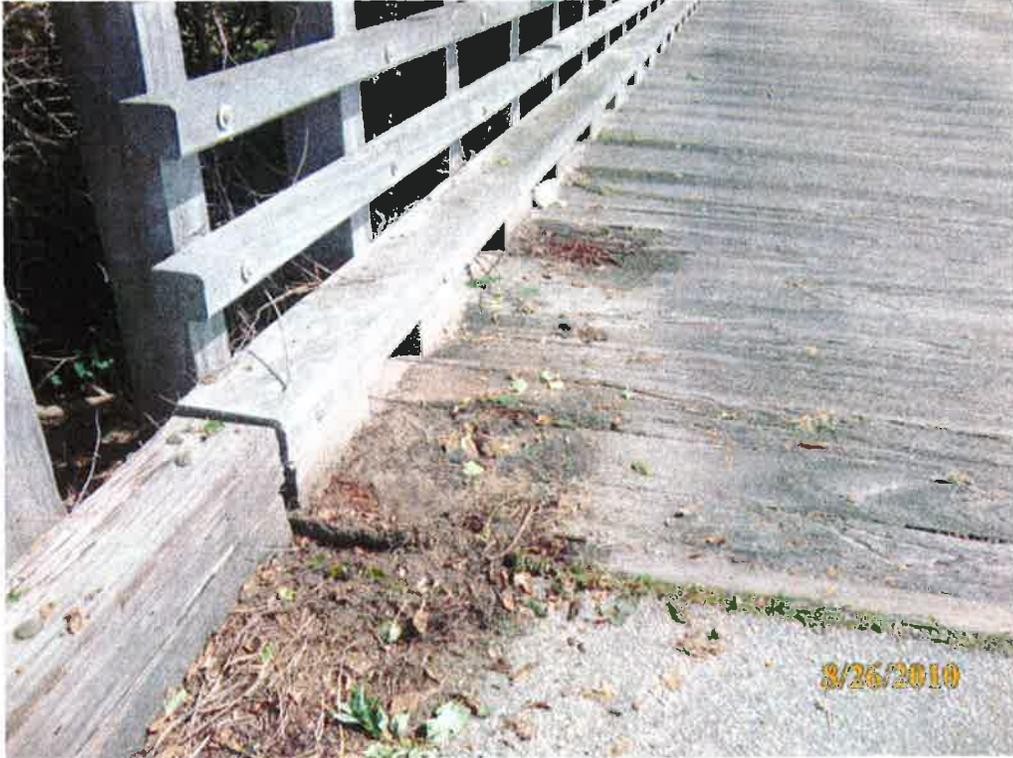
**Photo 5:** Northwest corner of Span #1 showing areas of splitting and rotting deck planks with debris in the voids and at the curb.

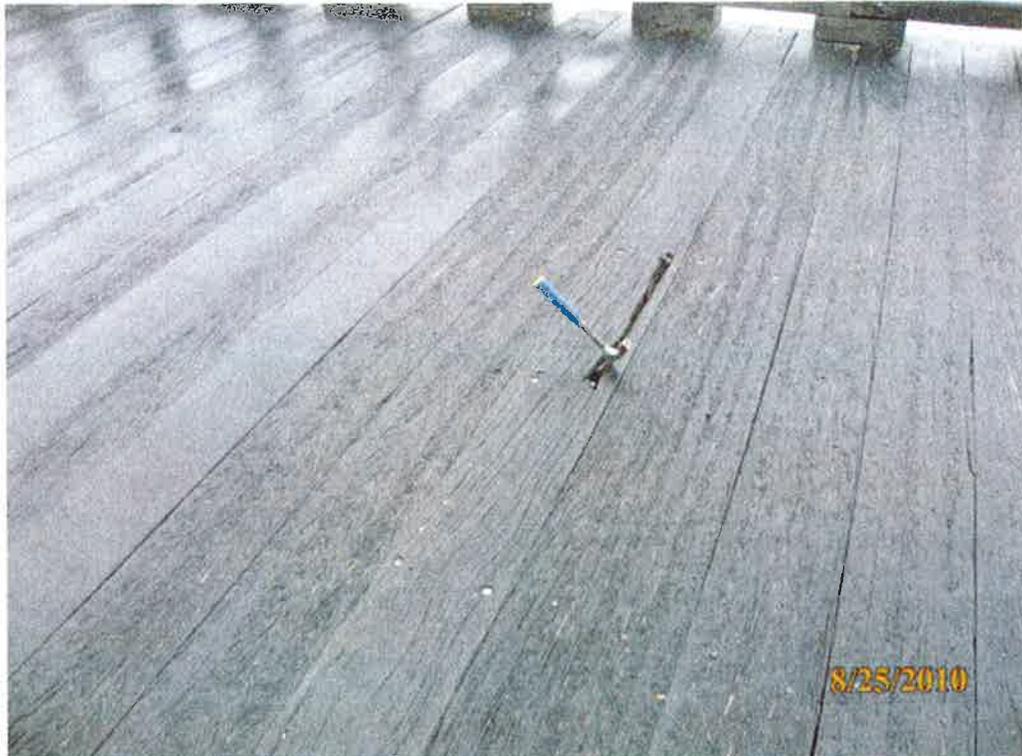
**Photo 6:** Deck in Span #20, showing 6.0' long section of rotted and split plank.

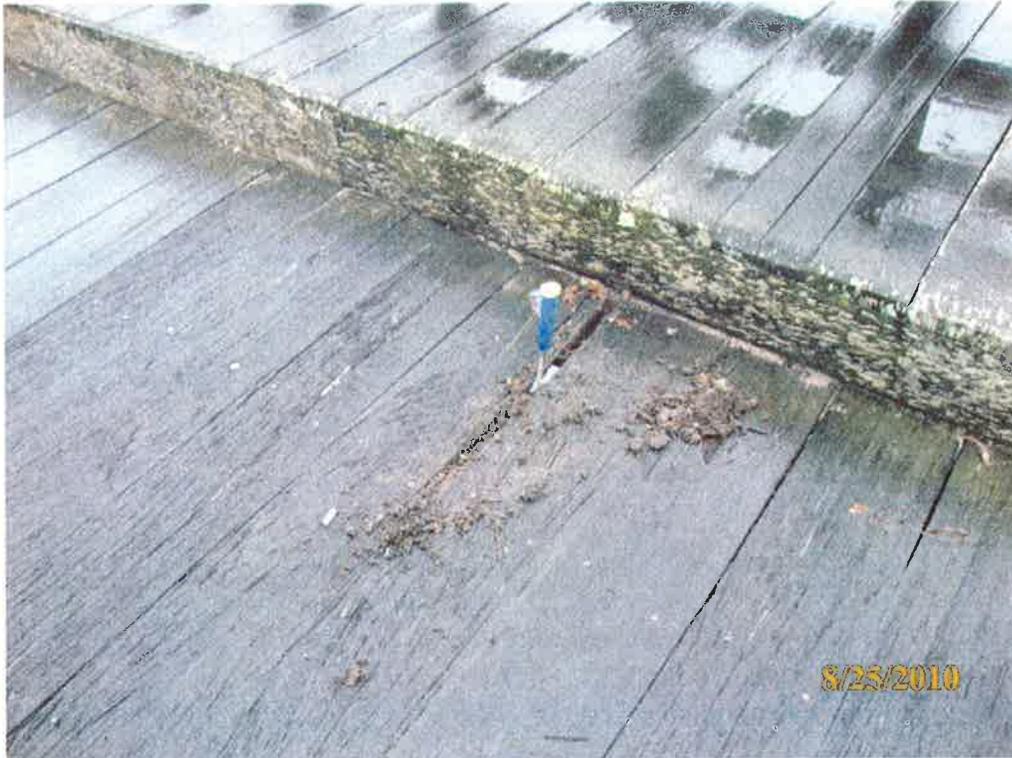
**Photo 7: Deck in Span #23, near Bent #24 at the South curb, showing 2.5' long split and rotted plank.**

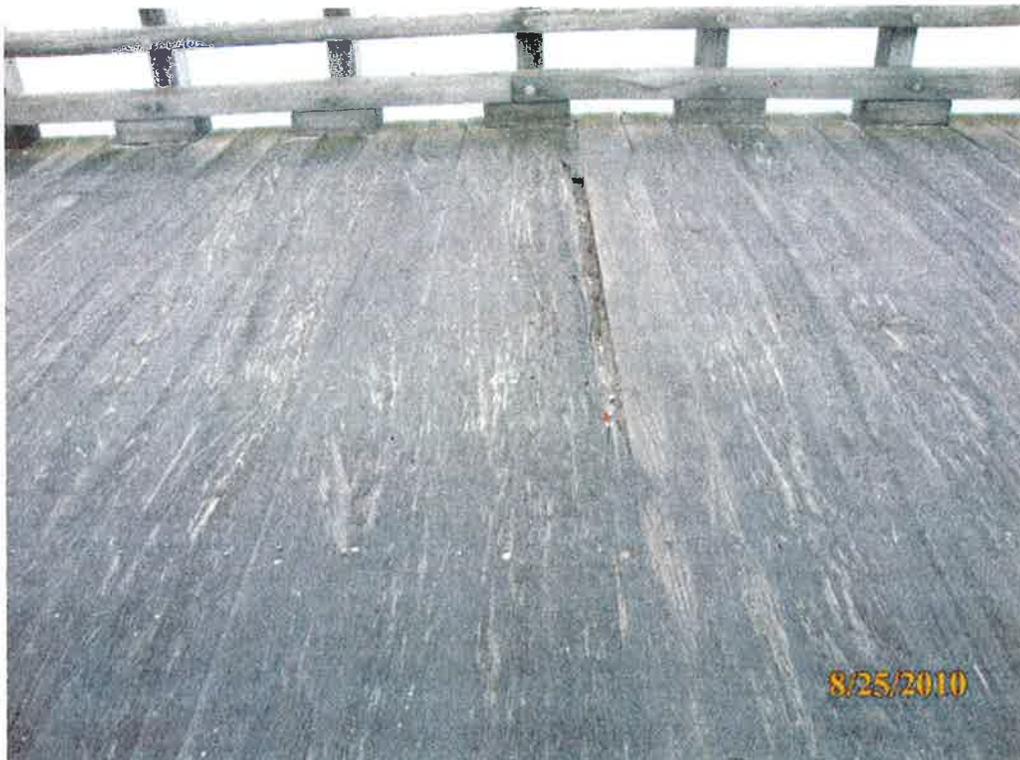
**Photo 8: Deck in Span #45 at Bent #46, showing rotted and split plank at the North portion.**

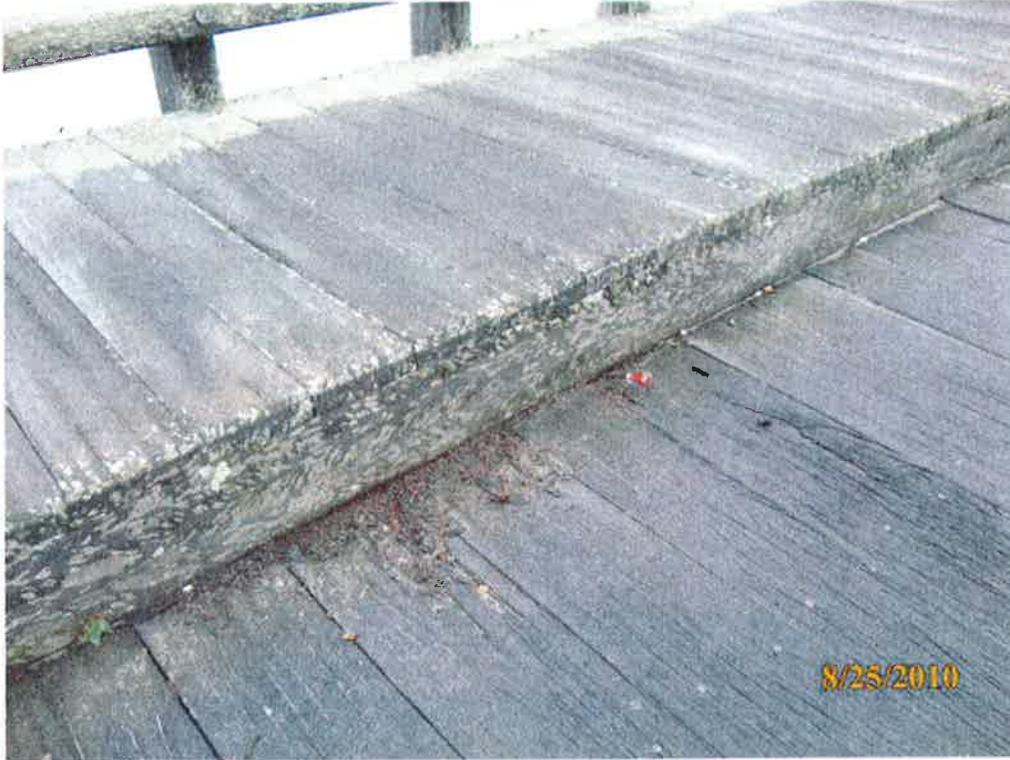
**Photo 9:** Deck in Span #50, showing rotting planks below the curb and lichen growth on sidewalk, curb and bridge rail.

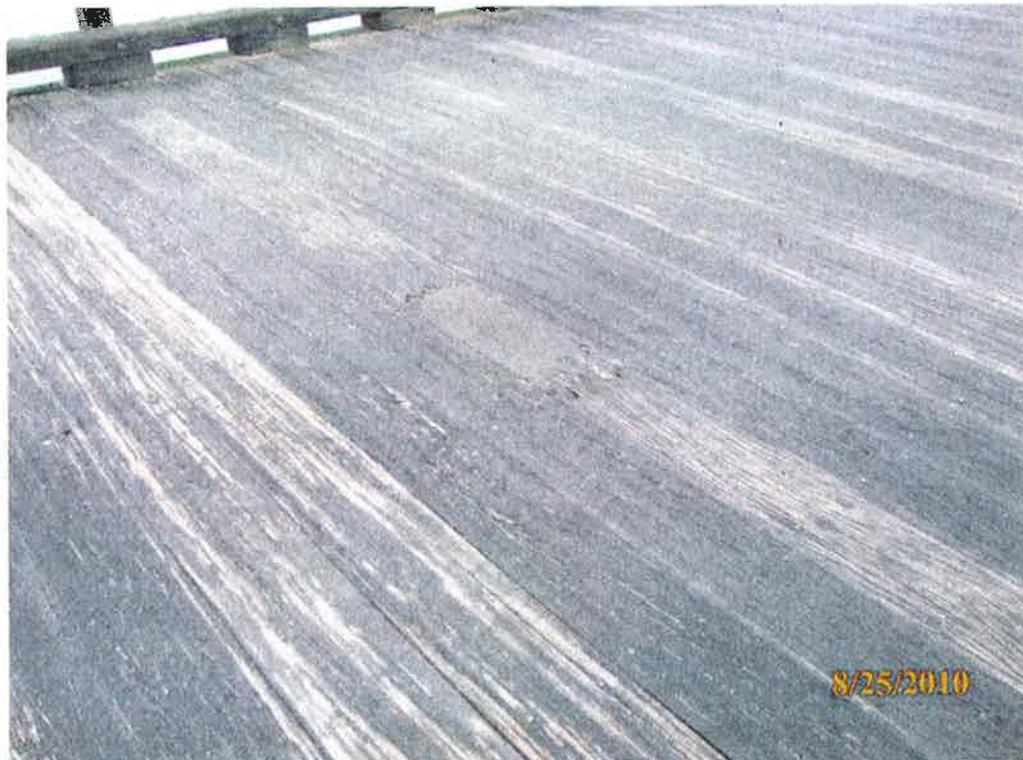
**Photo 10:** Deck planking at the center of Span #66, showing asphalt patch.

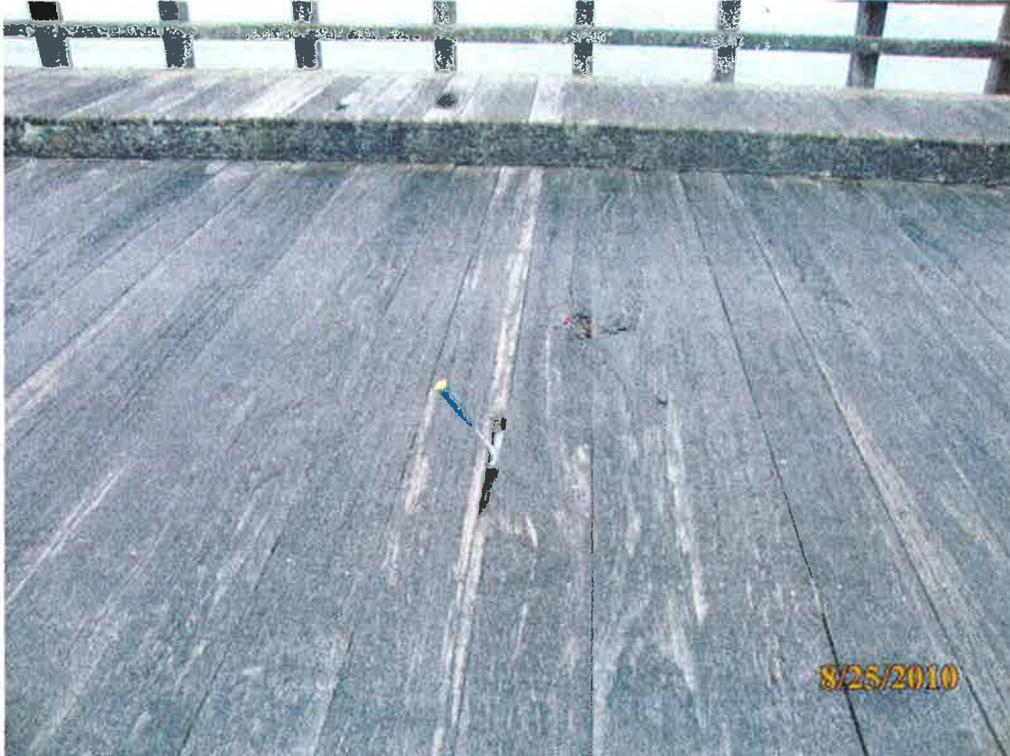
**Photo 11: Deck in Span #80, showing deterioration of the timber planks.**

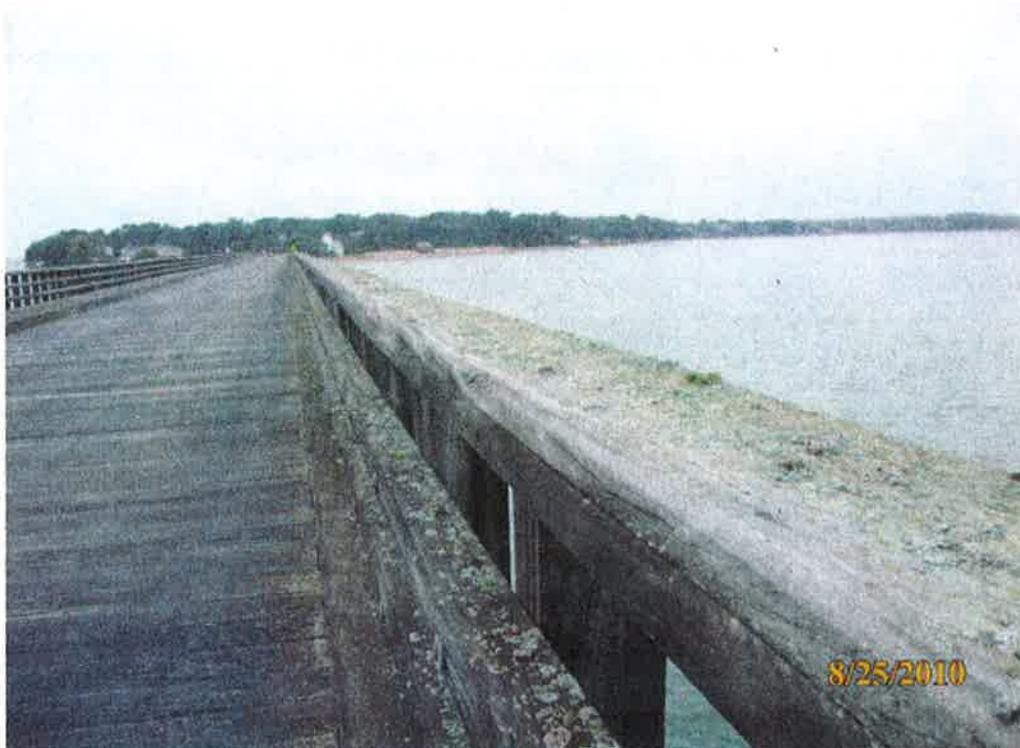
**Photo 12: Typical condition of the timber bridge rails (North rail shown near center) showing checks and lichen.**

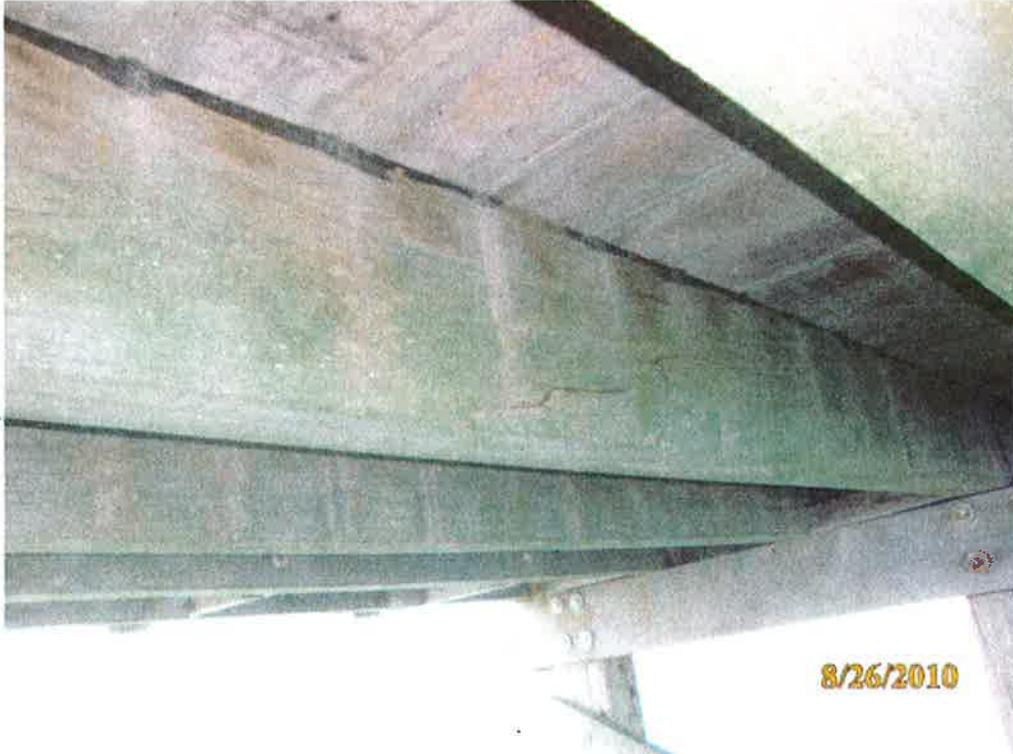
**Photo 15:** Beam #4 in Span #96 showing a diagonal split on the South face extending to the bottom face.

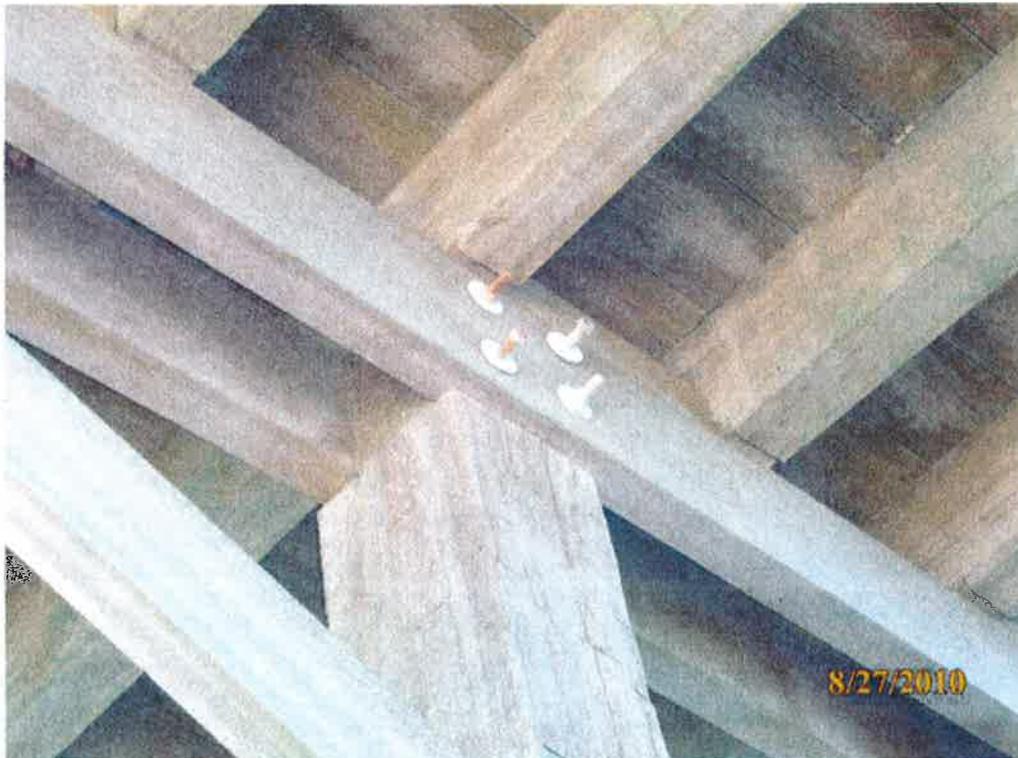
**Photo 16:** Pier bent cap above Pile "B", showing backed off connection nuts.

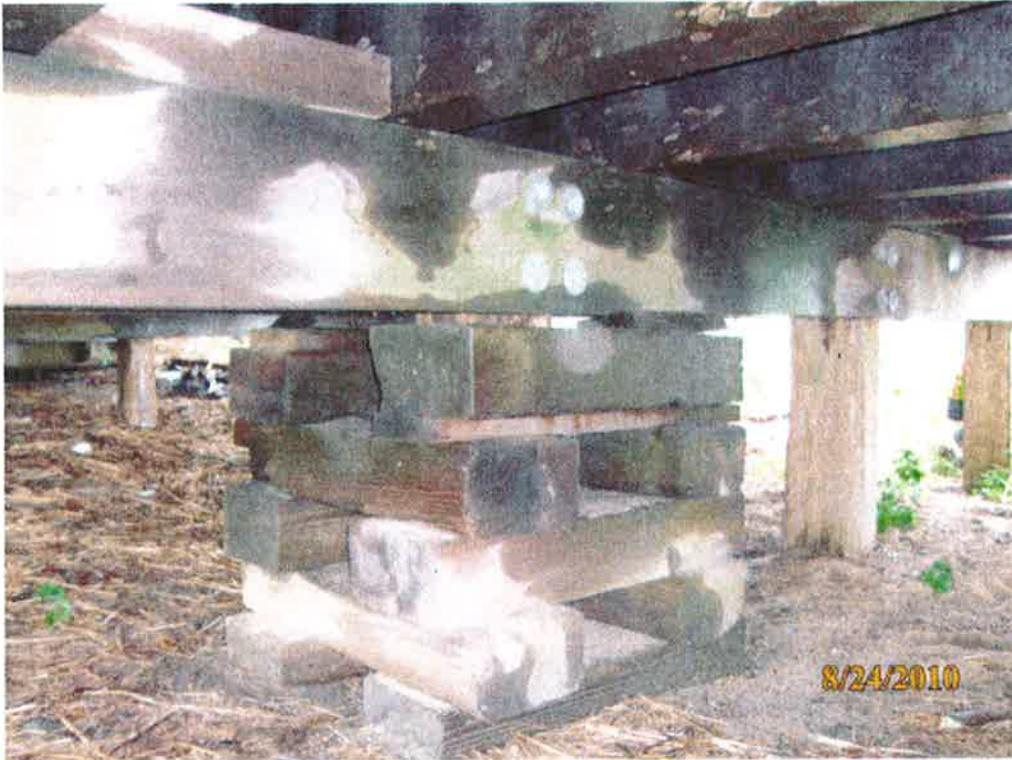
**Photo 21:** Bent #3, Pile "C", showing deterioration and gaps (not seated properly) at the top of the timber shoring.

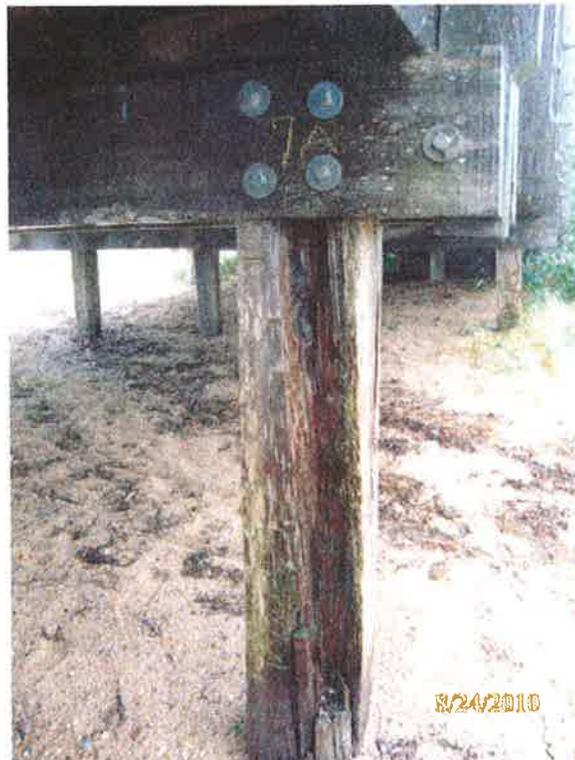
**Photo 22:** Bent #7, Pile "A", showing deterioration at the Northeast corner up to 7" deep.

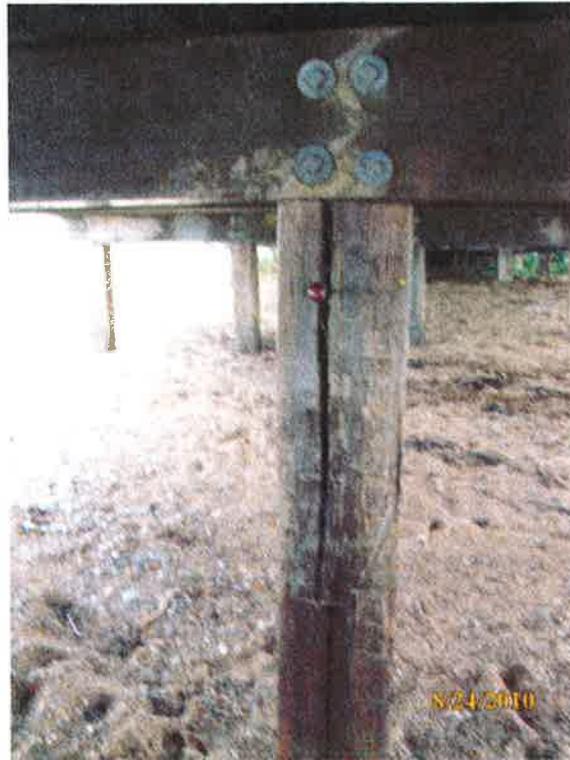
**Photo 23: Bent #7, Pile "C", showing a wide split at the top of the East face.**

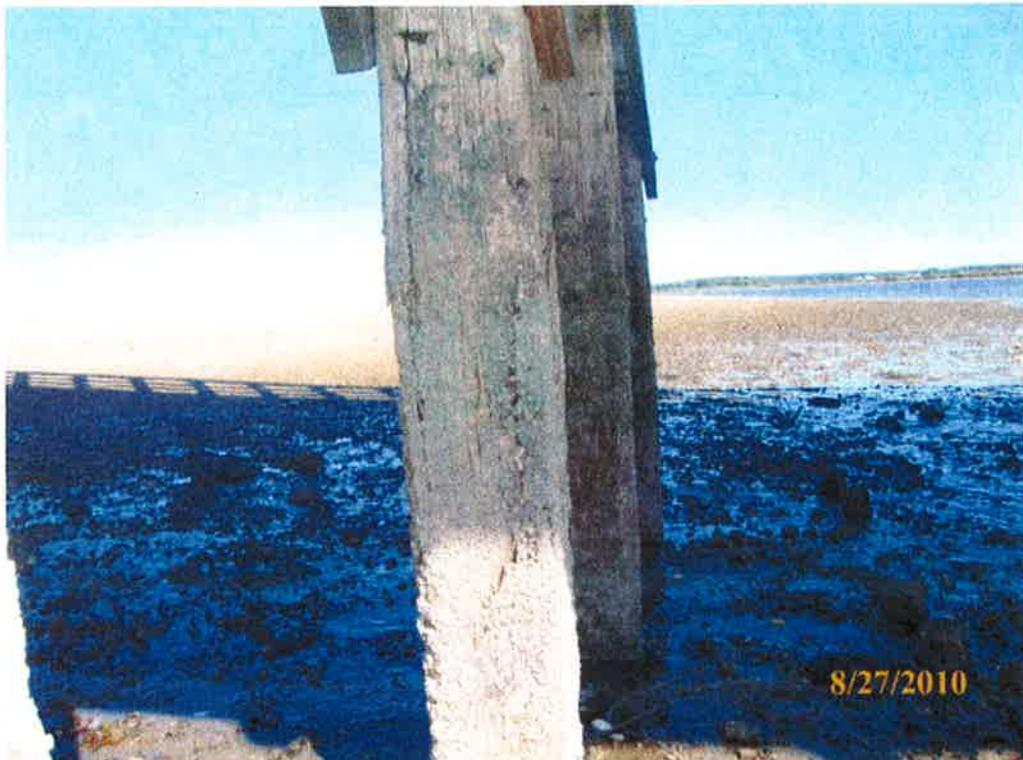
Photo 26: Bent #14, Pile "C", showing marine growth, brooming and ring checks.

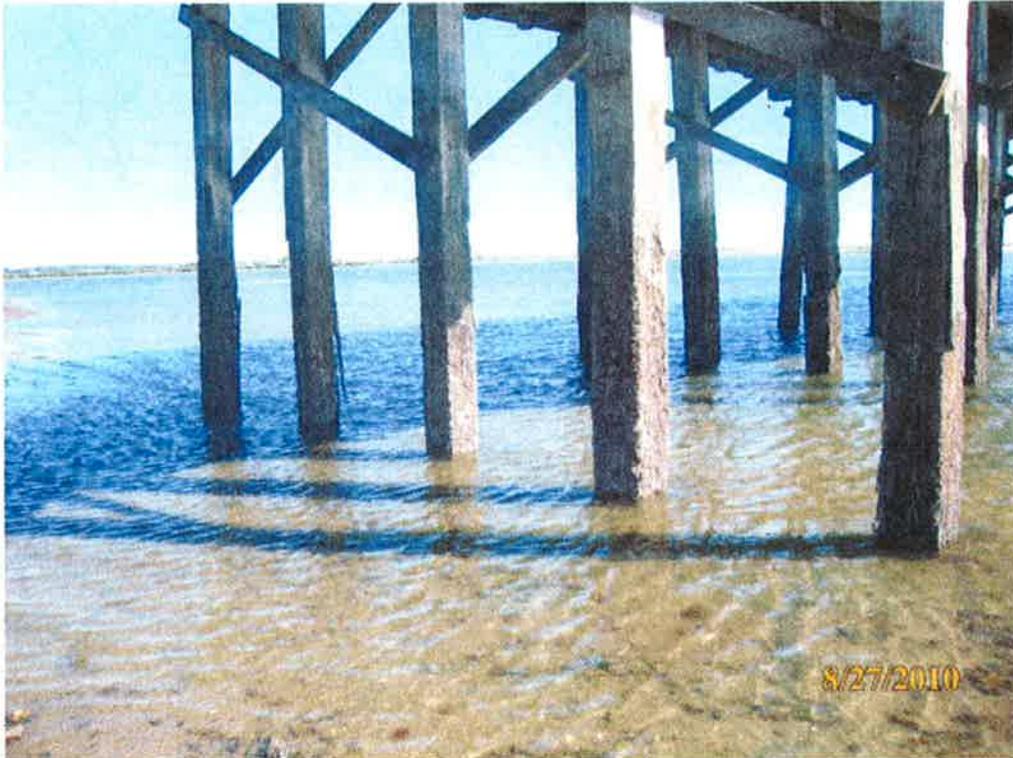
**Photo 27: Bent #15, Piles "A" to "E", showing deterioration, especially at Piles "A" and "B".**

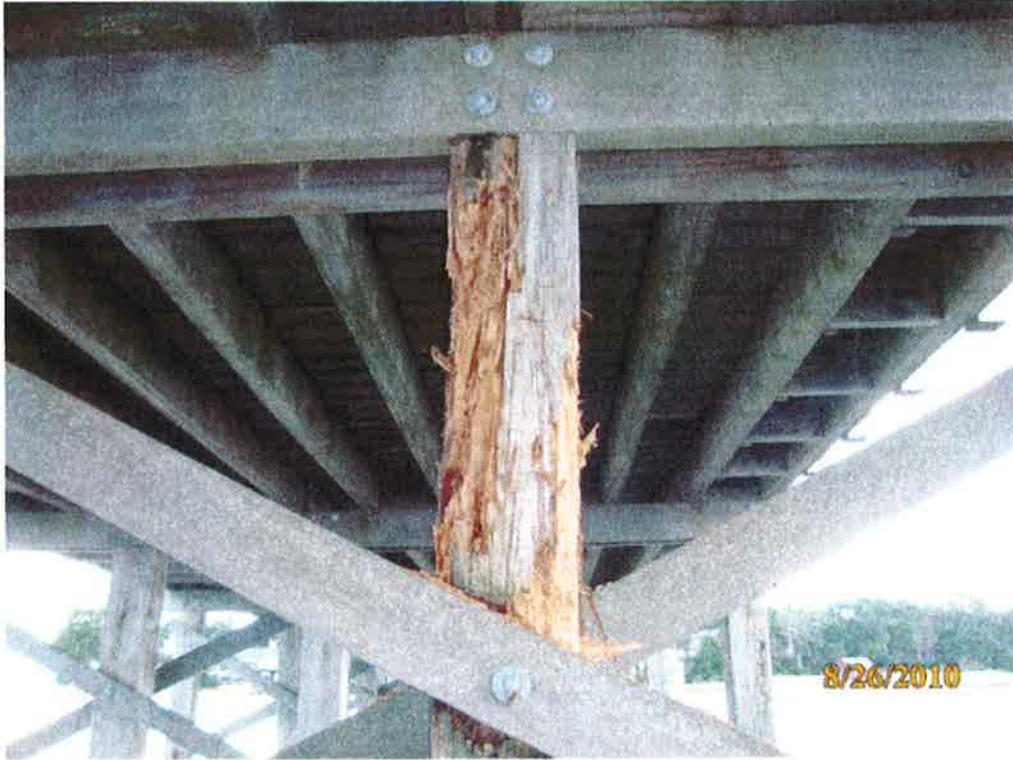
**Photo 31: Bent #25, Pile "B", showing dry rot at the top of the South face up to 3" deep and brown rot at the brace.**

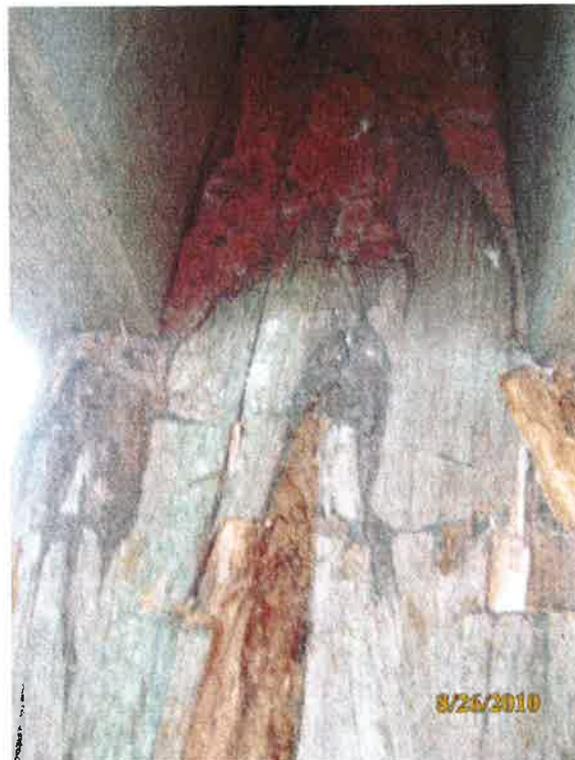
**Photo 32: Bent #26, Pile "A", showing brown rot and checking at the top of the West face.**

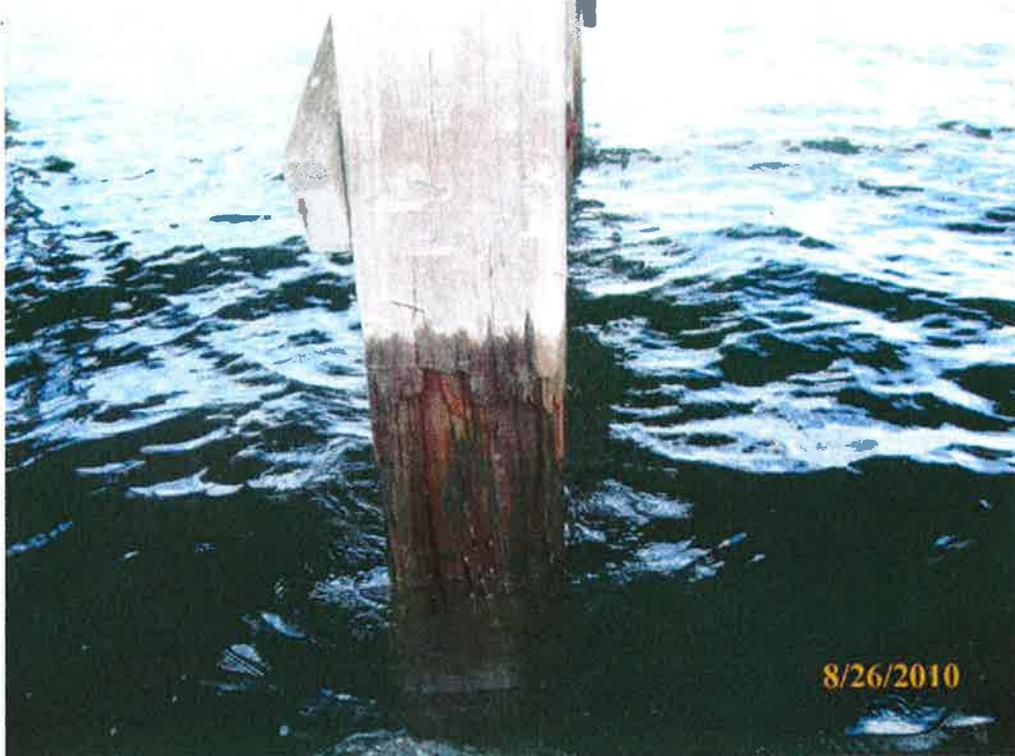
**Photo 33: Bent #27, Pile "A", showing delamination up to 7" in tidal zone (approximately 50% loss).**

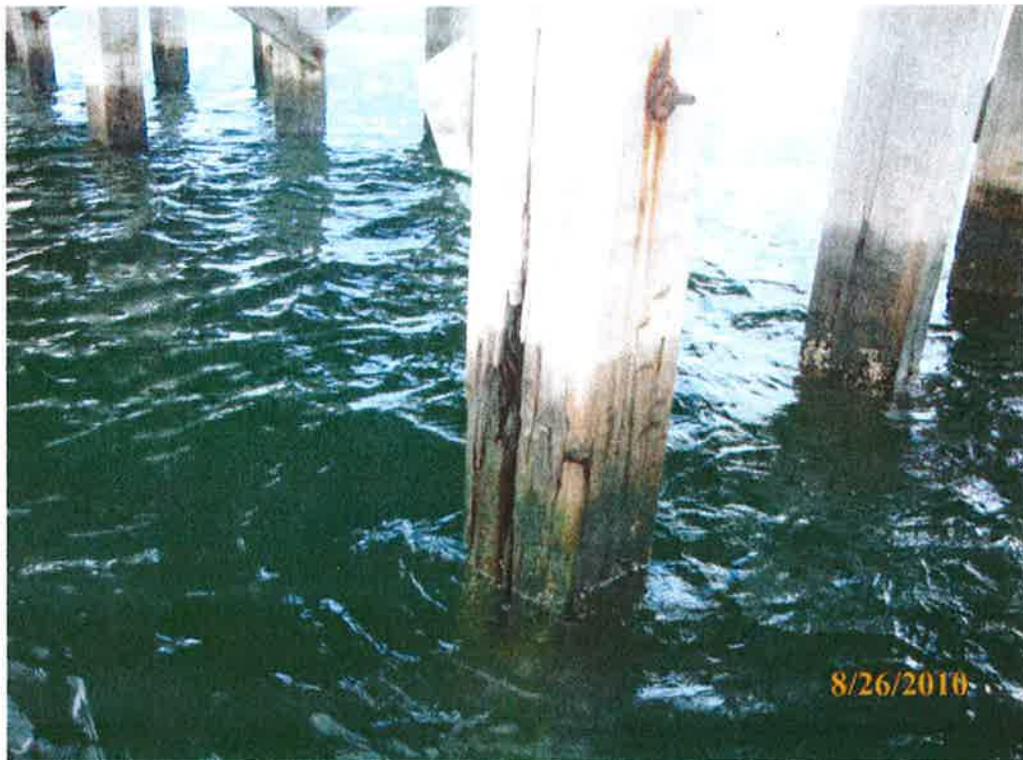
**Photo 34: Bent #29, Pile "A", showing a wide split to the North face.**

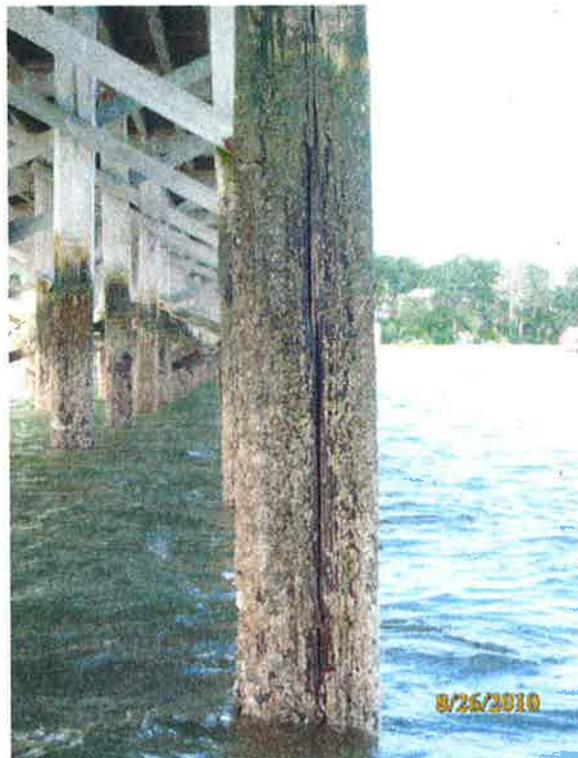
**Photo 36: Bent #39, Pile "A", showing brooming and checking in the tidal zone.**

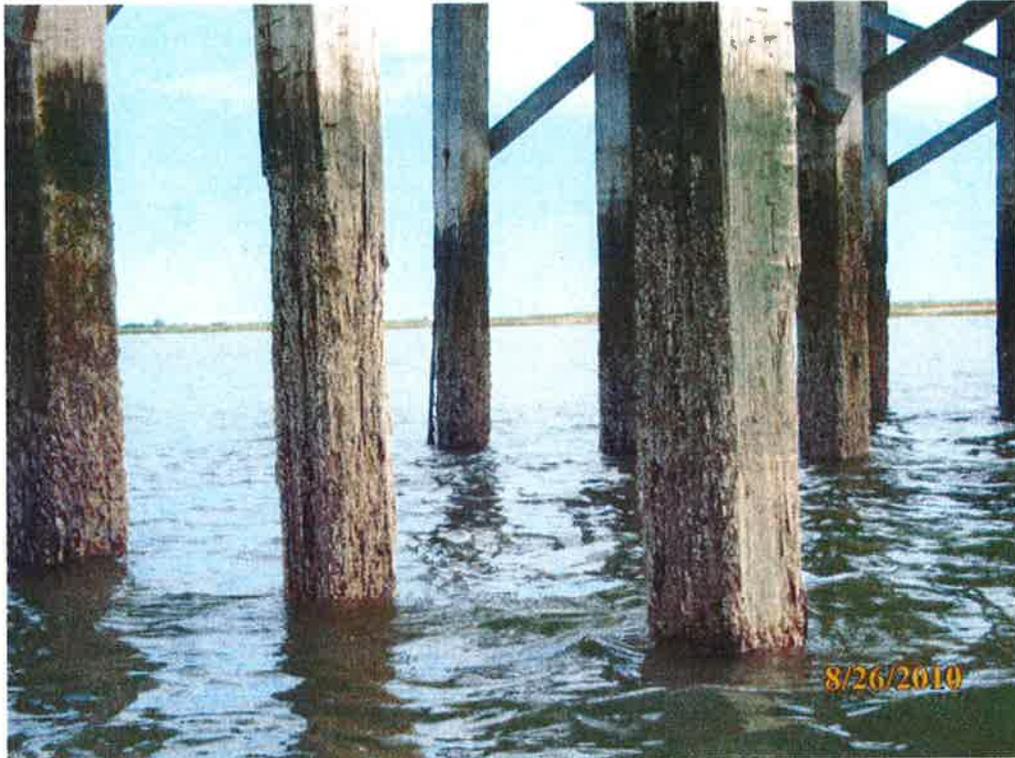
**Photo 37: Bent #40, Piles "D" and "E", showing brooming and checking up to 5" deep.**

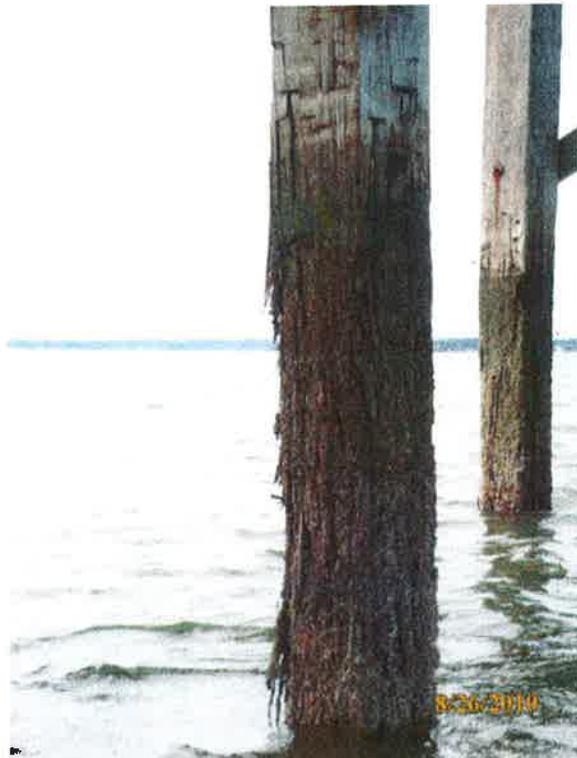
**Photo 38: Bent #42, Pile "C", showing heavy brooming and ring checks.**

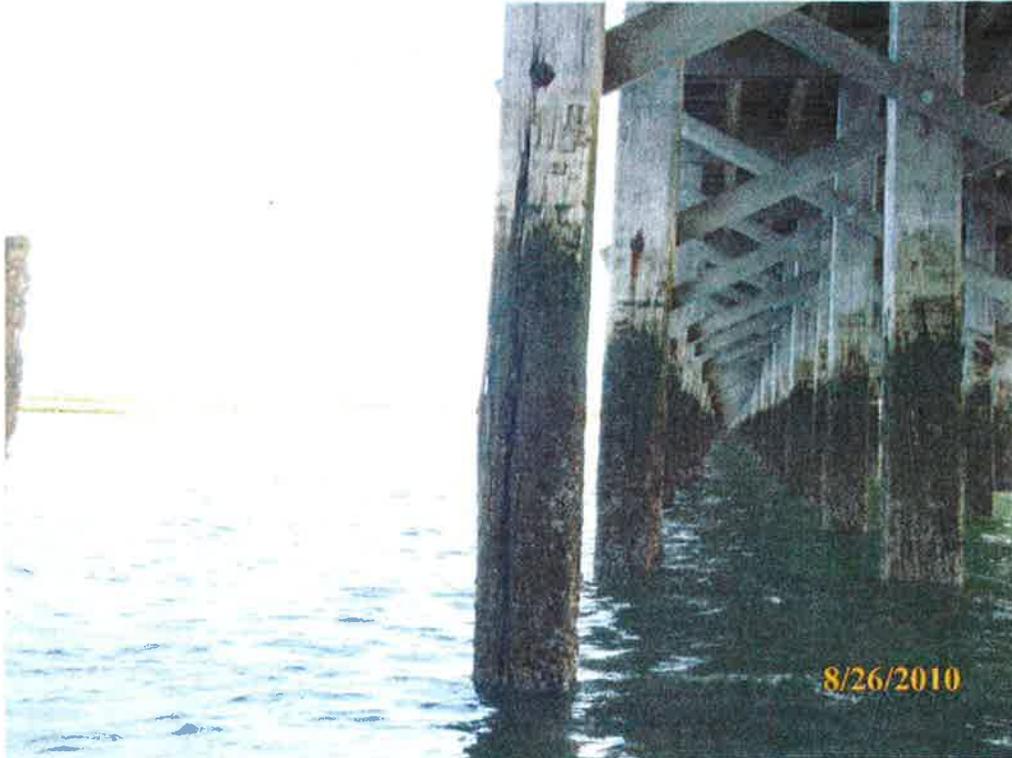
**Photo 39: Bent #43, Pile "A", showing ring check and wide checks up to 5" deep to the West face.**
