***Subject: Chatham, MA – Mitchell River Bridge Project  
Bridge Repair/Rehabilitation Feasibility Study***

**BRIDGE REPAIR/REHABILITATION FEASIBILITY**  
**STUDY**

**BRIDGE STREET**

**BRIDGE NO. C-07-001 (437)**

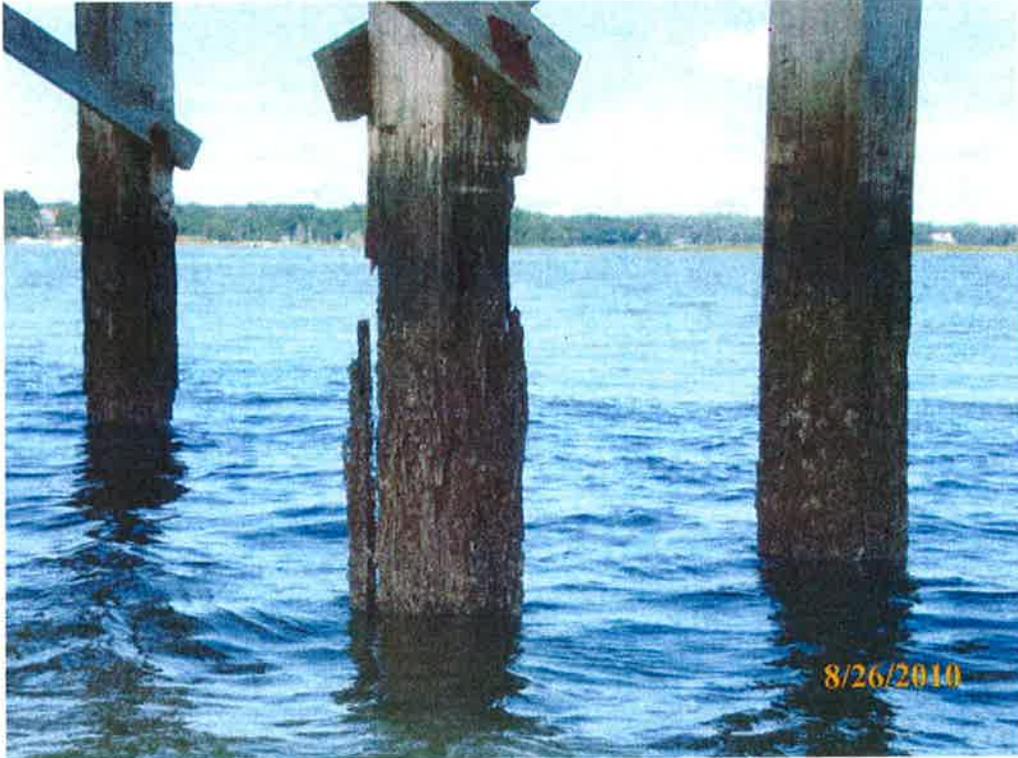
Photo 41: Bent #45, Pile "C", showing ring checks up to 5" deep

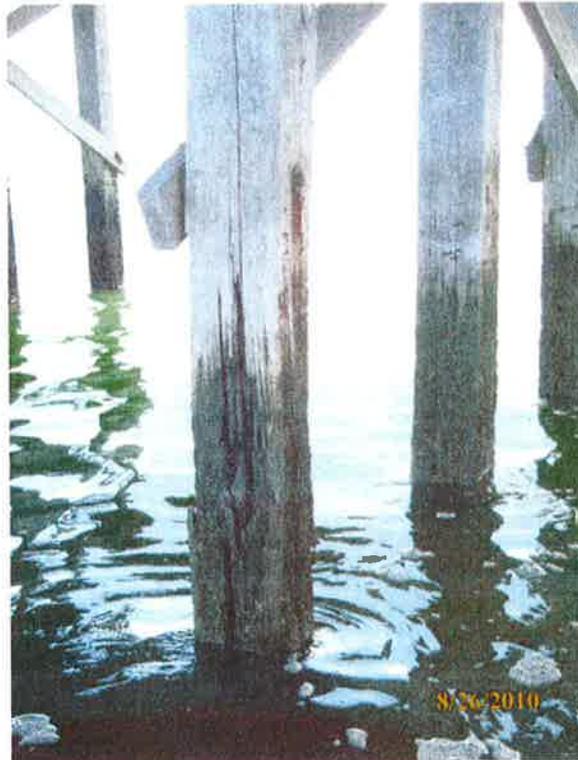
Photo 42: Bent #46, Pile "A", showing heavy deterioration and bowing outward at the West face.

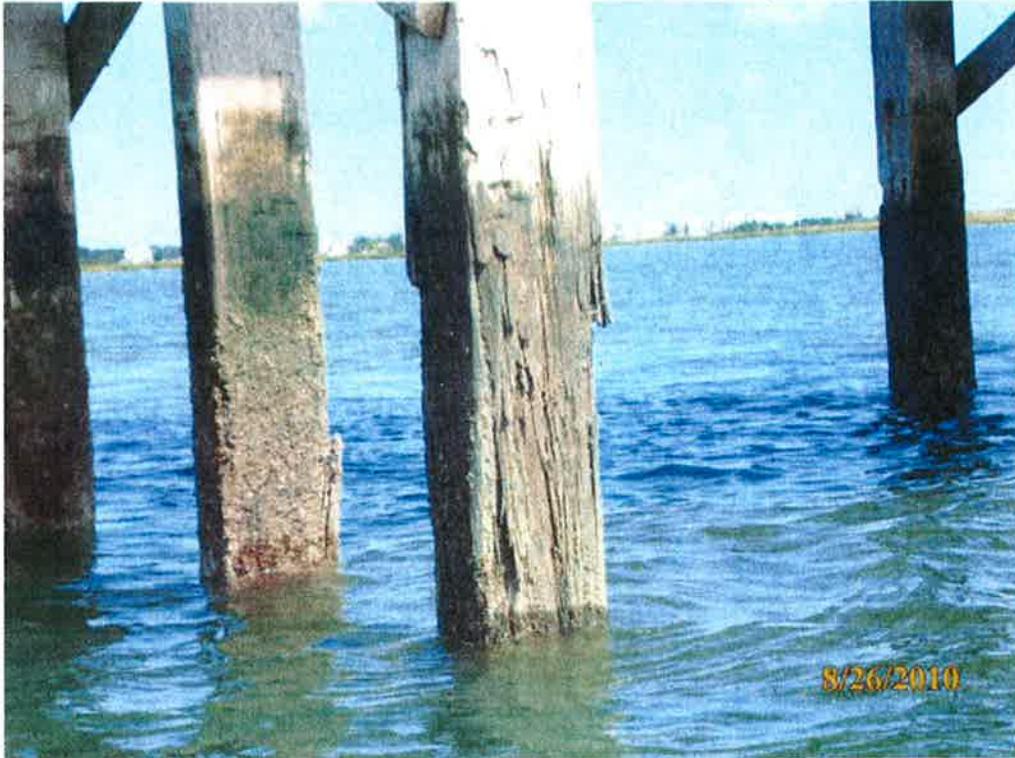
**Photo 43: Bent #46, Pile "E", showing ring checks at the corners up to 3" wide and splitting up to 5" deep.**

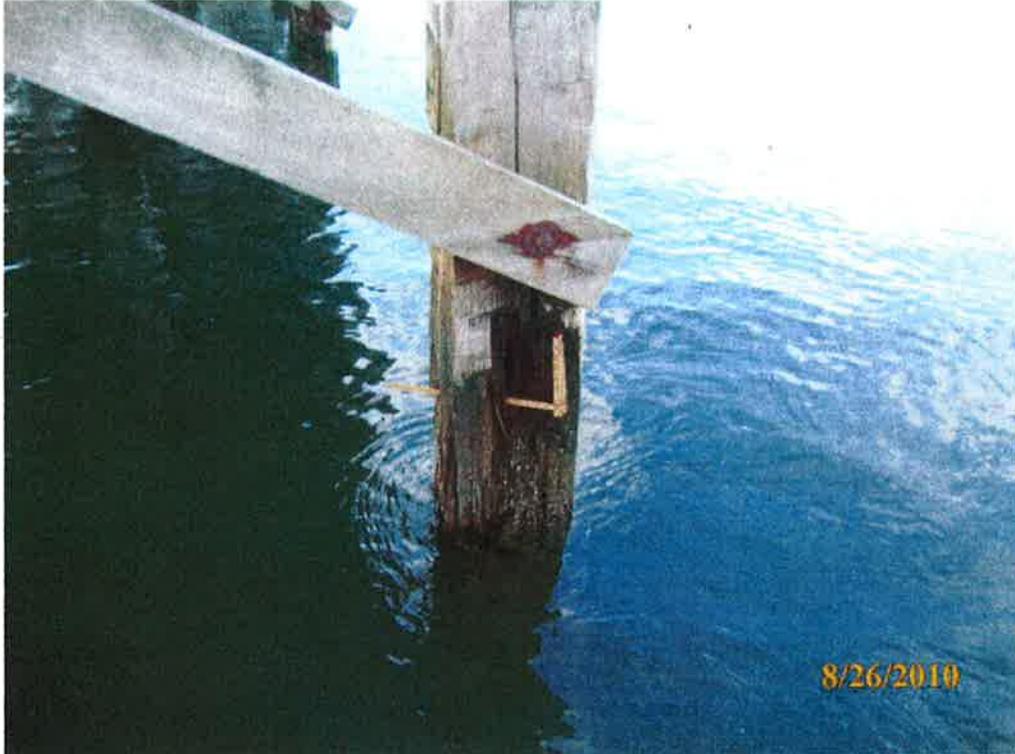
Pile D	1	3/8" wide check, full height x 4" deep
Pile E	1	Minor brooming in tidal zone
<b>BENT 51</b>		
Pile A	3+	Rotted wood to East face and Southeast corner up to 4.5" deep with delamination throughout; moderate brooming to East and West faces (see Photo #45)
Pile B	1	Minor brooming; check up to 2.5" deep
Pile C	2	3" wide ring checks to Northwest and Southwest corners; 3/8" wide x 1.5" deep check to South face
Pile D	2	2" wide ring checks to Northwest and Northeast corners; minor to moderate brooming throughout
Pile E	1

**Photo 45: Bent #51, Pile "A", showing heavy deterioration below brace, including ring checking up to 4.5" deep.**

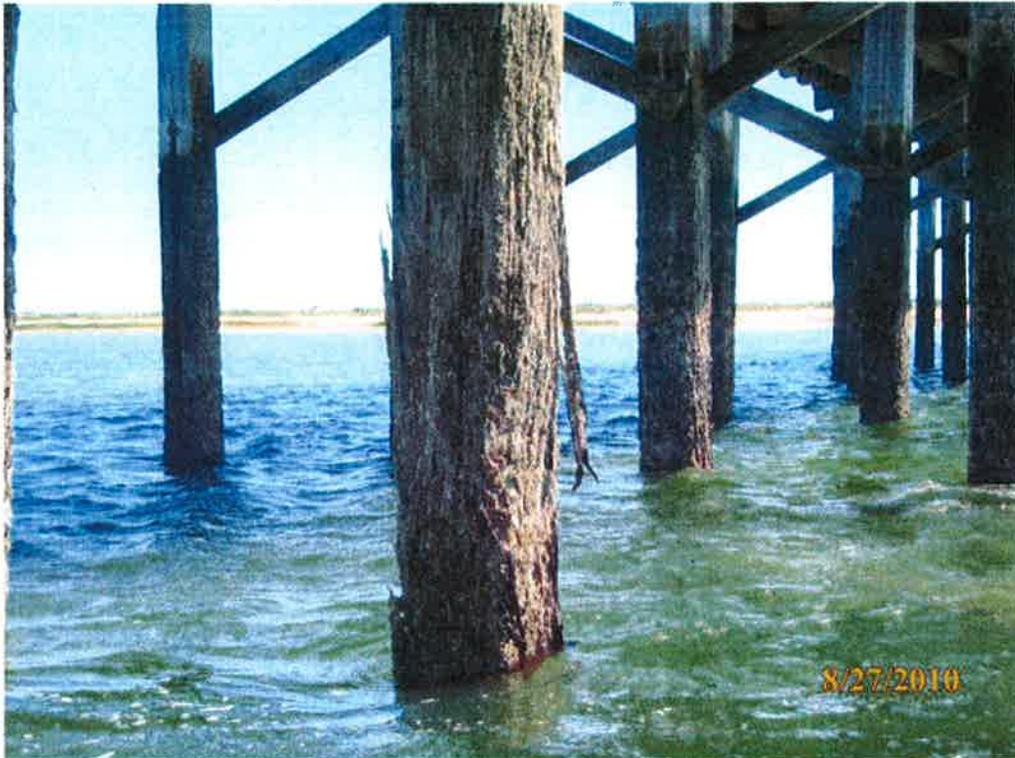
**Photo 47: Bent #59, Pile "D", showing extensive deterioration including brooming and delamination up to 2".**

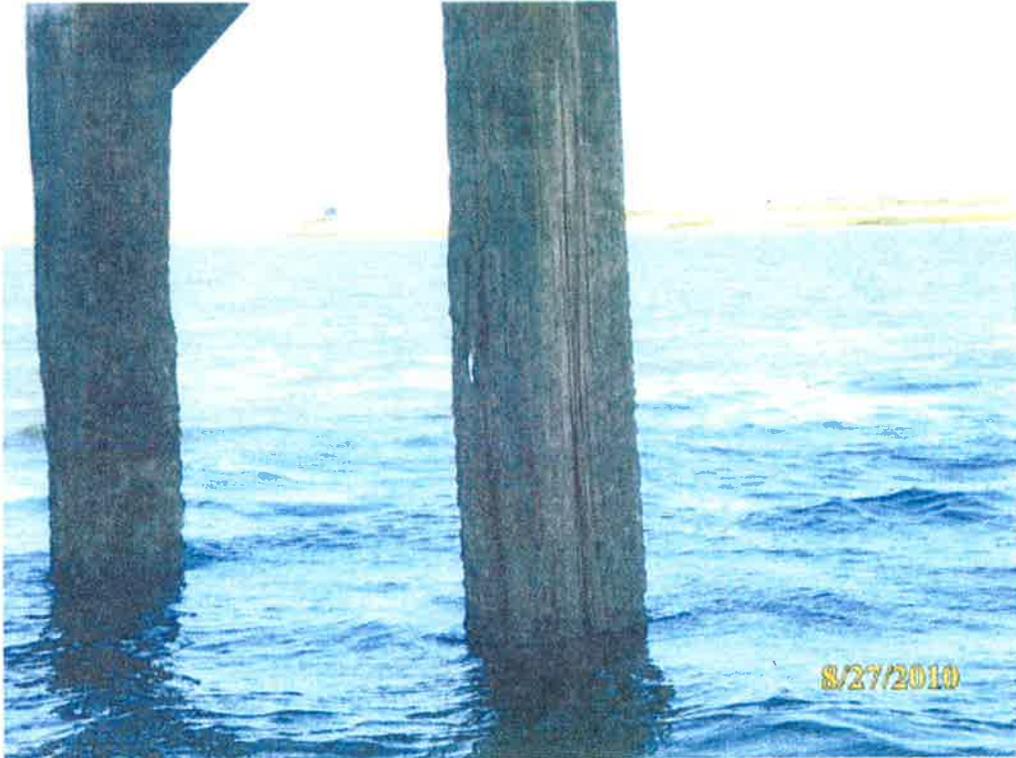
**Photo 49: Bent #65, Pile "B", showing extensive deterioration, including checks up to 6" deep.**

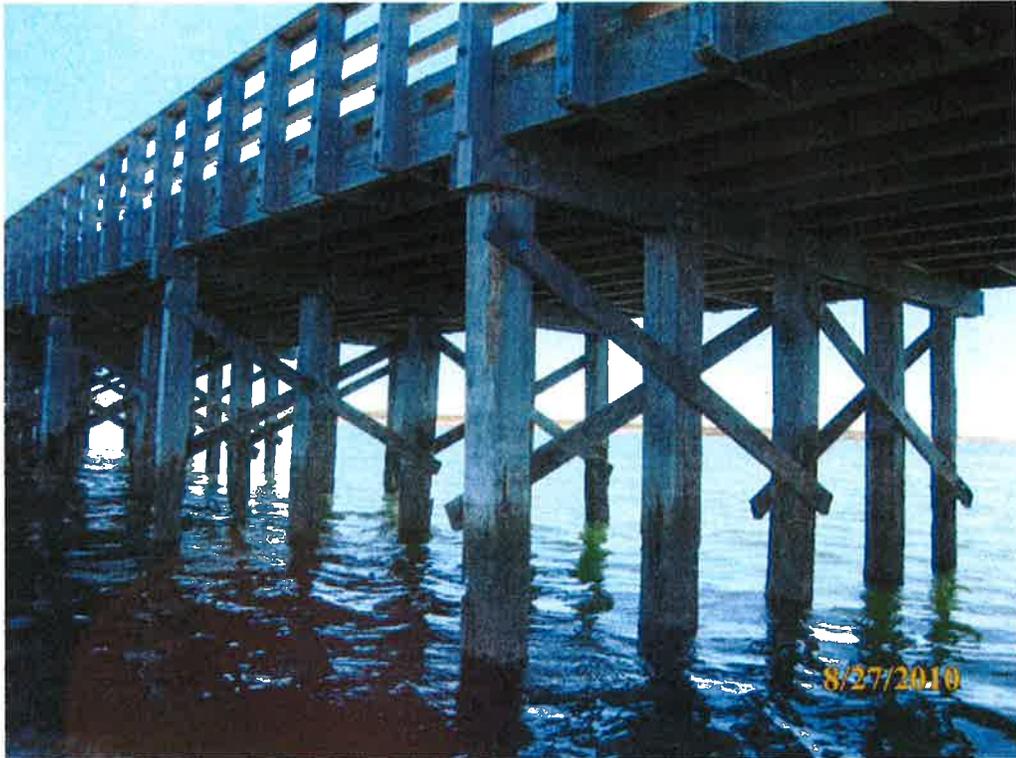
Photo 51: Bent #68, Pile "A", showing dry rot at the top of the Northwest corner up to 2" deep.

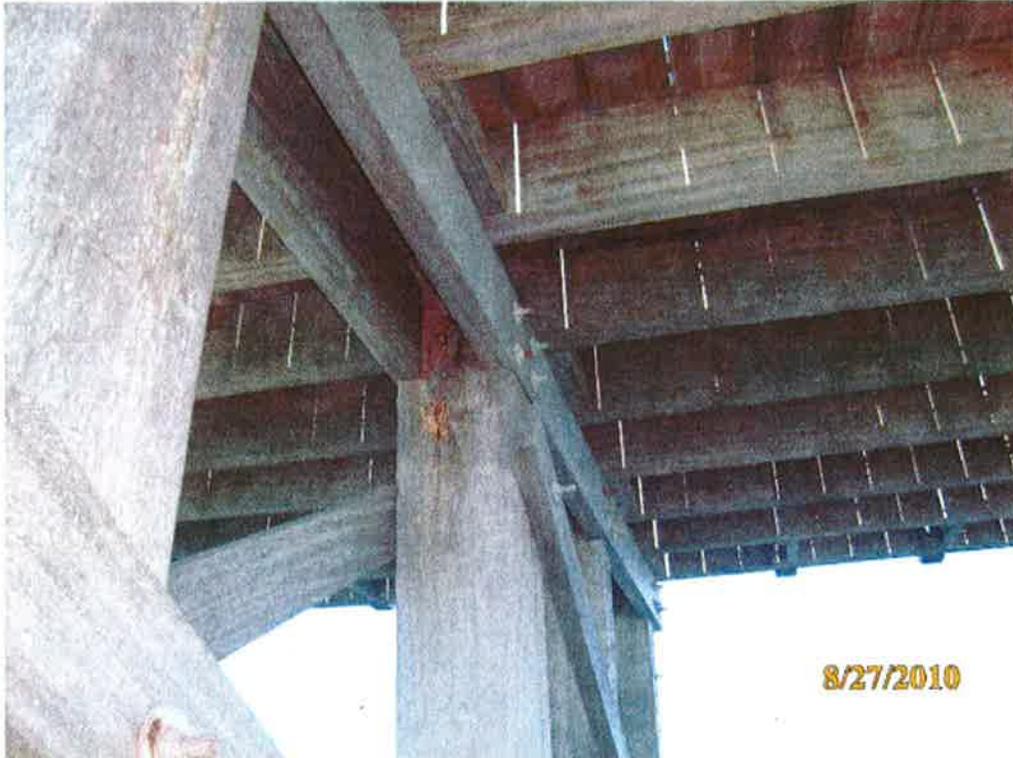
**Photo 53: Bent #69, Pile "C", showing minor brown rot at the top.**

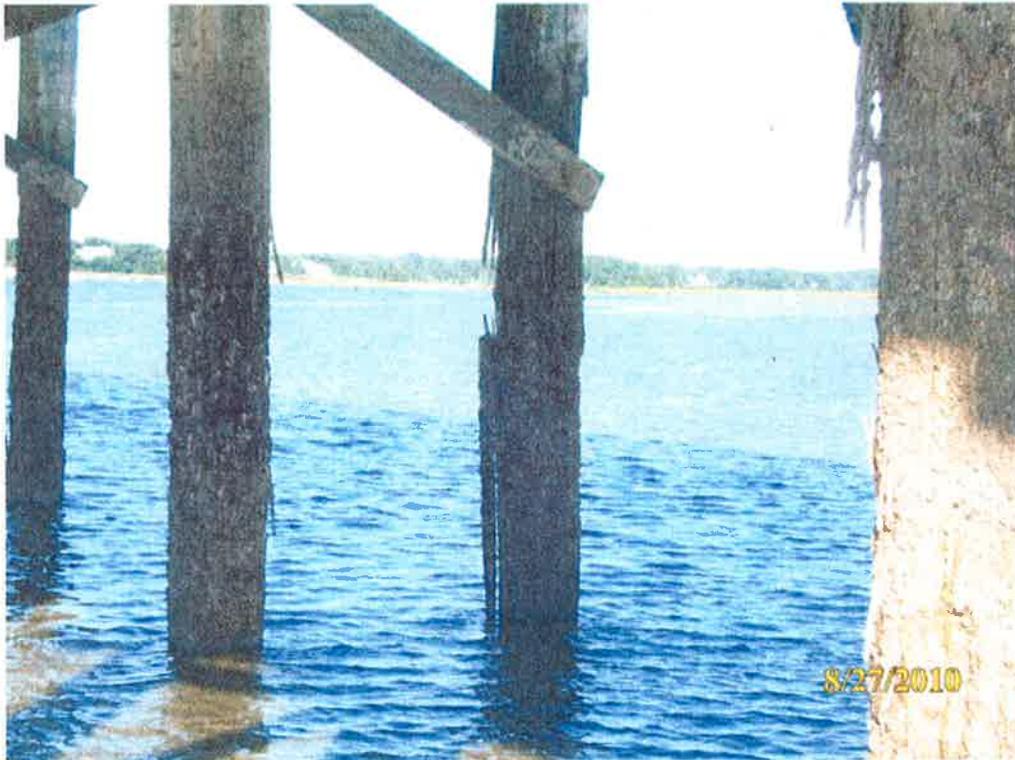
LOCATION	CONDITION	REMARKS
<b>Punky: Soft rot with minor penetration</b> <b>Delam.: Delamination (mainly brooming)</b> <b>Deterior.: Deterioration (Brooming, checks, rot)</b> <b>(+) Very Extensive</b>		
<b>BENT 86</b>		
Pile A	3	Heavy brooming; 3" wide ring check to Southwest corner (see Photo #55); bending of pile
Pile B	2	Moderate brooming
Pile C	2	Moderate brooming
Pile D	2	Moderate to heavy brooming; 2" wide ring check to Northeast corner
Pile E	1	
<b>BENT 87</b>		
Pile A	2 - 3	Moderate brooming; 1/2" wide check to South face in tidal zone
Pile B	3	Wide split from top past bracing to the East and West faces (see Photo #56)
Pile C	2	
Pile D	1	1/2" check to the top of the East face
Pile E	2	
<b>BENT 88</b>		
Pile A	2	Checks with moderate brooming; 1/4" full height check to the East face
Pile B	1	
Pile C	1	Minor to moderate brooming
Pile D	2	1/2" check to the top of the West face; 2" wide ring checks to Northeast and Northwest corners

**Photo 55: Bent #86, Pile "A", showing extensive deterioration, including brooming, 3" deep ring checks and bowing.**

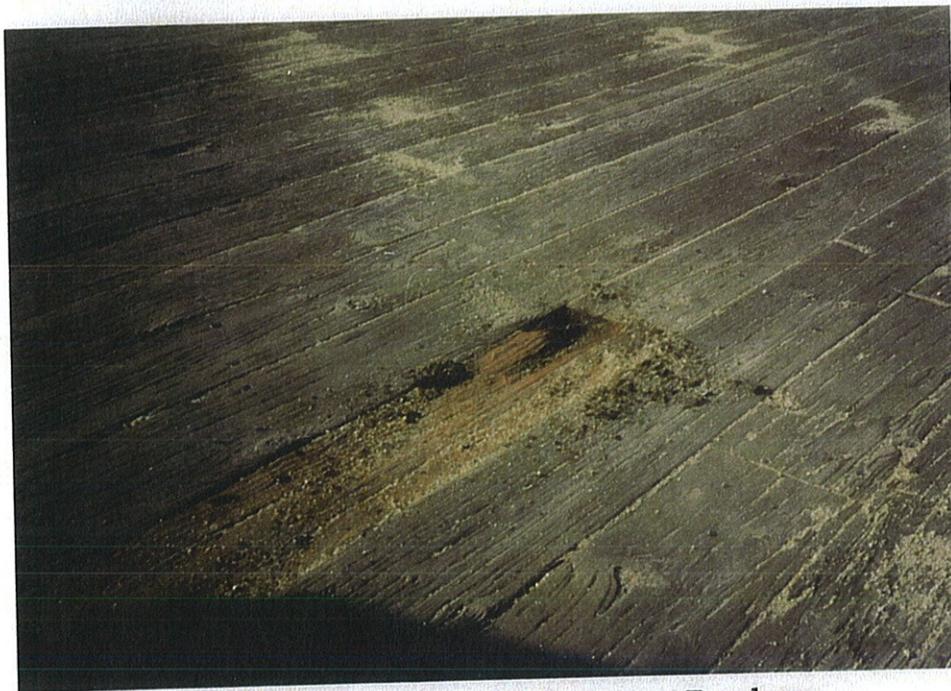
4. The diagonal deck wearing surface planks are in satisfactory condition with minor checks and splits, and medium punkiness at some locations. Approximately 15% of the planks have a soft rot of up to 1/2 inch from the top surface. This results in roughly a 20% loss of plank depth.

Deterioration of Wearing Surface at Roadway,  
 Looking North West from South Sidewalk (Photograph 6)

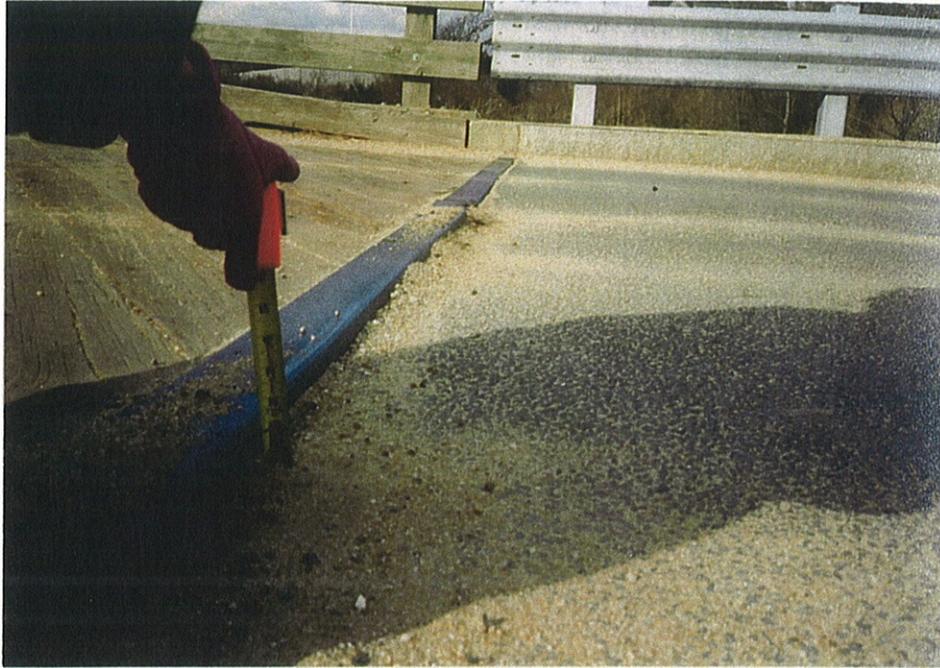
3. The approach roadway surface at the west and east abutment joints has settled. The settlement has resulted in a vertical misalignment of up to 1/2 inch on the south side at each abutment and poses a hazard for pedestrians.

Vertical Misalignment at Deck Joint over East Abutment, Looking North (Photograph 7)

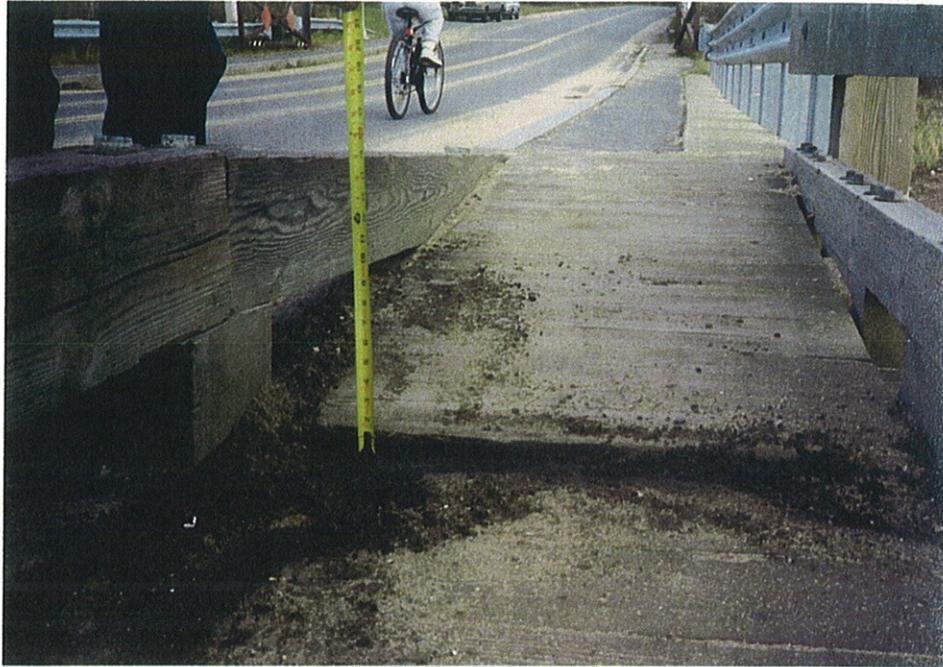
Vertical Misalignment at South East Sidewalk (Photograph 11)

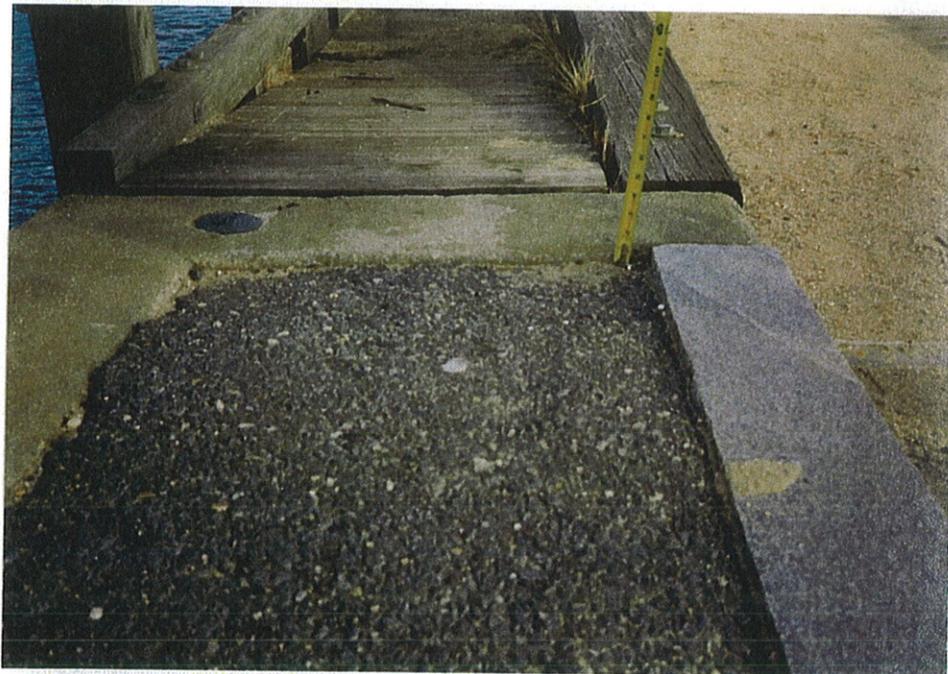
Vertical Misalignment at South East Sidewalk Approach (Photograph 12)

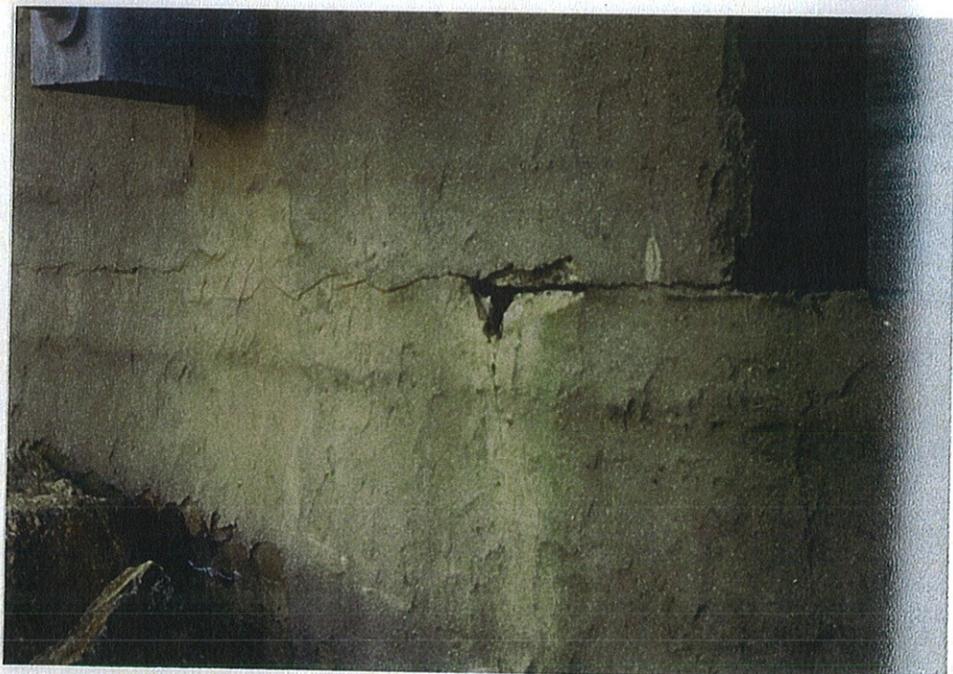
Crack Between Abutment and Backwall on South Side of West Abutment (Photograph 18)

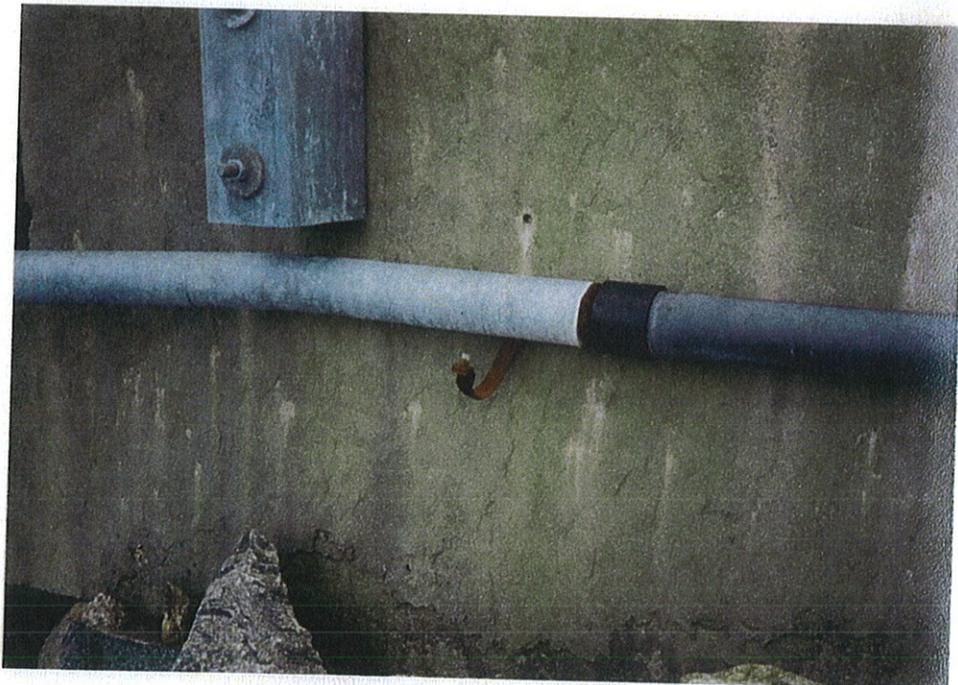
8. Minor cracks were observed on both abutments and the wingwalls. For detailed information of crack location and dimensions, please refer to the field notes, sketches and photographs.
9. Few of the hangers for the utility pipe on the north side of the bridge have deteriorated completely.
10. The bridge is presently not posted.

Typical Rusty and Broken Utility Pipe Bracket (Photograph 24)

New utility pipe hangers should be installed in place of the deteriorated and failed ones on the north side.
